# Greenbrook Townhouses Reserve Study

Reserve Study  
Project No. 15041

Prepared for  
Greenbrook Townhouses Association  
Aurora, Colorado

April 18, 2016

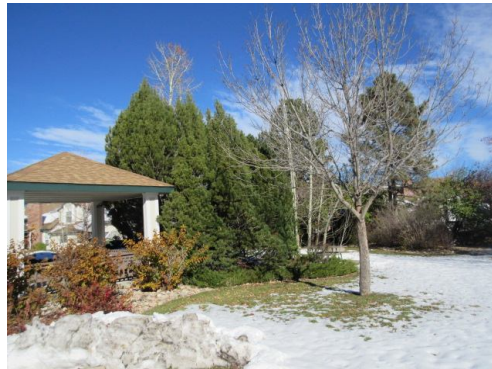
**Condition:** The building grading and drainage is in good to fair condition. It was noted that in several areas the grade next to the building foundation is quite flat.

- Cyclically regrade and maintain the earthen areas adjacent to the building foundation systems every 6 years, starting in 2018.

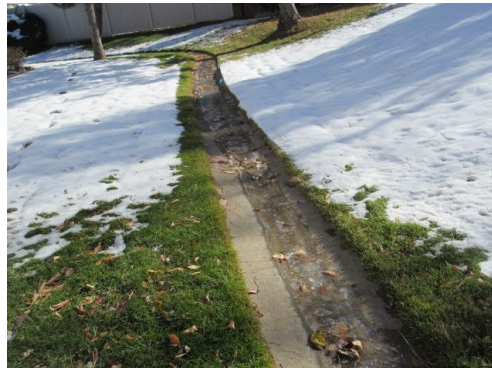
**Condition:** The onsite drainage systems are in good to fair condition. Some grass swales in areas are undefined and are in need of regrading to be more effective in conveying stormwater runoff.

- Cyclically regrade a portion of the grass swales every 8 years, starting in 2018.
- Cyclically check and clean debris from the metal grated inlets and area inlets along with replacement of damaged area inlet lids to ensure proper function every year. This cost is not included in the Study because normally associations perform this as a maintenance item and the cost is considered an operating expense.

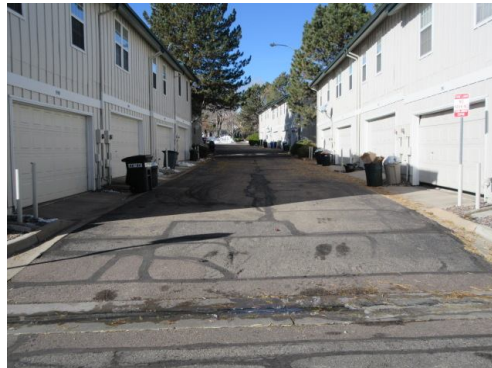
### Crackfill - 2017

**Condition:** Good to fair condition. Generally most of the asphalt pavement is structurally sound with some areas of stress cracking. There has been a lot of crack filling done which is good. There will be a need for full depth patch work over the next few years.

- Cyclically crackfill every year, starting in 2017.

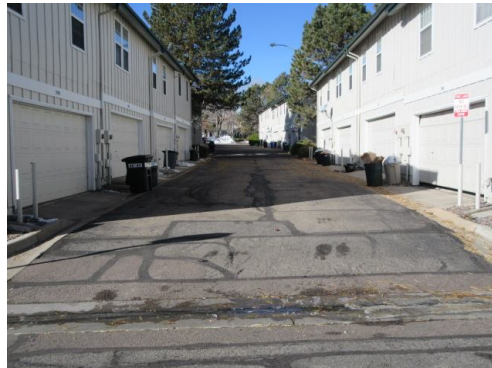
**Condition:** Good to fair condition. Generally most of the asphalt pavement is structurally sound with some areas of stress cracking. There has been a lot of crack filling done which is good. There will be a need for full depth patch work over the next few years.

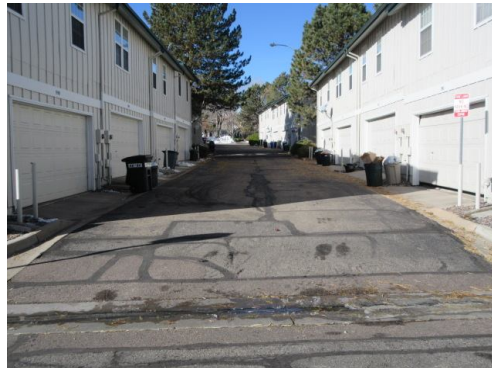
**Condition:** Good to fair condition. Generally most of the asphalt pavement is structurally sound with some areas of stress cracking. There has been a lot of crack filling done which is good. There will be a need for full depth patch work over the next few years.

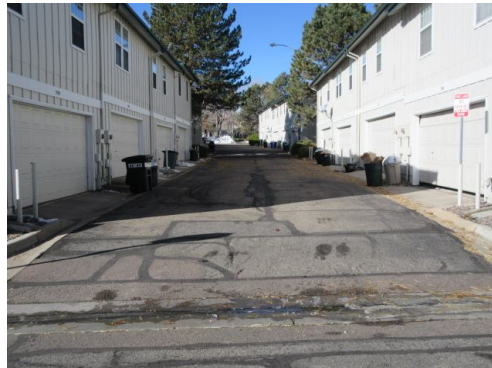
**Condition:** Good to fair condition. Generally most of the asphalt pavement is structurally sound with some areas of stress cracking. There has been a lot of crack filling done which is good. There will be a need for full depth patch work over the next few years.

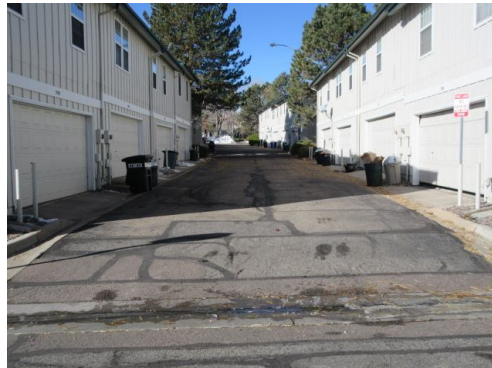
**Condition:** Good to fair condition. Generally most of the asphalt pavement is structurally sound with some areas of stress cracking. There has been a lot of crack filling done which is good. There will be a need for full depth patch work over the next few years.

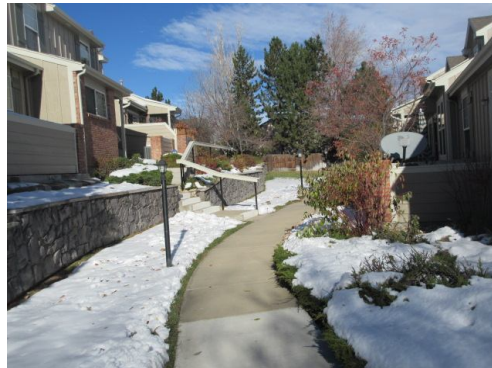
### Replace damaged sections - 2020

**Condition:** Good condition.

- Cyclically remove and replace damaged sections of the concrete walkways every 6 years, starting in 2020.
- Inspect the surface and repair any cracks or deteriorating concrete walkways every year. This cost is not included in the Study because normally associations perform this as a maintenance item and the cost is considered an operating expense.

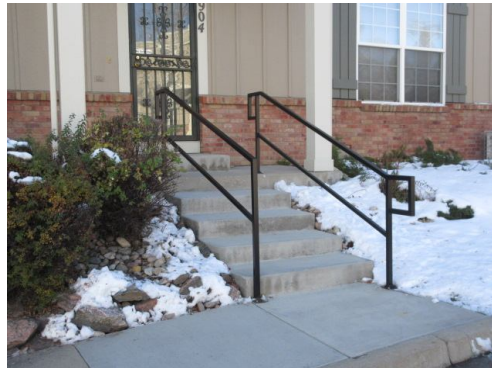
### Replace damaged sections - 2022

**Condition:** Good condition with no visual signs of deterioration or cracking.

- Cyclically remove and replace damaged sections of the concrete stairs every 10 years, starting in 2022.
- Inspect the surface and repair any cracks or deteriorating concrete stairs every year. This cost is not included in the Study because normally associations perform this as a maintenance item and the cost is considered an operating expense.

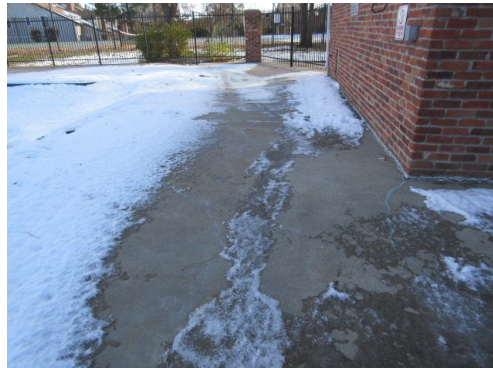
### Replace damaged sections - 2017

**Condition:** Good to fair condition with some random cracking. The concrete pool deck is moderately covered with cracks and it has been maintained by the use of crack sealant.

- Cyclically remove and replace damaged sections of the concrete pool deck every 6 years, starting in 2017.
- Inspect the surface and repair any cracks or deteriorating concrete pool deck every year. This is not included in the Study because normally associations perform this as a maintenance item and the cost is considered an operating expense.

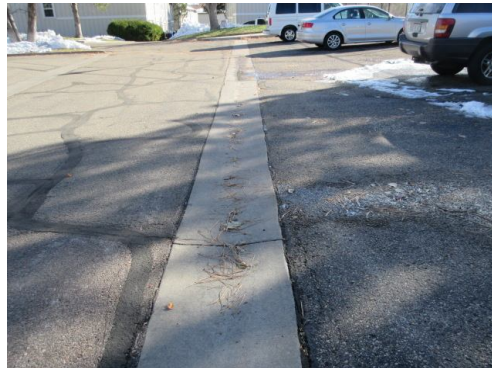
### Replace damaged sections - 2020

**Condition:** All concrete drain pans are in good to fair condition.

- Cyclically remove and replace damaged sections of the concrete drain pans every 5 years, starting in 2020.
- Inspect the surface and repair any cracks or deteriorating concrete pan every year. This cost is not included in the Study because normally associations perform this as a maintenance item and the cost is considered an operating expense.

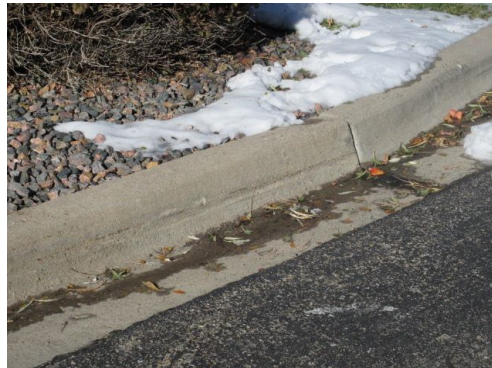
### Replace damaged sections - 2016

**Condition:** Good to fair condition. Most communities typically replace damaged sections of curb and gutter as needed rather than 100% replacement.

- Cyclically remove and replace damaged sections of the concrete curb and gutter every 6 years, starting in 2020.
- Inspect the surface and repair any cracks or deteriorating concrete curbs every year. This cost is not included in the Study because normally associations perform this as a maintenance item and the cost is considered an operating expense.

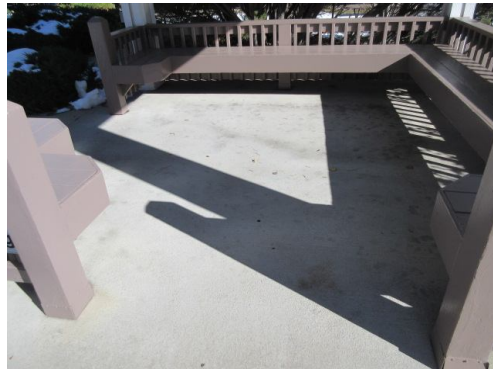
**Condition:** The concrete slabs are in good condition.

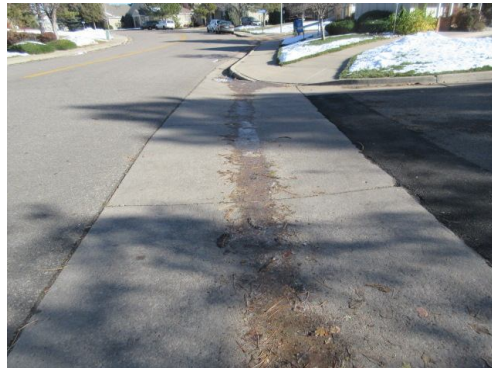
### Replace damaged sections - 2021

**Condition:** Good to fair condition.

- Cyclically remove and replace damaged sections of the concrete slabs every 7 years, starting in 2021.
- Inspect the surface and repair any cracks or deteriorating concrete cross pans every year. This cost is not included in the Study because normally associations perform this as a maintenance item and the cost is considered an operating expense.

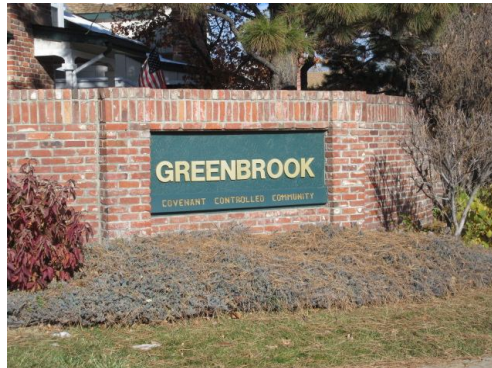
**Condition:** Good to fair condition.

- Cyclically tuck-point the mortar joints and replace any damaged or deteriorated bricks every 10 years, starting in 2022.
- Inspect and maintain the concrete signs and lettering every year. This cost is not included in the Study because normally associations perform this as a maintenance item and the cost is considered an operating expense.

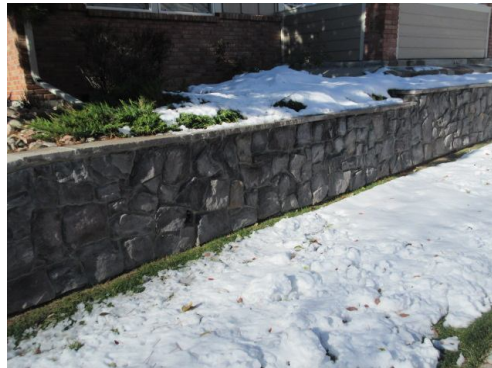
**Condition:** Excellent condition. We were informed that the wall was built in 2009.

- Cyclically tuck-point the mortar joints and replace any damaged or deteriorated stones every 10 years, starting 2022. The cost is not included in the Study because it falls below the minimum fund threshold.

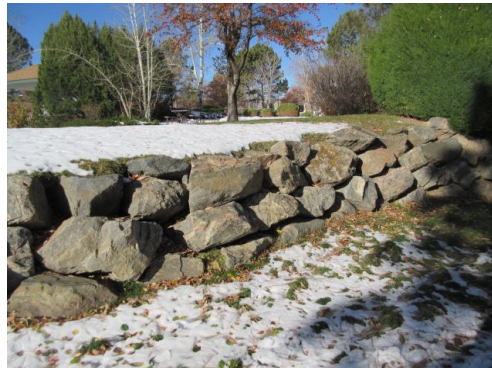
### Restack and repair - 2025

**Condition:** Good to fair condition.

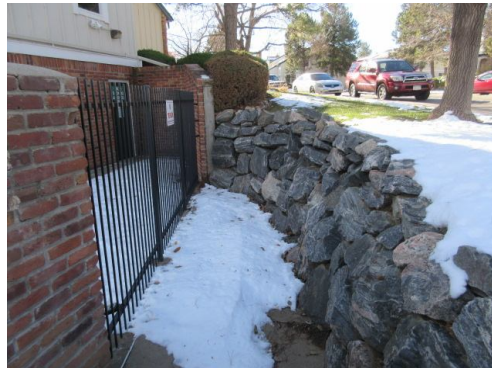
**Condition:** Good to fair condition.

- Cyclically tuck-point the mortar joints and replace any damaged or deteriorated bricks every 10 years, starting in 2019. The cost is not included in the Study because it falls below the minimum fund threshold.

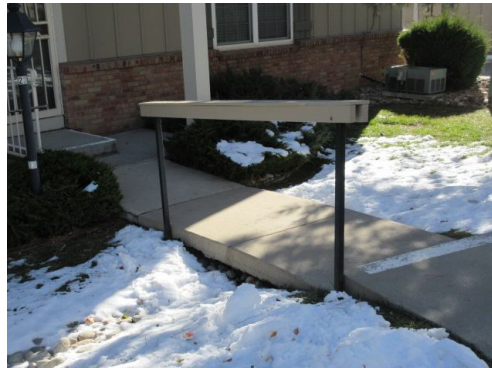
### Scrape, rust proof and paint - 2018

**Condition:** Good to fair condition.

- Cyclically scrape, rust proof and paint the metal and wood handrails every 6 years, starting in 2018.

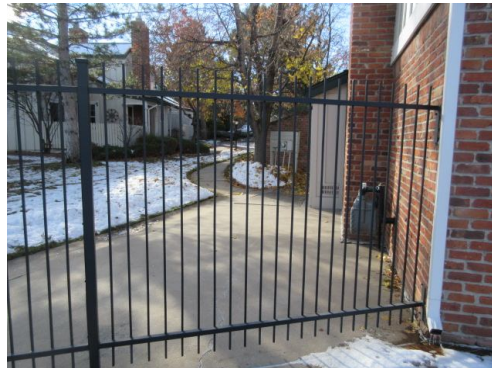
### Remove and replace - 2025

**Condition:** Good to fair condition.
