Regarding: Reserve Study Final Version

Level 1, Platinum Reserve Analysis

Innsbruck in Aurora COA, Inc. 2503 S. Peoria Aurora, CO. 80014

Date of Property Observation – August 30, 2022

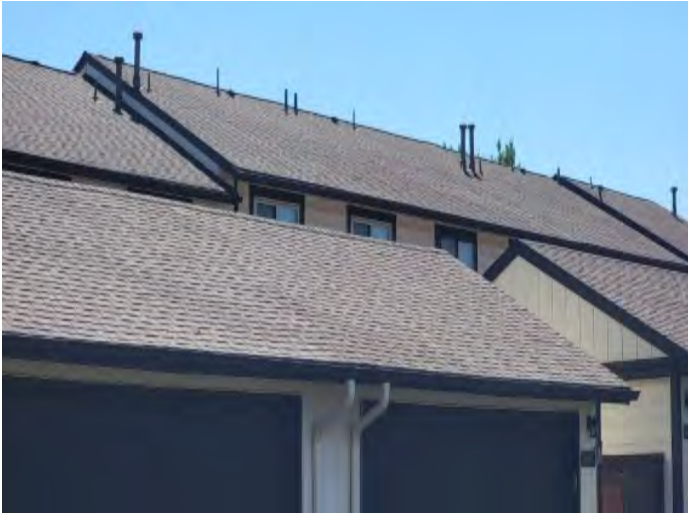
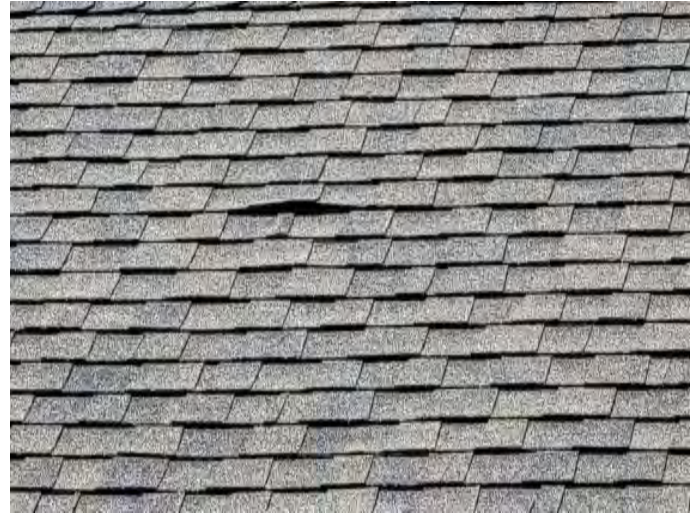
Comp #: 105 Comp Shingle Roof - Replace

- It was reported roofs were replaced in 2008. From a ground level observation point (temperatures were too hot to access roofs without causing damage), current conditions exhibit normal signs of wear and deterioration
- It appears this roof material is rated as a 30 - 40 year product. Despite this rating, a life expectancy of 18 - 20 years is expected in this environment.
- Due to the potentially harsh winters, extensive freeze/thaw cycle, and likelihood of hail events over the useful life of the roof, we typically see associations replacing roofs sooner than the manufacturer's suggested useful life.
- Remaining life is based on age of roof and observed conditions.

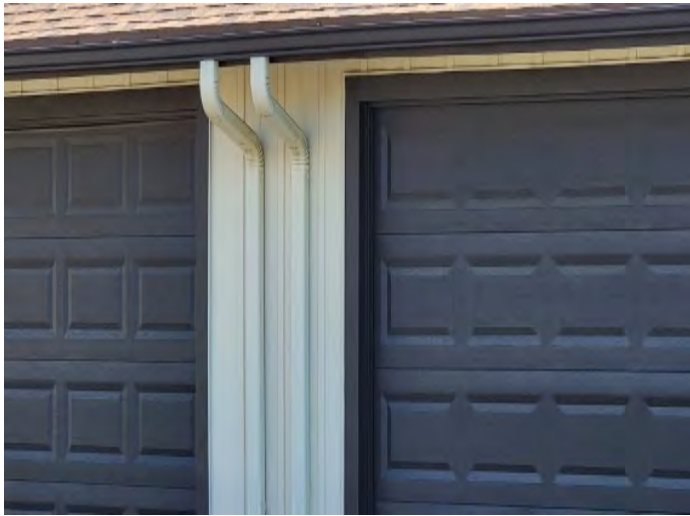
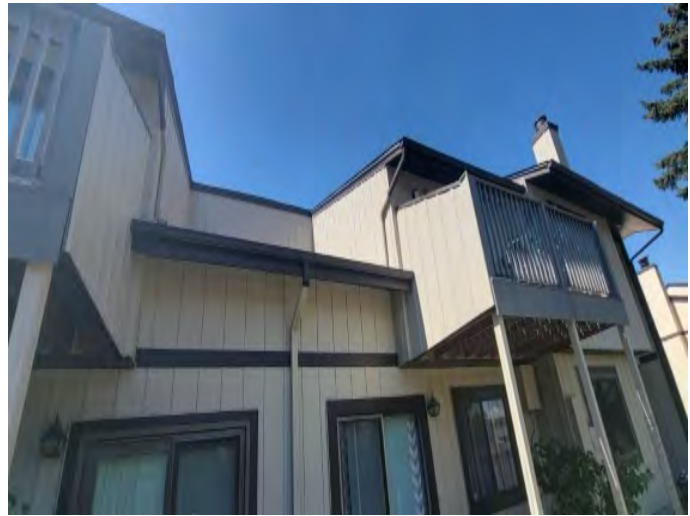
Comp #: 120 Gutters/Downspouts - Replace

- No unusual conditions observed or reported at time of site visit. It was reported gutter lines were moved to front of the garage units in 2003 due to water originally draining into the private patio.
- The average life expectancy for gutter lines ranges between 20 - 25 years depending on the quality of the materials. However, it is typical to replace at same time as roofing materials for best drainage results.
- Lines should be cleaned out at least twice a year to prevent clogging of lines and moisture retention that will cause premature deterioration.

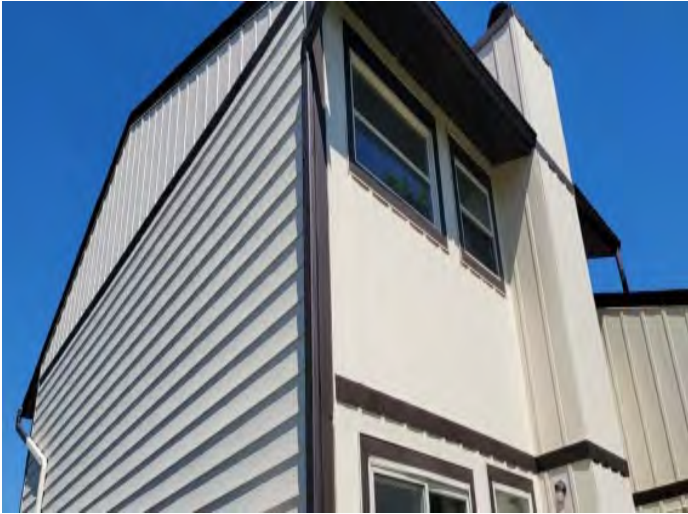
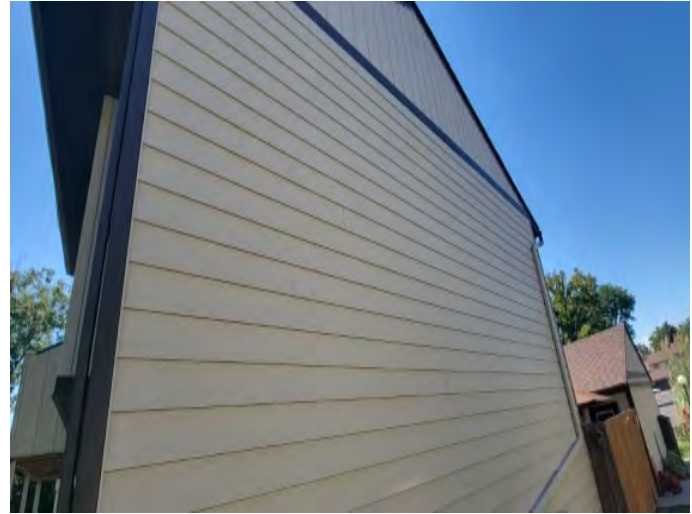
Comp #: 204 Building Ext Surfaces - Repair/Repaint (Ph 1)

- Metal siding and trim is in process of being painted in three different phases. This line item covers the first phase that was completed in 2020
- We recommend that all exterior surfaces (body, trim, decking, railings, soffits, etc.) are painted every 7 - 10 years, depending on the type of base materials
- This cycle is recommended in order to protect the base materials from exposure to elements and maintain an appropriate appearance.
- Proper prepping, and minor maintenance, should take place with every painting cycle.

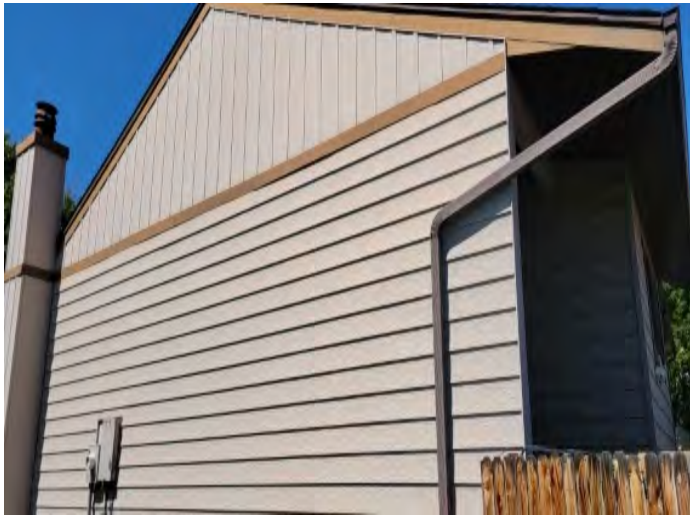
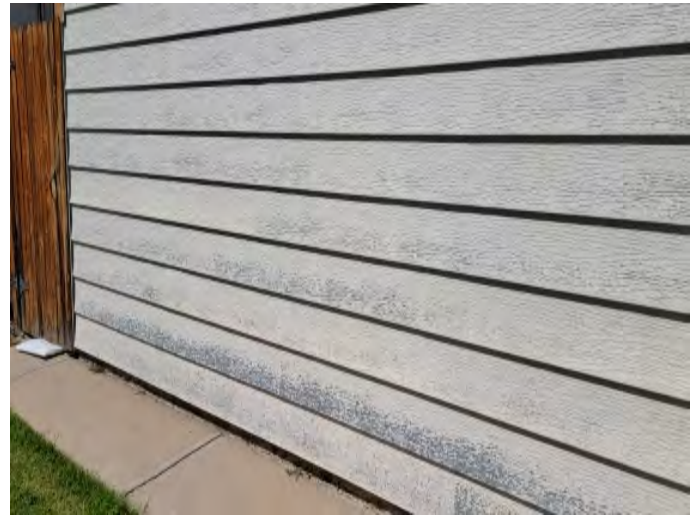
Comp #: 204 Building Ext Surfaces - Repair/Repaint (Ph 3)

- Metal siding and trim is in process of being painted in three different phases. This line item covers the last phase that was completed in 2022 (painting was occurring at the time of our site visit)
- We recommend that all exterior surfaces (body, trim, decking, railings, soffits, etc.) are painted every 7 - 10 years, depending on the type of base materials
- This cycle is recommended in order to protect the base materials from exposure to elements and maintain an appropriate appearance.
- Proper prepping, and minor maintenance, should take place with every painting cycle.

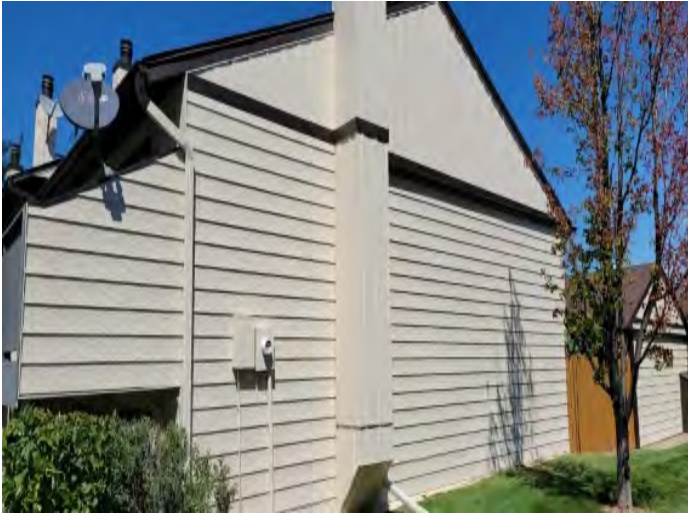
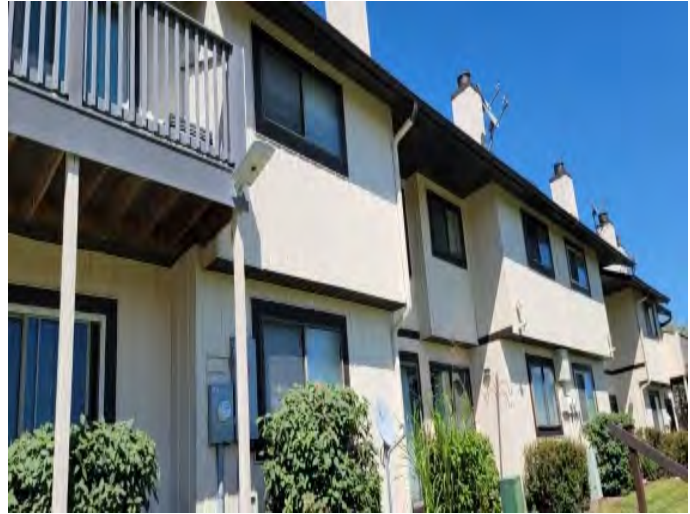
Comp #: 204 Building Ext Surfaces - Repair/Repaint (Ph 2)

- Metal siding and trim is in process of being painted in three different phases. This line item covers the second phase that was completed in 2021
- We recommend that all exterior surfaces (body, trim, decking, railings, soffits, etc.) are painted every 7 - 10 years, depending on the type of base materials
- This cycle is recommended in order to protect the base materials from exposure to elements and maintain an appropriate appearance.
- Proper prepping, and minor maintenance, should take place with every painting cycle.

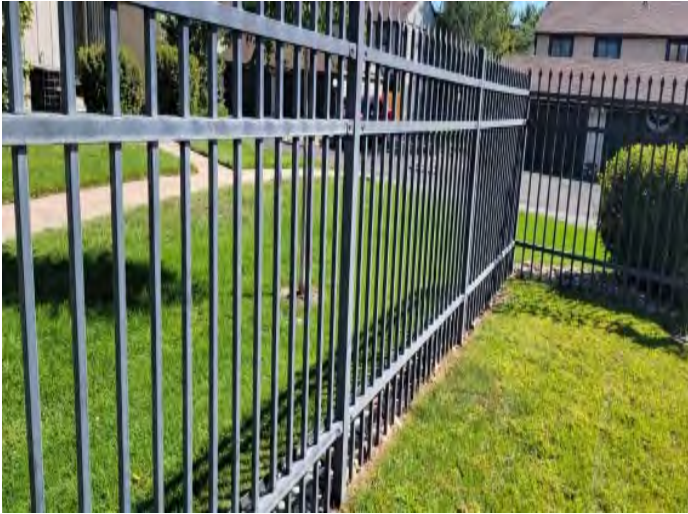
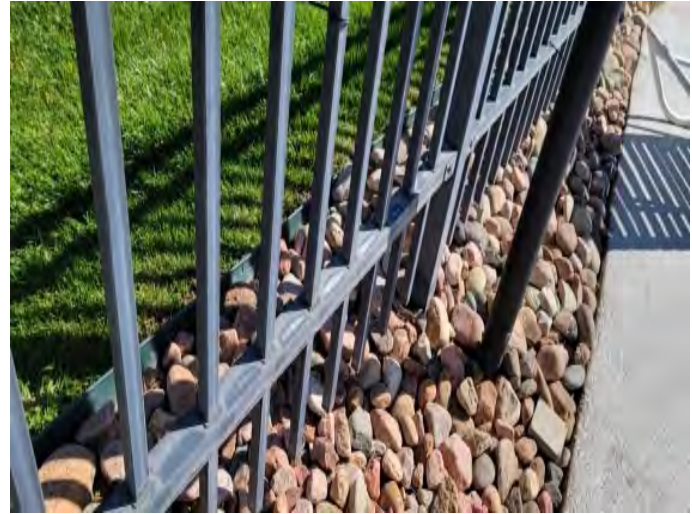
Comp #: 207 Aluminum Fencing - Repaint

- Fence around the pool area is dull and faded, paint would improve appearance.
- This type of fence should be repainted every 4 - 5 years to protect the metal from deterioration
- The proper way to paint aluminum fencing is by cleaning the surface, remove any loose or flaking paint, apply a primer so the paint adheres to the surface properly, then application of new paint.
- By following this process, paint should last 7 - 10 years, as opposed to 4 - 6 years if proper prep is not followed.

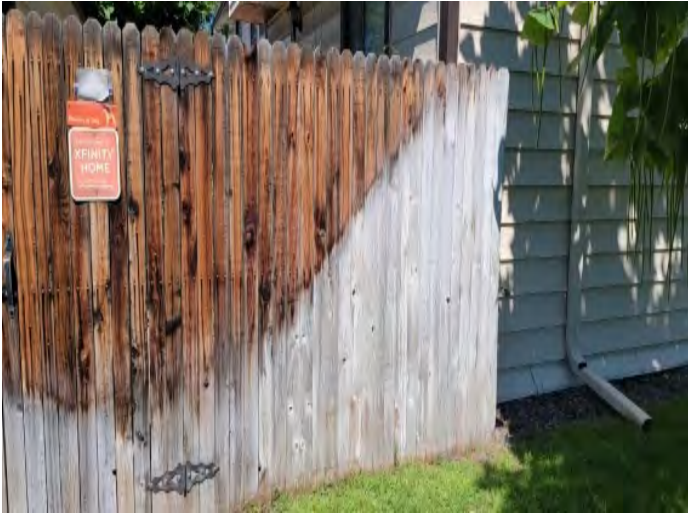
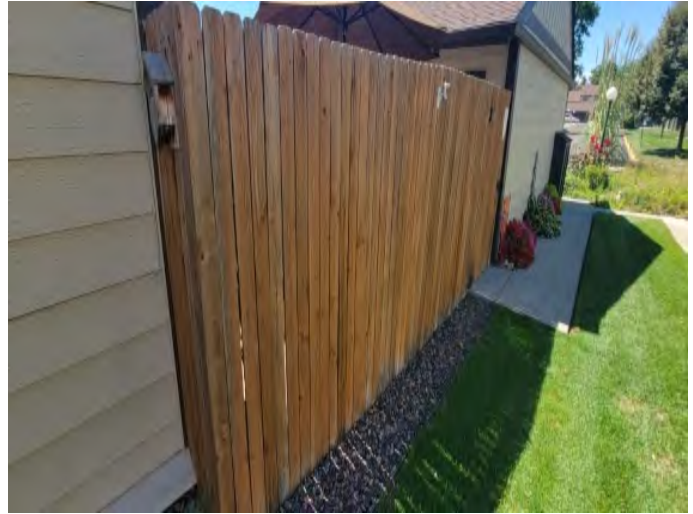
Comp #: 209 Wood Fencing - Restain

- Some fences have been stained, while others remain as raw wood and exhibiting some water stains from irrigation spray.
- It appears it is up to the homeowner as to whether they prefer to have stained fences.
- Therefore, since this is a homeowner expense, and not a common responsibility, Reserve funds are not required for this component

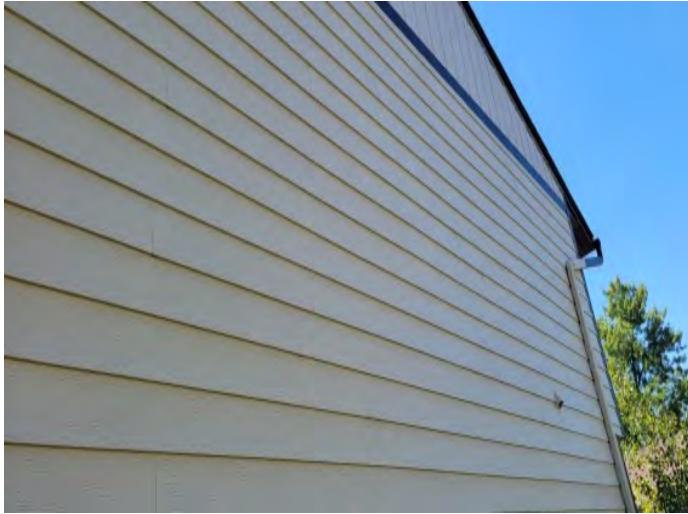
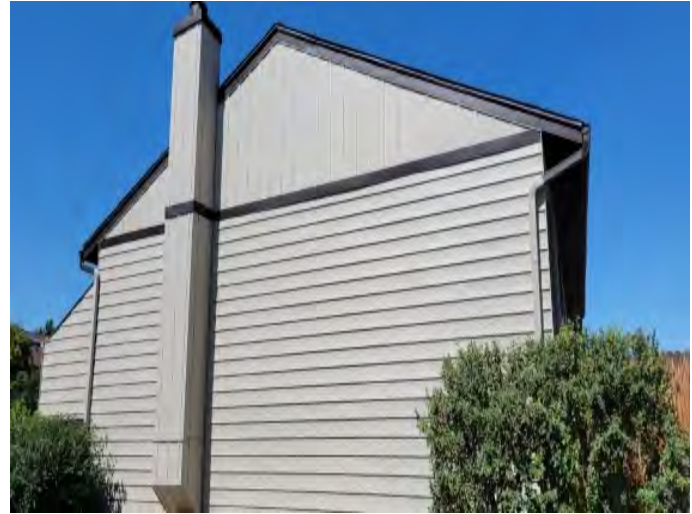
Comp #: 310 Metal Siding - Replace

- Metal siding materials were replaced in the mid 1990's and is still in very good condition. The original finish was beginning to fade and required painting, which began in 2020. Any damaged siding or trim is repaired as part of prep work before painting.
- Under normal conditions, this type of siding has an extended life expectancy and replacement is unlikely.
- Therefore, at this time, Reserve funding is not required, as long as materials are repaired and painted on a routine schedule
- Continue to monitor in future Reserve Study updates and if conditions change, then consider adding funding

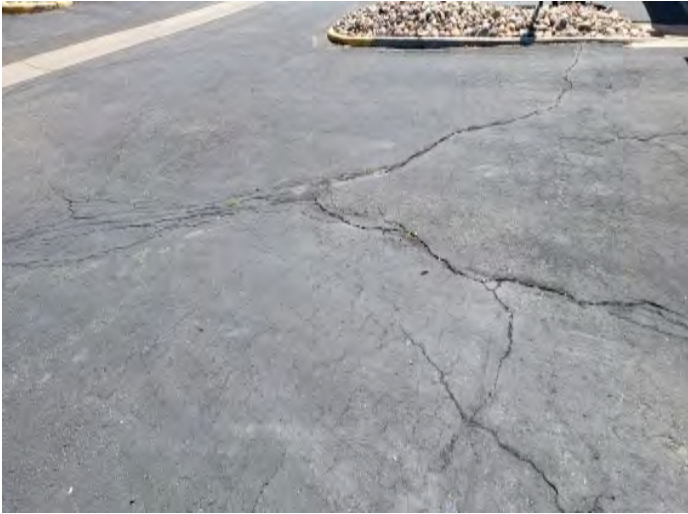
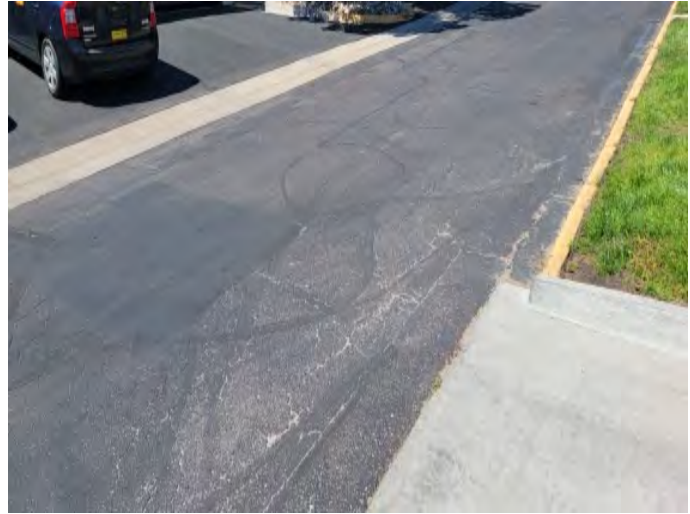
Comp #: 401 Asphalt - Major Overlay

- It was reported the asphalt has been milled and overlaid once since the community was constructed, The exact year this was performed is unknown.
- The average life expectancy for asphalt surfaces ranges between 20 - 27 years for surfaces that are maintained on a regular schedule.
- Maintenance includes crack fill and repairing small potholes annually as an operating expense.
- In addition, asphalt should be seal coated every 3 - 4 years, depending on the level of traffic and snow removing techniques.

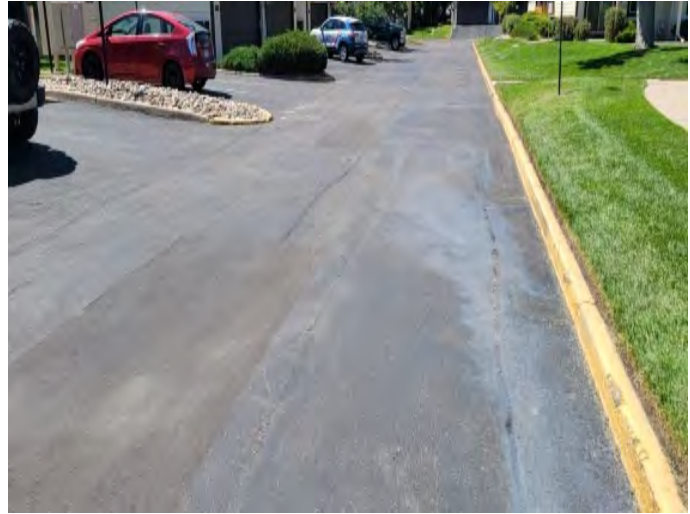
Comp #: 402 Asphalt - Surface Application

- Current conditions are fair to poor with some thin areas, and sections that are raveling.
- Surface treatments are used to extend the useful life of asphalt and to help maintain aesthetics; there are a broad range of products to choose from so we recommend consulting a reputable contractor for your community's needs.
- The recommendation is an allowance for the mid range surface treatments that are available in today's market.
- Expect to seal coat, chip seal or slurry seal, and repair (infrared heats) raveling sections of asphalt every 4 - 5 years, as the asphalt ages it may be necessary to adjust the frequency and or cost of these projects.

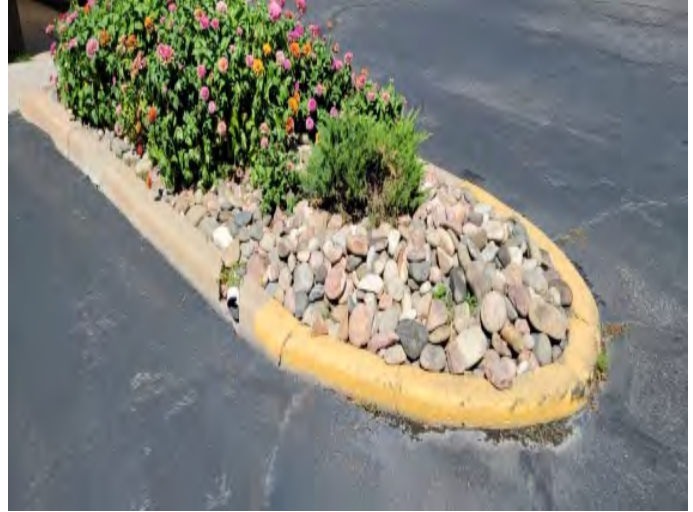
Comp #: 403 Concrete Drive Materials - Partial Replace

- Majority of the drain pans are in good condition, but many curbs and gutters are cracked and damaged.
- It is unlikely that all concrete will fail and need to be replaced at the same time. Therefore, we recommend reserving an allowance for periodic repairs to a percentage (10% or 1100 GSF) of the total area.
- Coordinate this project with other concrete and/or asphalt projects for best cost estimates based on quantity of work.
- This line item is not intended to be interpreted as complete replacement.

Allowance to replace 10% of area every 4 yrs.

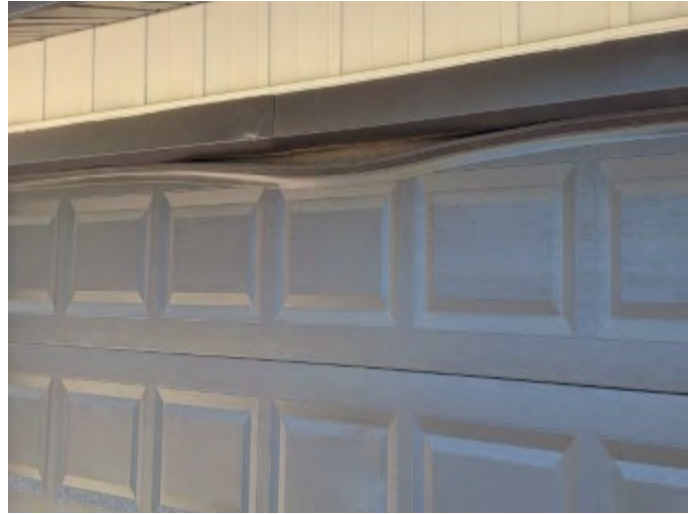
Comp #: 502 Garage Doors - Replace

- According to Article 8, subsection 1 (a), the association shall maintain the exterior of the buildings, provided however that such exterior maintenance shall not include doors (except painting).
- Some associations decide to include garage doors as an association expense to obtain the best cost available and to maintain a consistent appearance for the association.
- Unless otherwise noted, Reserve funding will not be included based on the rules stated in the declarations.
- We suggest the association establish a design guideline so that when an owner goes to replace a door, it will match and be consistent with the others.

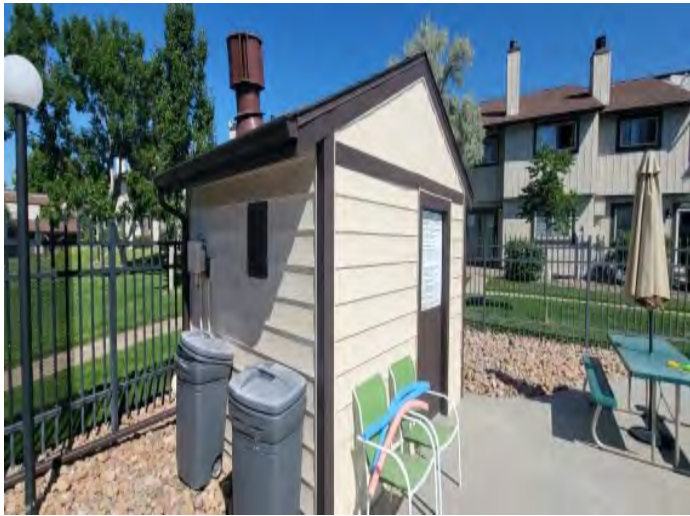
Comp #: 503 Doors - Replace

- It was reported a door was replaced at 12010 E. Harvard Street in 2021.
- However, the declarations indicate doors are the responsibility of the owner, not the association
- The only common area door the association is responsible for is the door for the pool equipment shed.
- Due to small quantity of doors, we recommend replacing on an as needed basis with general operating funds.

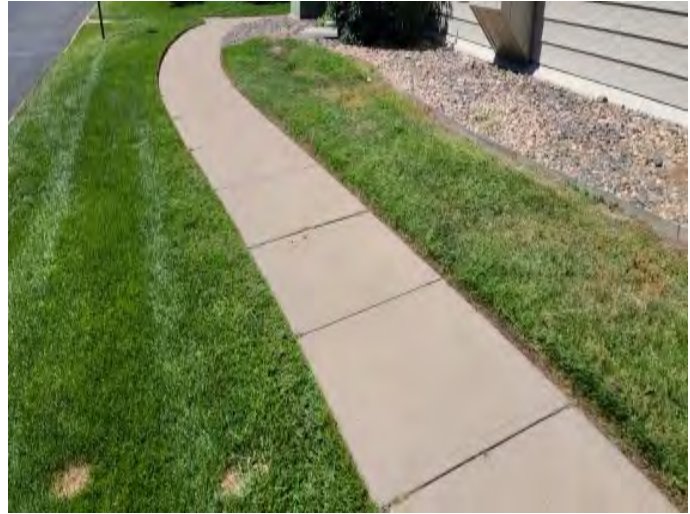
Comp #: 601 Concrete Flatwork - Partial Replace

- Similar to other concrete assets within the community, it is unlikely that all will fail at the same time, therefore, we recommend reserving to replace approximately 10% of the total area (1,475 GSF) every 4 years.
- Coordinate this project with other concrete projects for best cost estimates based on quantity of work.

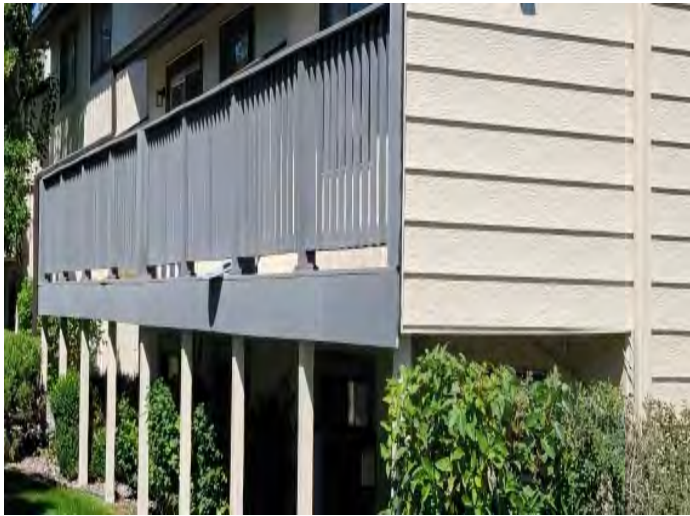
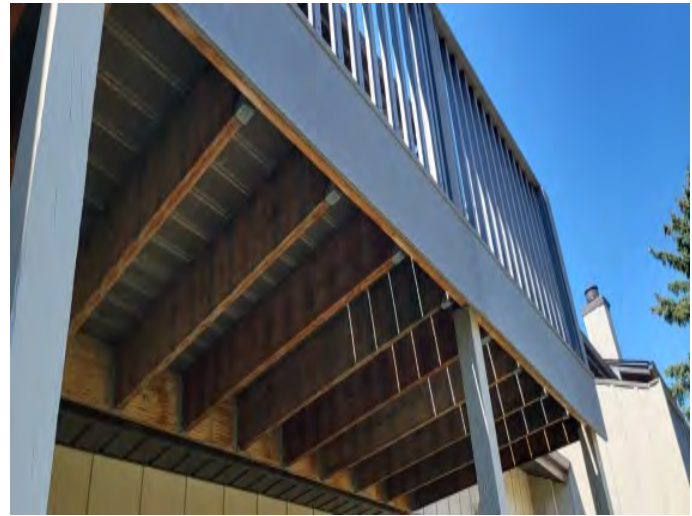
Comp #: 607 Unit Decks - Replace

- It was reported that all of the decks have been replaced with a composite (Trex) material.
- While the life expectancy established by the manufacturer is considered "lifetime", this material is also subject to scratching and deterioration that could warrant replacement within 20 - 25 years.
- For aesthetic purposes, we suggest establishing a life cycle of 25 years at this time.
- If it later turns out that the deterioration rate is not as we expected, then the life and remaining life can be adjusted in future Reserve Study updates.

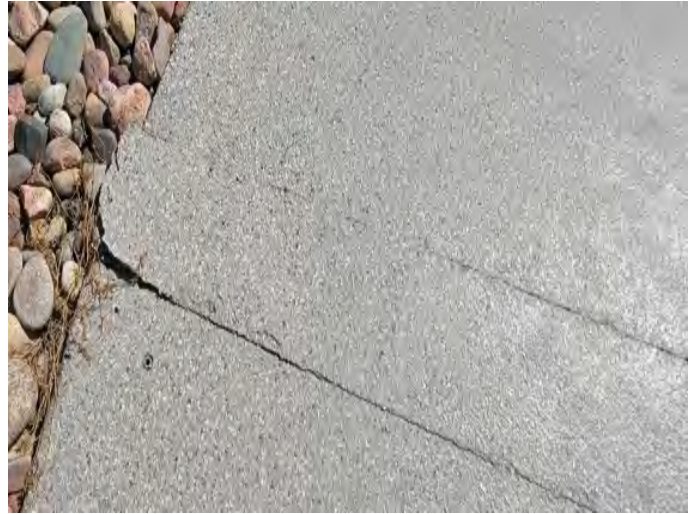
Comp #: 608 Pool Deck - Replace

- At some point, an epoxy coating was applied to the pool deck. This surface is very slippery when it gets wet, and there are sections of the deck that are deteriorating.
- To improve the safety of the deck, it is recommended the pool deck is replaced
- Since the liner needs to be replaced, and the skimmers are at the end of their life as well, we recommend doing a full renovation of the pool area at the same time for best cost estimate and best results.

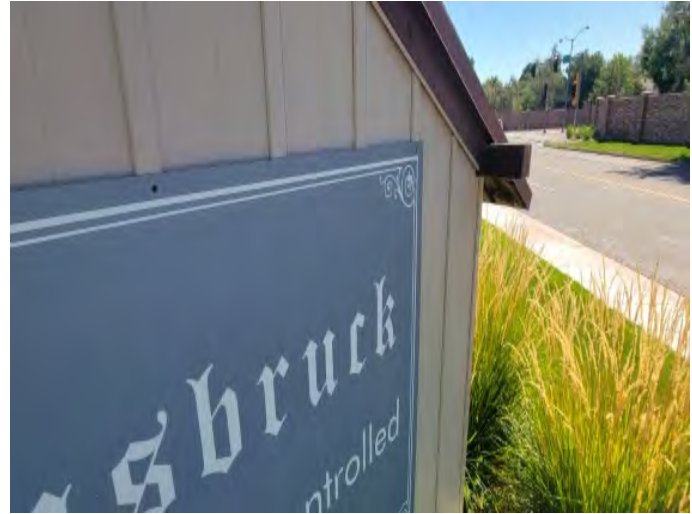
Comp #: 801 Monuments - Rebuild

- The monument structure appeared in good condition at time of observation with no noticeable damage to the materials.
- It is unlikely that the monument will require replacement or rebuilding due to the materials failing. However, due to changes in decorative trends, we recommend reserving to update the monument every 20 - 25 years to ensure an appropriate and attractive appearance to the community entrance.

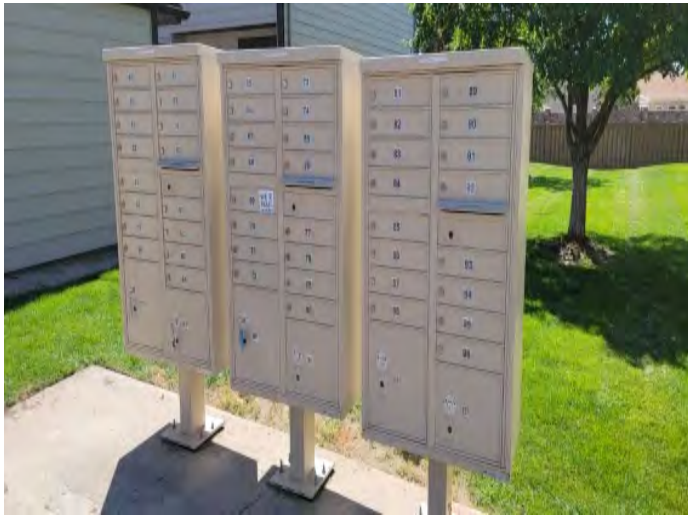
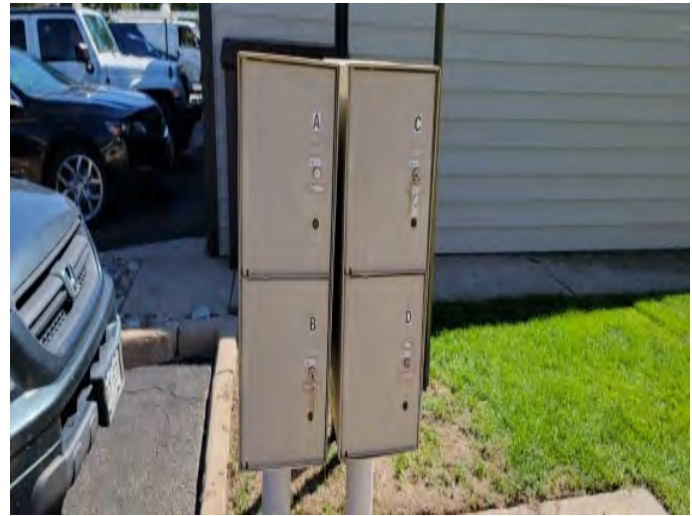
Comp #: 803 Mailboxes - Replace

- The mailboxes were replaced in 2015 and are in good condition. The parcel lockers are older, but functional with no reported problems.
- Per Postal regulations effective 2012, "all customers are responsible for repairs and replacement of keys, locks, or the boxes/cluster units themselves".
- Based on our experience, these boxes will have a life expectancy of 15 - 20 years due to location and quality.
- Remaining life is based on age and observed condition.

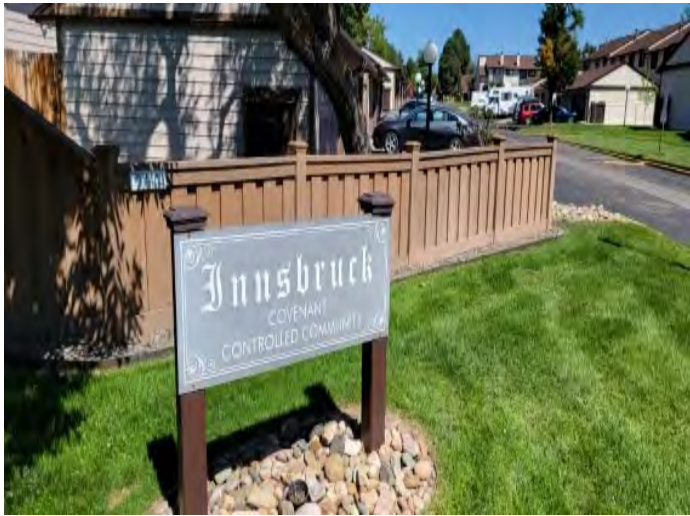
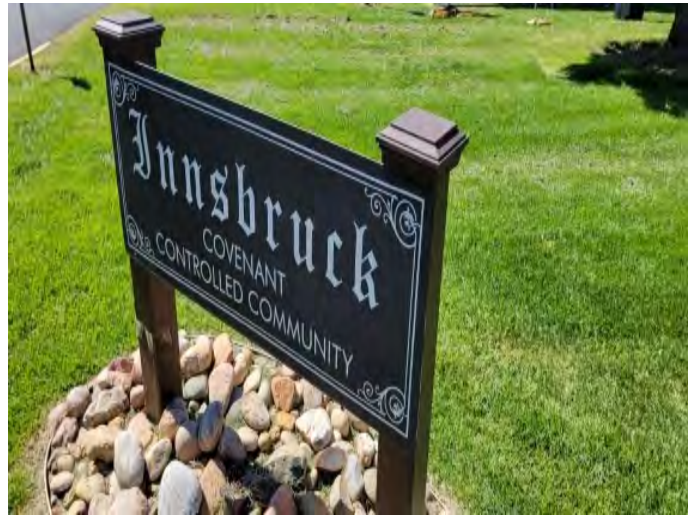
Comp #: 805 Entrance Signs - Replace

- Signs are legible and in good condition
- There is some fading noted on the sign at the western entrance off of Yale, but the sign is still legible.
- Depending on the quality of the printing on the sheet metal, we recommend replacing every 10 - 15 years.
- The remaining life is based on the observed conditions and the approximate age of the signs

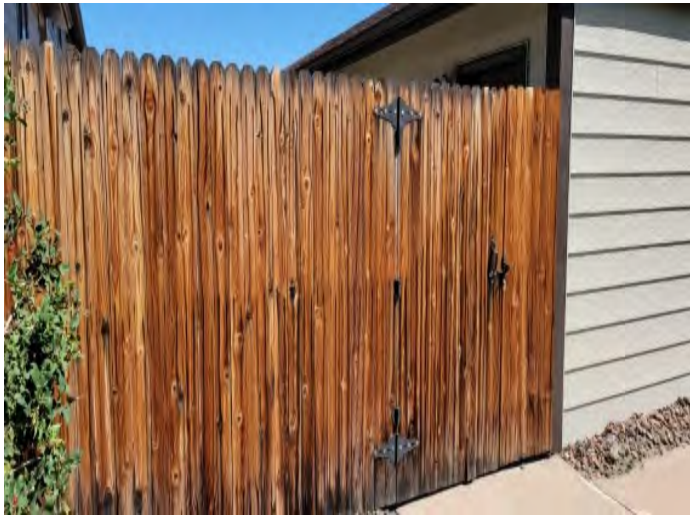
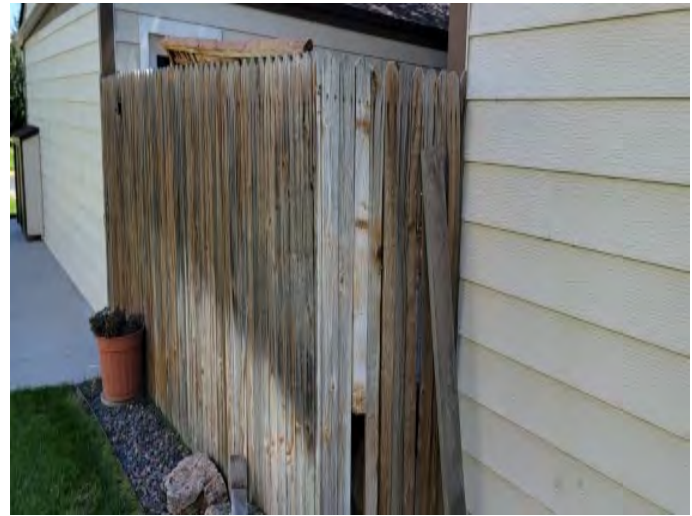
Comp #: 1001 Wood Fencing - Replace

- The replacement cycle is based on the observed quality of fence installed and the current condition.
- In our experience, fences that are stained on a periodic basis (every 3 - 4 years), have a replacement cycle of 20 - 25 years
- The conditions of the fencing varies from unit to unit. It was reported the cost of the fence is shared 50/50 with the homeowner of fence that separates the common area from their courtyard.
- As a result, the estimated cost reflects 50% of the cost to replace wood fencing
- Due to varying condition levels, we have provided funds to replace 25% of fencing every 6 years

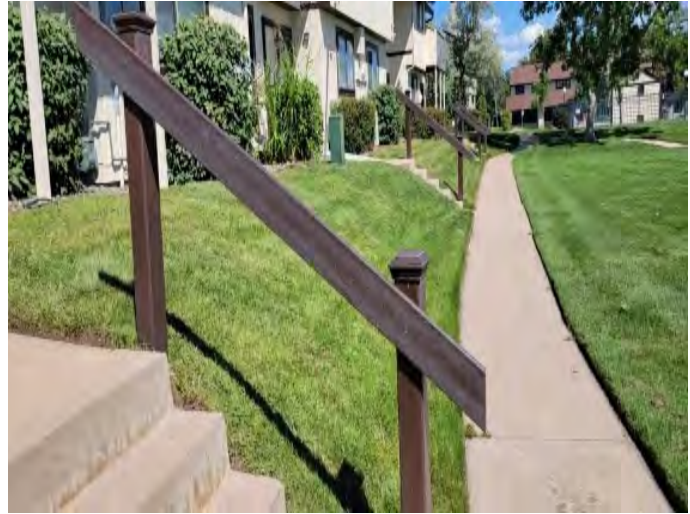
Comp #: 1002 Hand Rails - Replace

- Due to small quantity, we recommend replacing these on an as needed basis with general operating funds.

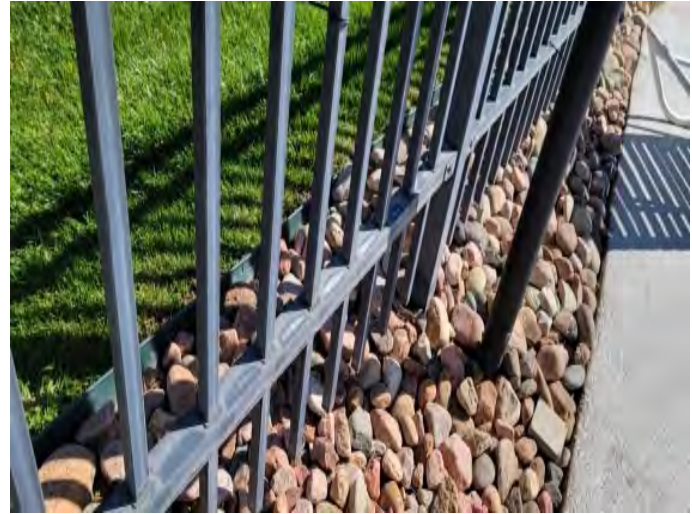
Comp #: 1002 Aluminum Fencing - Replace

- The average life expectancy for metal fences ranges between 25 - 30 years, depending on maintenance schedules and exposure to elements.
- The remaining life is based on age of fence and observed conditions.

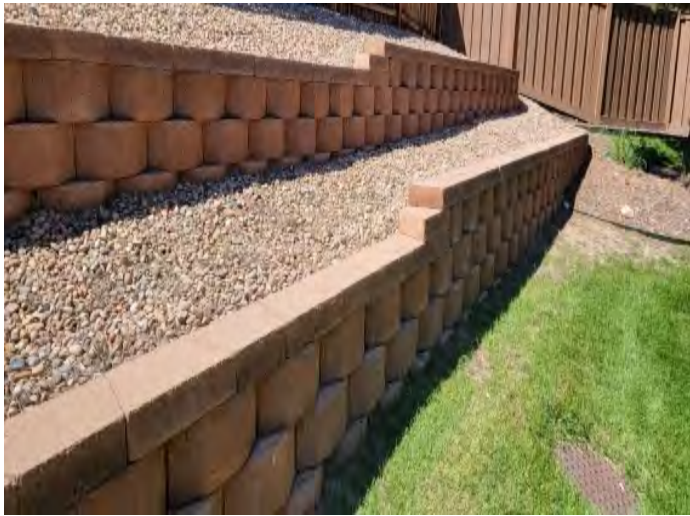
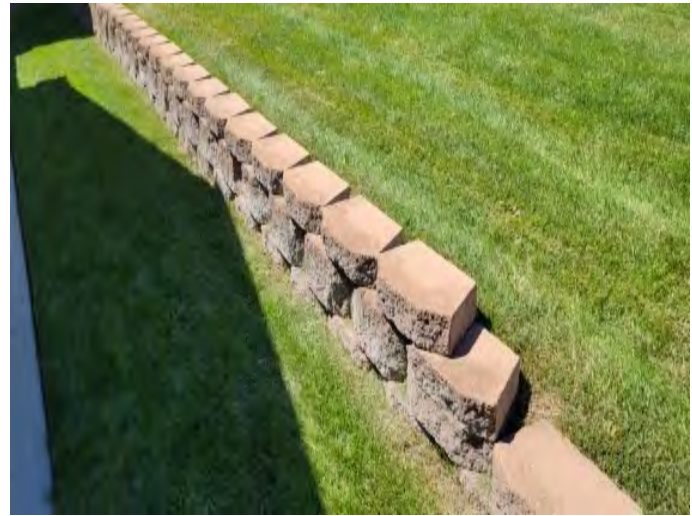
Comp #: 1005 Block Wall - Major Repairs

- As long as block wall was installed conforming to county code requirements, this wall should have an extended useful life.
- This type of material has an indefinite life expectancy and complete replacement is unlikely.
- However, establish some funds for periodic major repairs due to the possibility of shifting and minor deterioration of blocks.

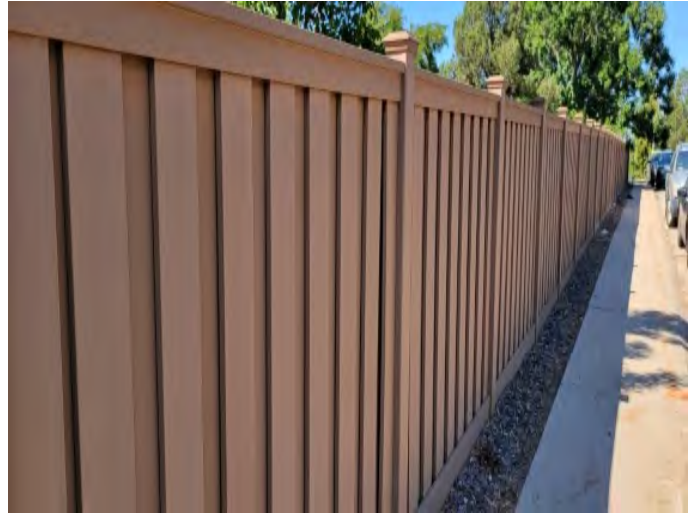
Comp #: 1008 Composite Fencing - Replace

- According to the manufacturer, Trex products shall be free of material defects in workmanship and materials, and shall not check, split, splinter, rot, or suffer structural damage from termites or fungal decay.
- The commercial warranty for Trex fencing is 10 years that is offered from the manufacturer.
- Since this product was introduced to the industry, we have seen some minor warping, discoloring from irrigation spray, and minor cracking that gradually starts developing after approximately 10 - 15 years from installation date
- At the current time, we suggest establishing a replacement cycle of 25 years.

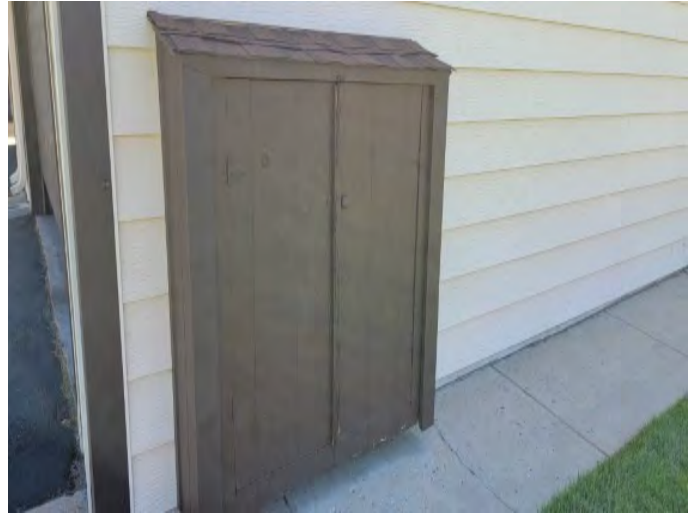
Comp #: 1010 Trash Cabinets - Rebuild

- Conditions vary throughout community
- We recommend treating repairs on an as needed basis with general operating funds, or include as part of prep work prior to painting.
- Therefore, at this time, separate Reserve funding is not required for this component

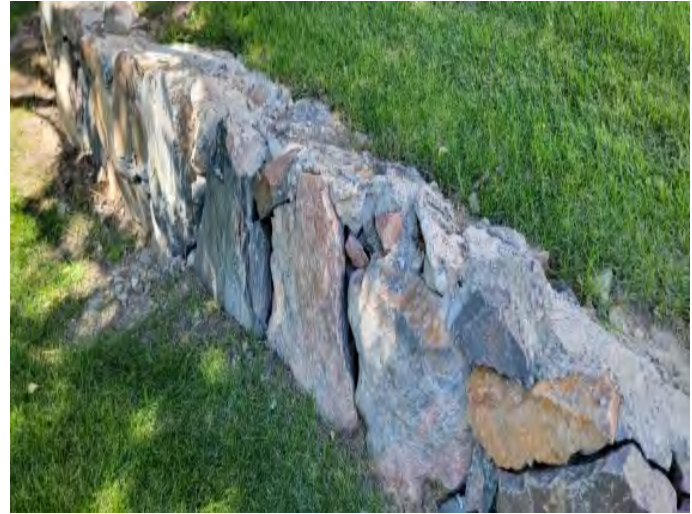
Comp #: 1011 Rock Wall - Replace

- Wall appears to be structurally stable and in good condition.
- This wall should have an indefinite life expectancy and replacement is unlikely.
- At this time, separate Reserve funding is not required for this component.

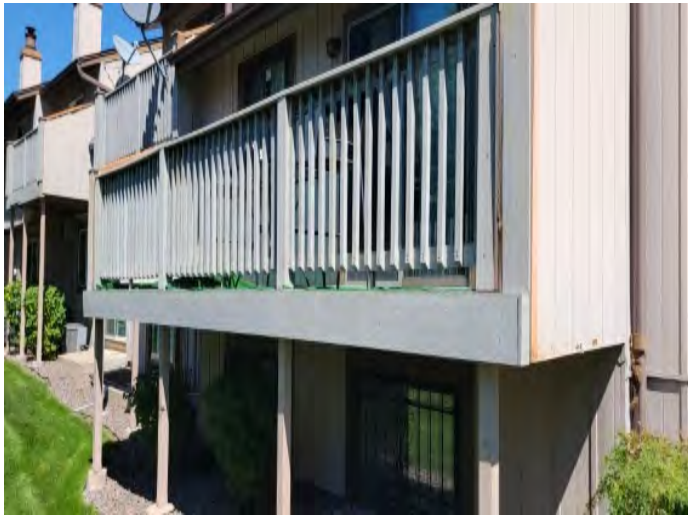
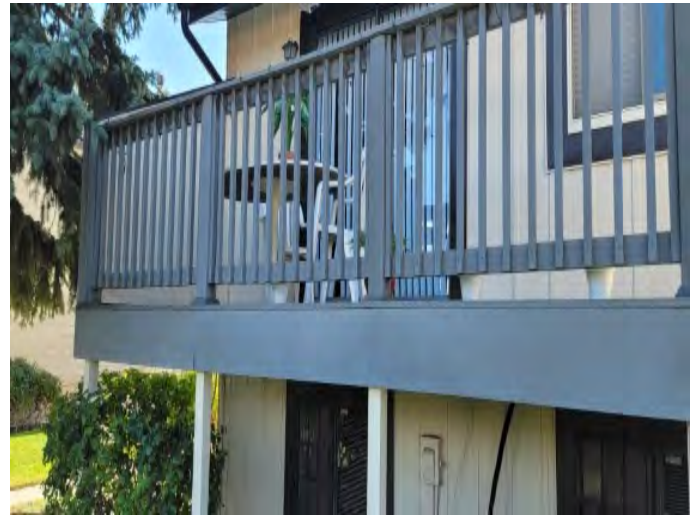
Comp #: 1012 Deck Rails - Replace

- Periodic inspections and repairs should occur to ensure safe and secure railings
- Funding for replacement is included in the unit deck line item (see component #607)

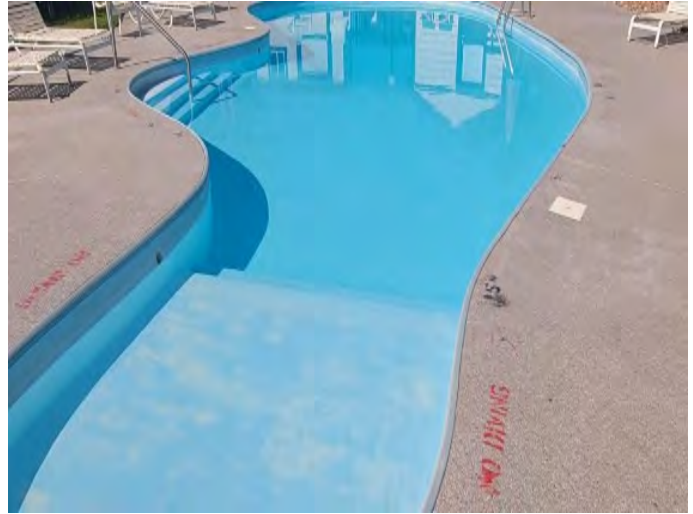
Comp #: 1101 Fiberglass Pool - Reline

- It was reported there is a small hole in the liner that needs to be repaired.
- Depending on the quality of the liner, in our experience, we have seen these liners last on average 20 - 25 years
- Based on the age of the liner and the report of a hole, we recommend the association plan on replacing the liner soon.
- Since the pool deck needs to be replaced and one of the skimmers is not working, we recommend planning on a total retrofit of the pool area this year.

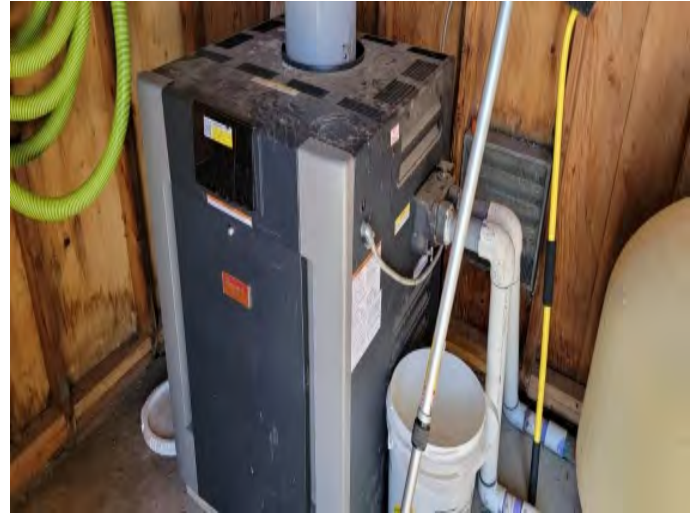
Comp #: 1105 Pool Heater - Replace

- Heater is about 5 years old and there are no signs of scaling or deterioration under the burners.
- The overall life expectancy depends on the level of maintenance and the quality of the water running through the system.
- For this type of heater, the average replacement cycle will range between 12 - 18 years with proper maintenance and under normal conditions.

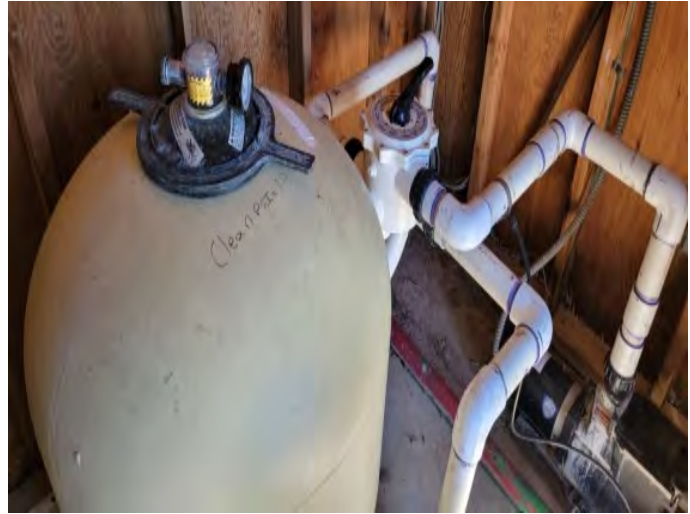
Comp #: 1108 Pool Filter - Replace

- Filtration system is almost 10 years and there are no reported problems with the system.
- The shell will have an extended useful life of 18 - 20 years and most leaks can be attributed to gaskets and seals that can be replaced on an as needed basis.
- Remove and replace filter sand on an as needed basis using operating funds.

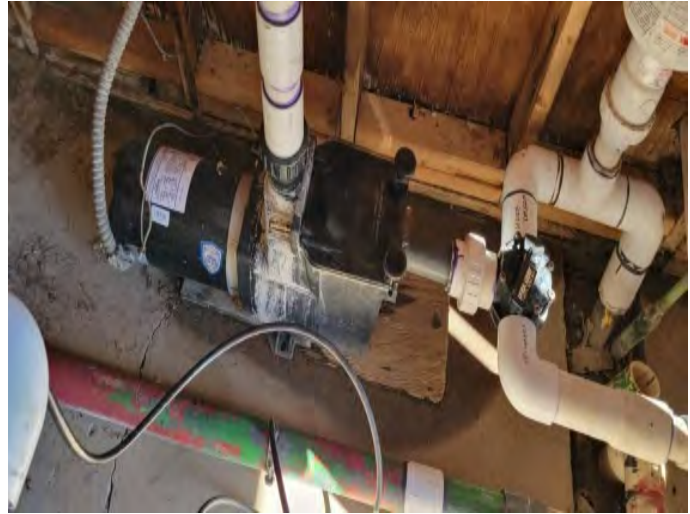
Comp #: 1117 Miscellaneous Pool Equipment - Replace

- The individual replacement cost of these items is too small for separate Reserve designation.
- Replace on an as needed basis with general operating funds.

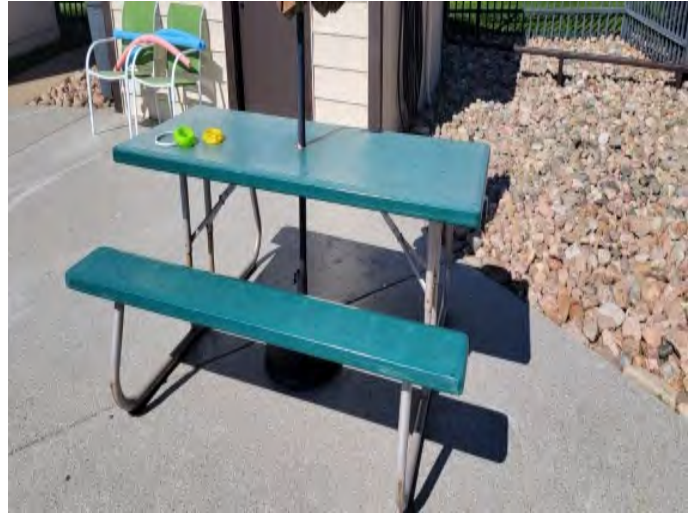
Comp #: 1121 Pool Furniture - Replace

- Straps are in poor condition, they are cracking and rotting. Types of furniture varies, and it appears the association purchases pieces as needed.
- Due to varying types of furniture and different levels of use each piece received, we recommend establishing funds for partial replacement every 5 years.
- Remaining life is based on the observed conditions of the strapped furniture.

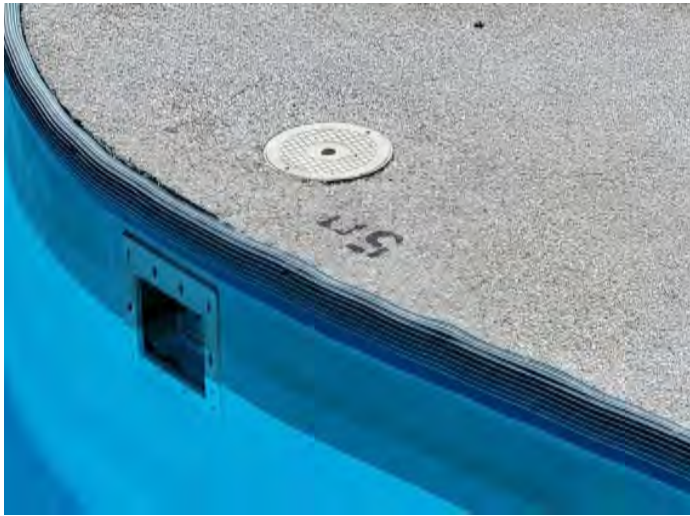
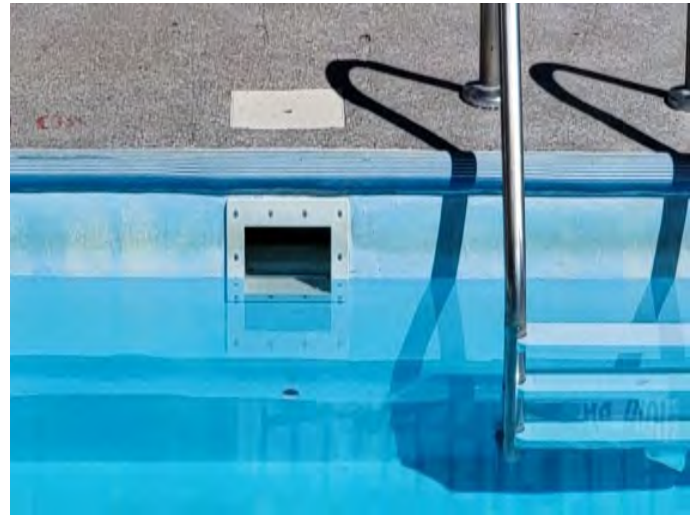
Comp #: 1126 Skimmers - Replace

- It was reported one of the skimmers is not functioning and as a result, additional labor is required for cleaning the pool.
- In our experience, we have seen the need to replace skimmers every 20 - 25 years.
- It is typical to replace at the same time as major pool surfacing work
- Therefore, we suggest setting aside Reserve funding for replacement every 25 years at this time.

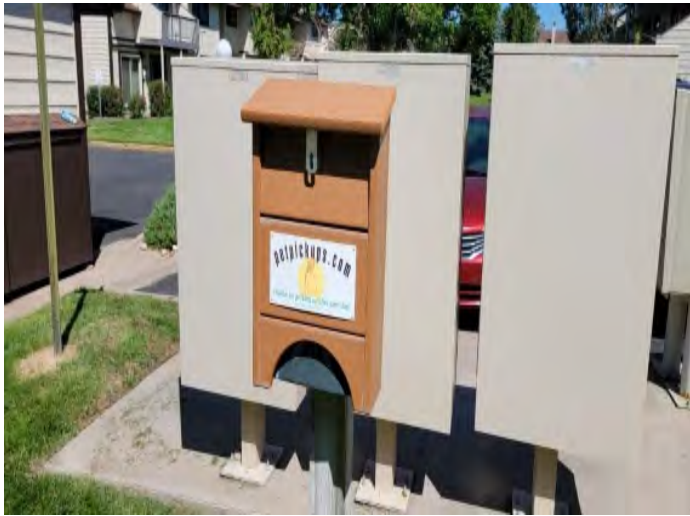
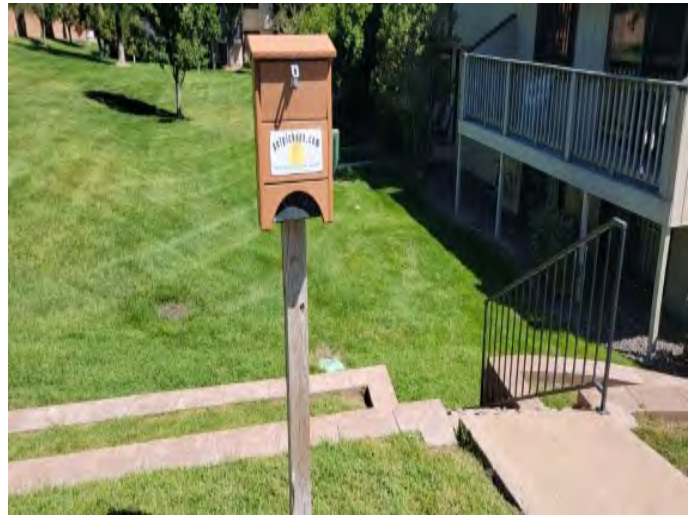
Comp #: 1311 Pet Waste Bag Dispensers - Replace

- Due to the low quantity, unlikely event that all will require replacement at the same time and the relatively low cost of individual replacement, we do not recommend reserving for replacement at this time.
- Maintain and replace on an as needed basis using operating funds.
