Regarding: Reserve Study Final Version

Level 1, Platinum Reserve Analysis

Innsbruck in Aurora COA, Inc. 2503 S. Peoria Aurora, CO. 80014

Date of Property Observation – August 30, 2022

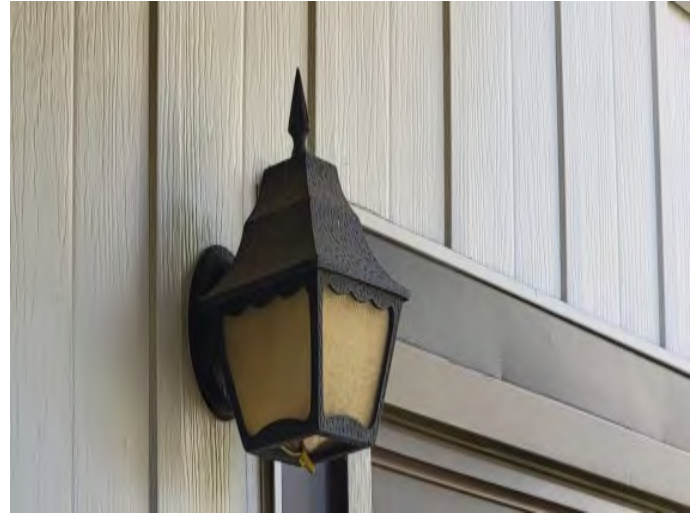
Comp #: 1602 Exterior Wall Mount - Replace

- Lights differ from unit to unit, but according to the declarations, the association is responsible for repair, replacement, and maintenance of light fixtures (Article 8, section 8.1 (b))
- While replacement can occur on an as needed basis, it is our opinion and recommendation to replace all lights at the same time every 15 - 20 years to maintain a consistent appearance throughout the property.
- In addition, by replacing multiple fixtures, the association will be able to obtain a quantity discount for the fixtures.

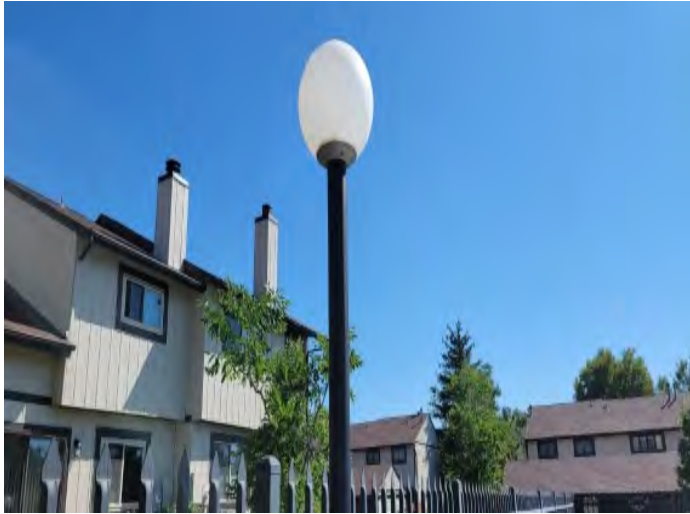
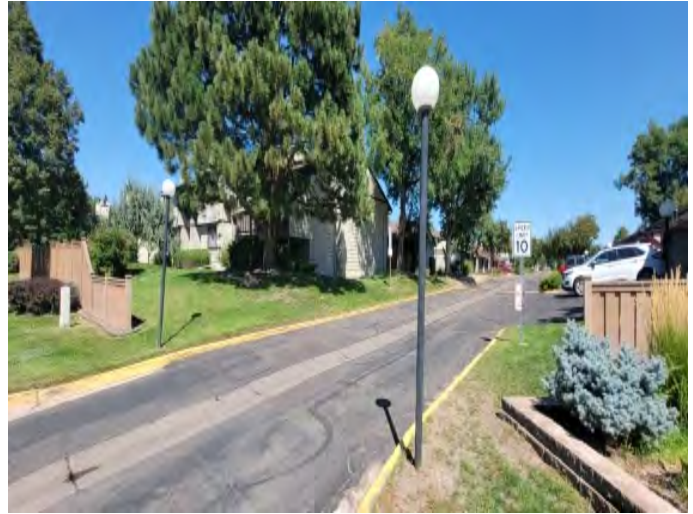
Comp #: 1604 Pole Lights - Replace

- No reported problems with the pole lighting.
- The conditions of the underground wiring is unknown
- Paint these pole lights regularly to prevent rust damage and ensure full life.
- Expect to replace these lights approximately every 25 - 30 years to maintain appearance and function.
- Included in the estimated replacement cost is a small allowance for wiring issues, if anything is discovered at time of replacement.

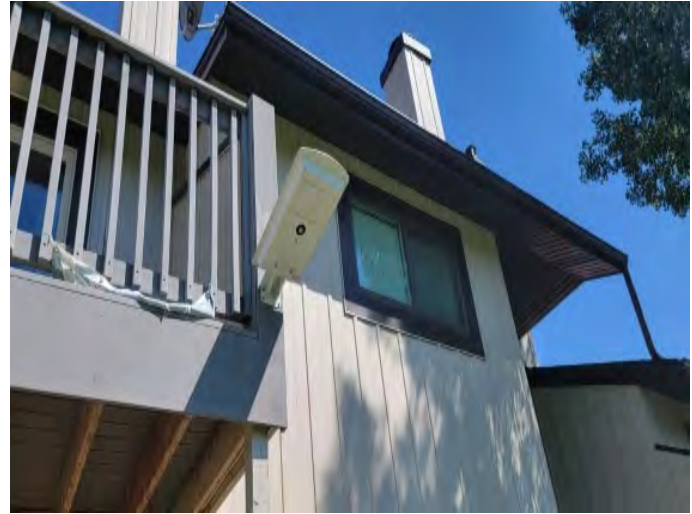
Comp #: 1612 LED Wall Paks - Replace

- Styles of lights differ on various decks. It appears these have been installed at various times as the need arises.
- LED technology is still relatively young, but is expected to have at least a 10 - 15 year life expectancy under normal conditions
- If projections differ from expectations, then the useful life can be adjusted in future Reserve Study updates.

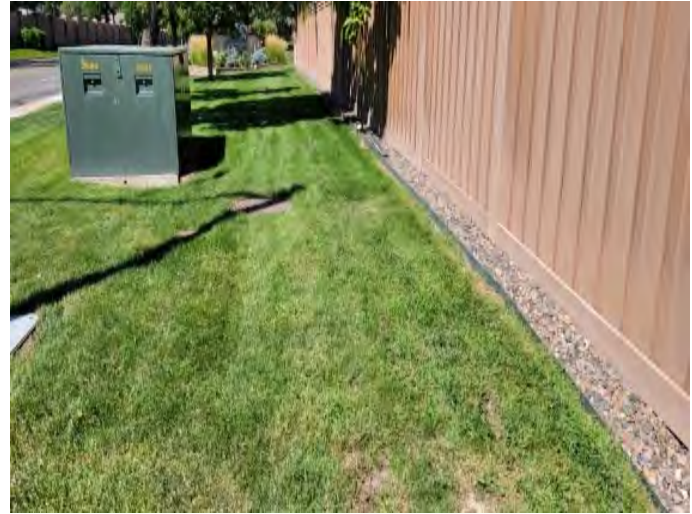
Comp #: 1701 Irrigation System - Major Repairs

- This line item is for repairs and replacement that lies outside the scope of routine maintenance: bulk sprinkler head replacement, bulk valve replacement, controller, backflow device, rerouting lateral lines, rewiring, etc.
- In order to ensure the funds are available for major repairs, we recommend reserving funds for these projects every 4 - 5 years.
- The funding on this line item is for major repairs and is not to be interpreted as complete irrigation system replacement.

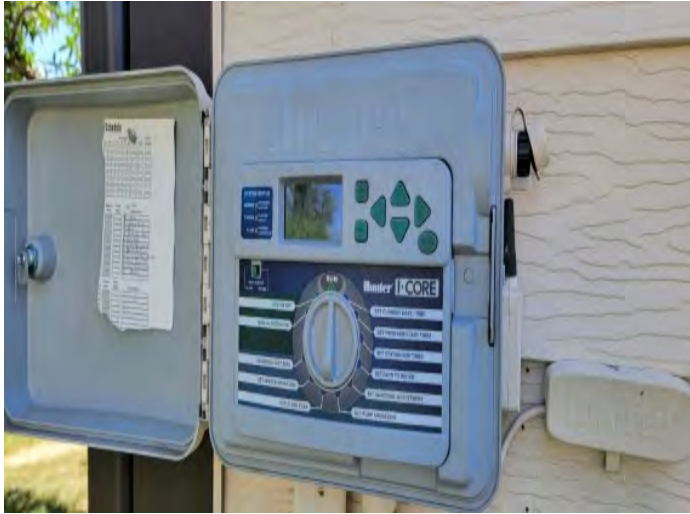
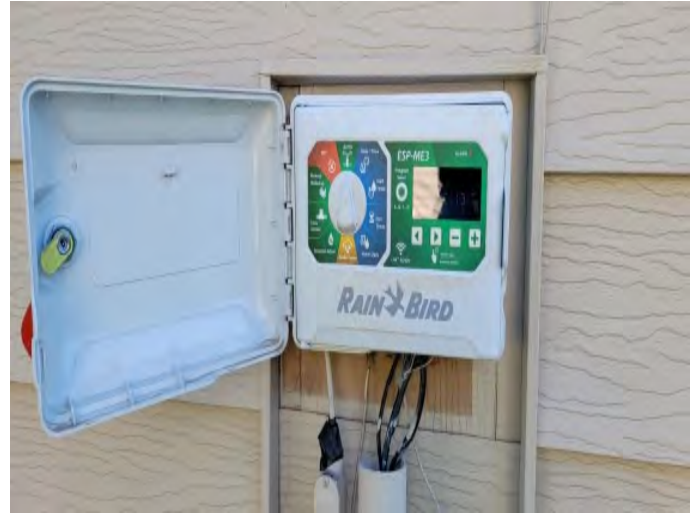
Comp #: 1703 Irrigation Controllers - Replace

- Ages of controllers range from 2 years to 13 years old.
- Expect to replace irrigation controllers every 10 - 15 years if properly maintained and under normal conditions.
- Due to the varying ages, sizes, and types of controllers, we have included an allowance in the irrigation system - major repairs line item for replacement of controllers when needed
- Or, funding can be handled out of the operating budget

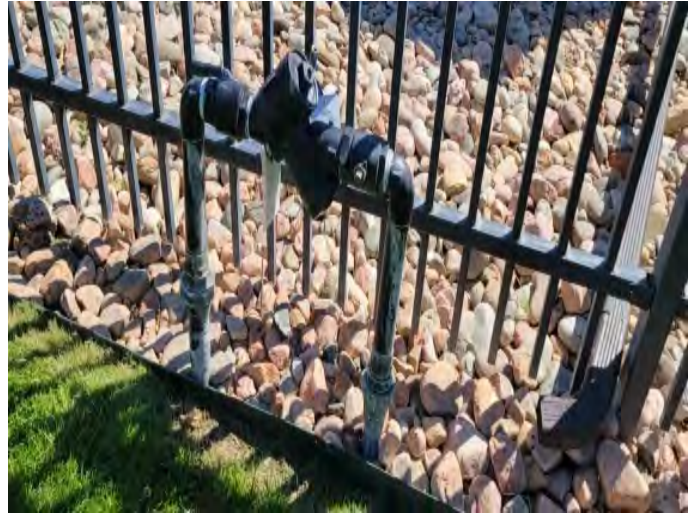
Comp #: 1706 Backflow Devices - Replace

- No reported problems with any of the devices.
- Due to the ability to rebuild and replace these devices for a relatively low cost and the fact that failure of the device is unpredictable, we do not recommend reserving for replacement.
- Repair and/or replace these devices on an as needed basis using operating funds.

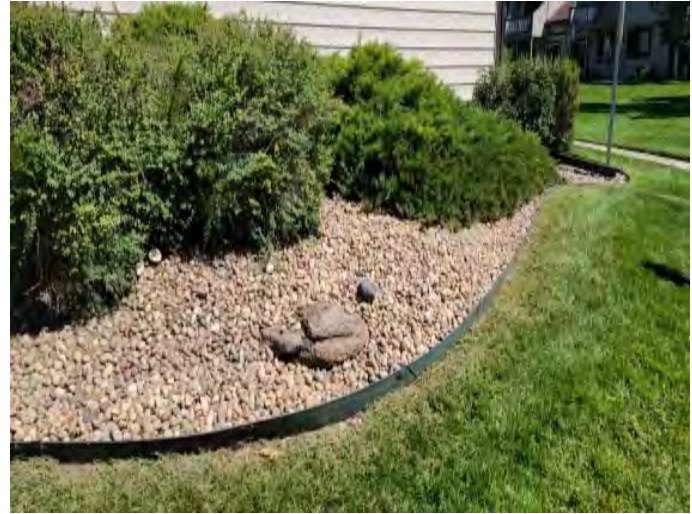
Comp #: 1801 Groundcover - Replenish

- The majority of the edging has corroded to a point that it either is not effective, or is dangerous for bare feet.
- Also, there is a lot of juniper bushes that can be a fire hazard for careless people discarding cigarettes.
- This line item, similar to irrigation repairs, is for projects that lie outside the scope of routine maintenance.
- In order to preserve an attractive curb appeal and to maintain the health of the plants and shrubs, we recommend reserving for refurbishment projects every 2 - 3 years.
- This line item is for cyclical refurbishment and should not be considered as complete landscaping replacement.

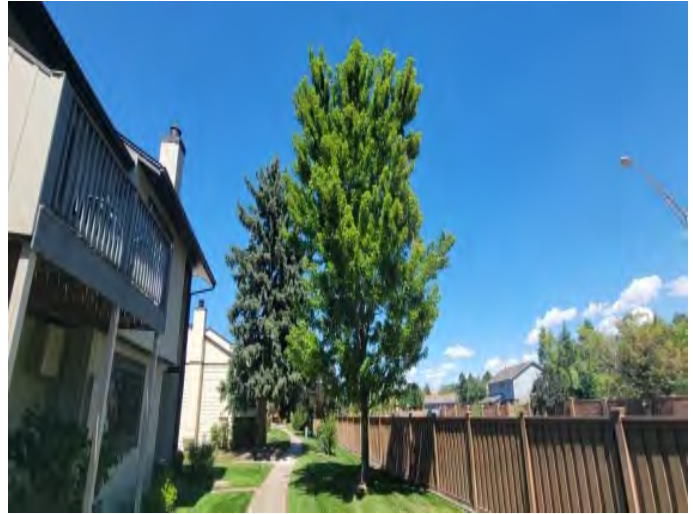
Comp #: 1804 Tree - Replacement/Major Maintenance

- It is very difficult to predict a replacement cycle for trees as there are several factors that will contribute to a tree dying.
- Factors such as disease, infestation of insects, heavy snow storms, etc. can all attribute to eventual tree replacement.
- Since it is difficult to predict when the replacement will be necessary, Reserve funding is typically not a factor.
- However, based on our recent experience, an allowance for periodic replacement has been included.
