Level 2, Premium Reserve Analysis

# Carriage Homes at Stapleton

8606 E. 25<sup>th</sup> Pl.  
Denver, CO. 80236

## FINAL VERSION

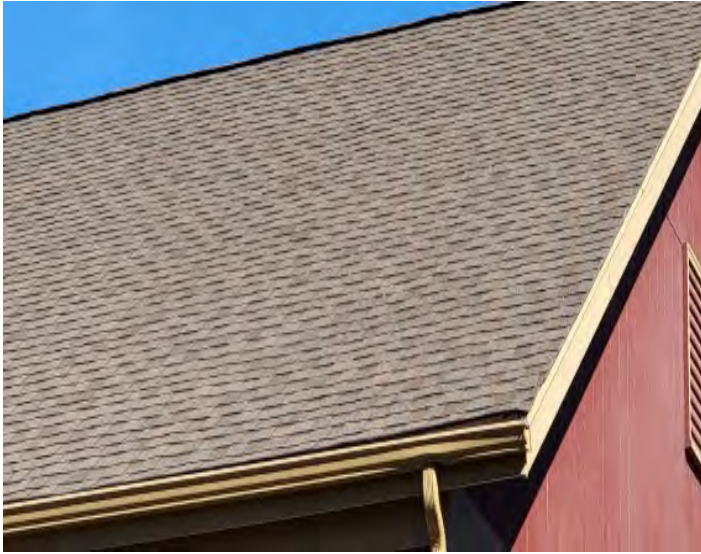
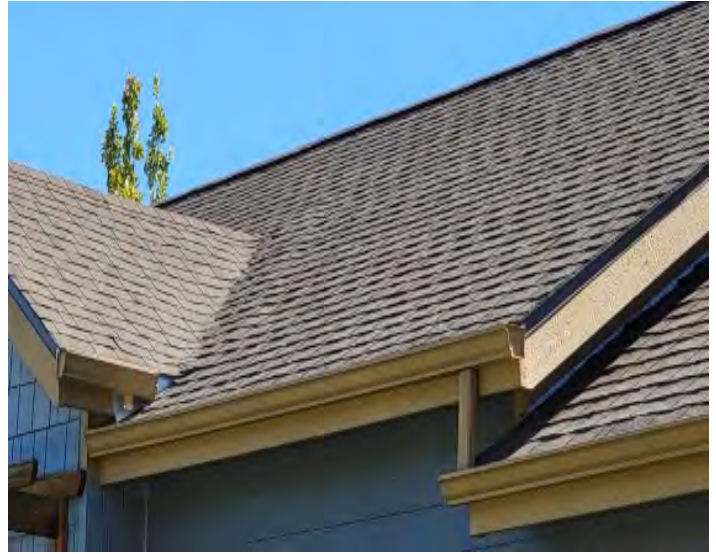
Comp #: 105      Comp Shingle Roof - Replace

- All roofs were replaced in 2014 as a result of damage sustained during a hail storm.
- It appears this roof material is rated as a 30 - 40 year product. Despite this rating, a life expectancy of 18 - 20 years is expected in this environment due to heavy snow, ice, UV, and temperature fluctuations.
- Remaining life is based on age of roof and observed conditions.

*Best Cost:*                    **\$614,000**  
 \$500/square; Estimate to remove and replace

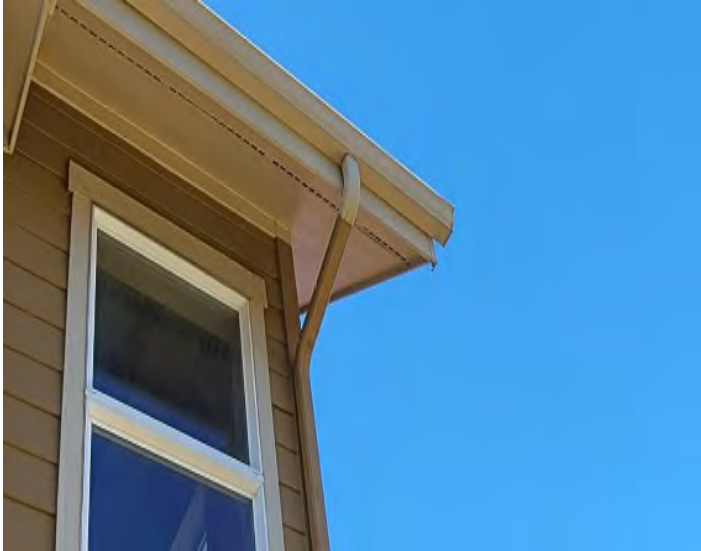
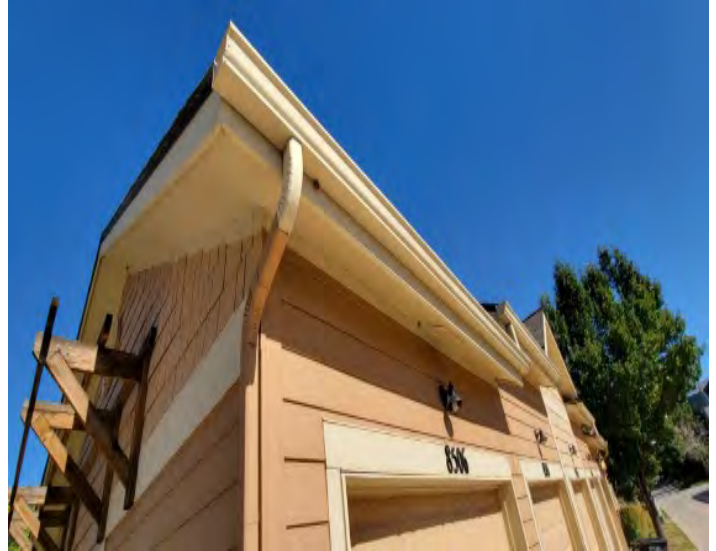
Comp #: 120 Raingutters/Downspouts - Replace

- At time of site observation, it is noted that the downspout is missing on garage 10381
- It is typical for debris, such as roof granules and dirt, to build up in the lines.
- When debris remains in the raingutters, it will stay wet after rains and snow melt which will cause premature deterioration of the materials.
- Therefore, we recommend cleaning out the lines at least once a year as a maintenance expense to ensure full life expectancy.
- Average life expectancy for gutters and downspouts ranges from 20 - 25 years under normal conditions.
- It is typical to replace raingutters and downspouts at the same time as roof materials for best cost estimate.
- However, lines were not replaced in 2014 along with roofing, so remaining life is based on the age of the original lines.

*Best Cost:* **\$88,350**  
\$7.75/LF; Estimate to replace

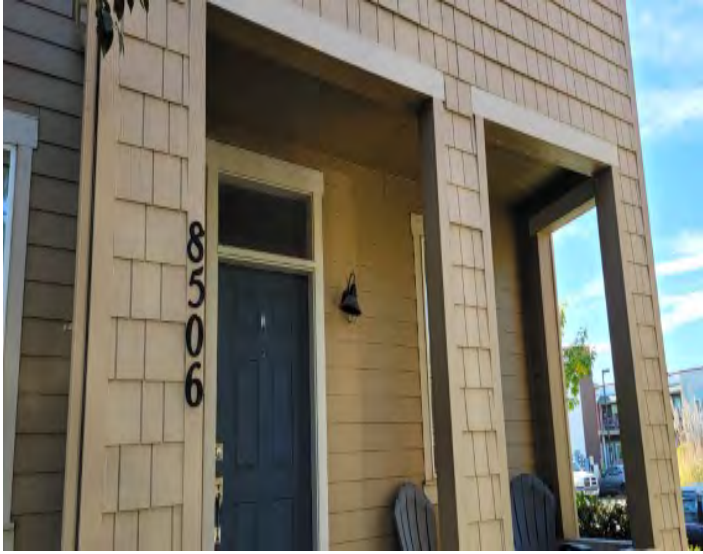
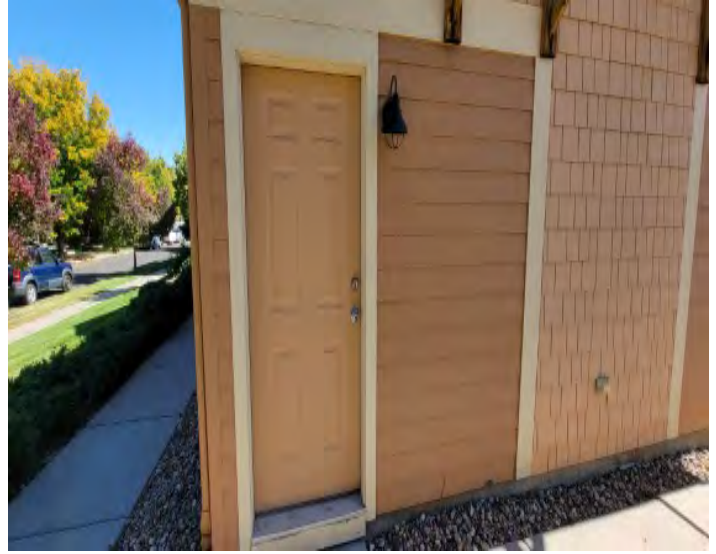
Comp #: 203    Doors - Repaint

- Estimated painting cost is included with building exterior surfaces (components #204 - #206).
- Therefore, separate Reserve funding is not required for this component.

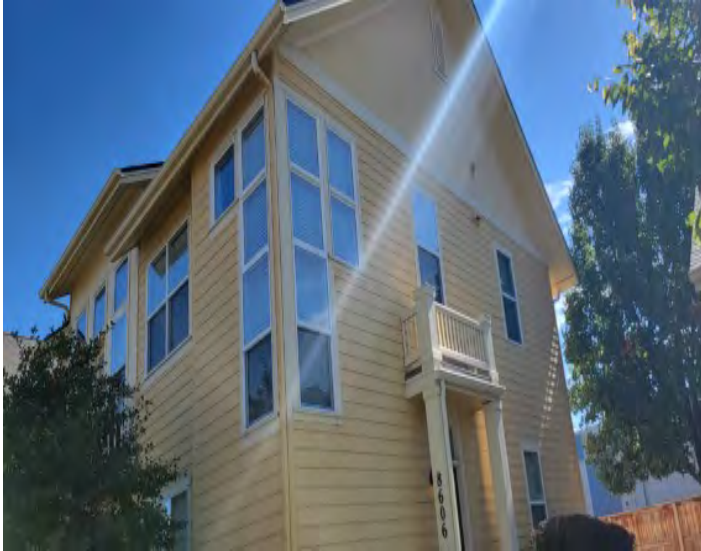
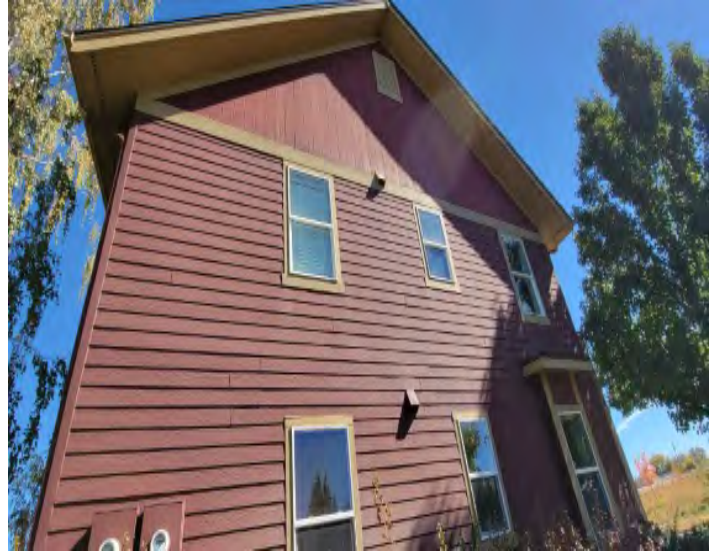
Comp #: 204 Exterior Surfaces - Repaint (Ph 1)

- Reported ALL buildings were last painted at the same time in 2015. No reported painting since then.
- Despite this information, client requested in the last Reserve Study that the community is separated into a 3-year cycle.
- Based on observed conditions, it does not appear any pf the buildings have been painted
- If the association still prefers to paint in phases, we recommend starting with the first phase immediately.

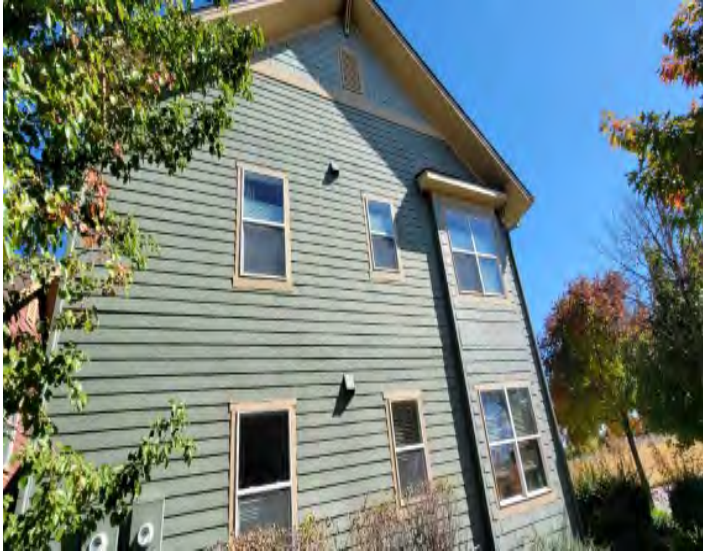
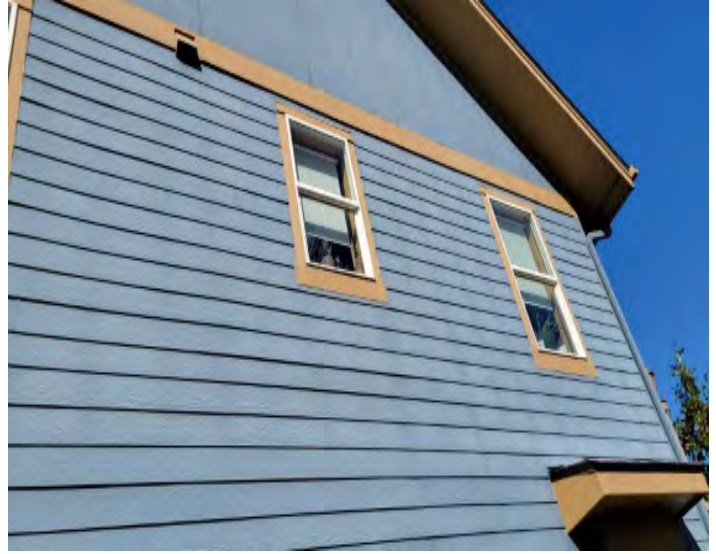
Comp #: 204 Exterior Surfaces - Repaint (Ph 2)

- Reported ALL buildings were last painted at the same time in 2015. No reported painting since then.
- Despite this information, client requested in the last Reserve Study that the community is separated into a 3-year cycle.
- Based on observed conditions, it does not appear any pf the buildings have been painted
- If the association still prefers to paint in phases, we recommend starting with the first phase immediately.

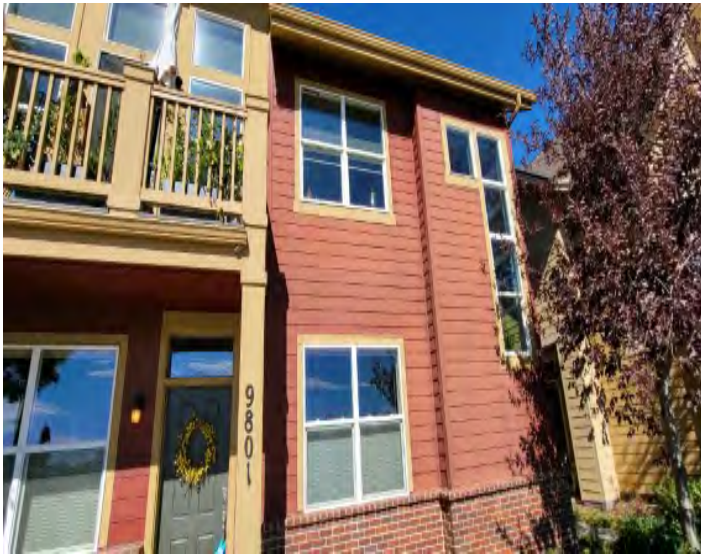
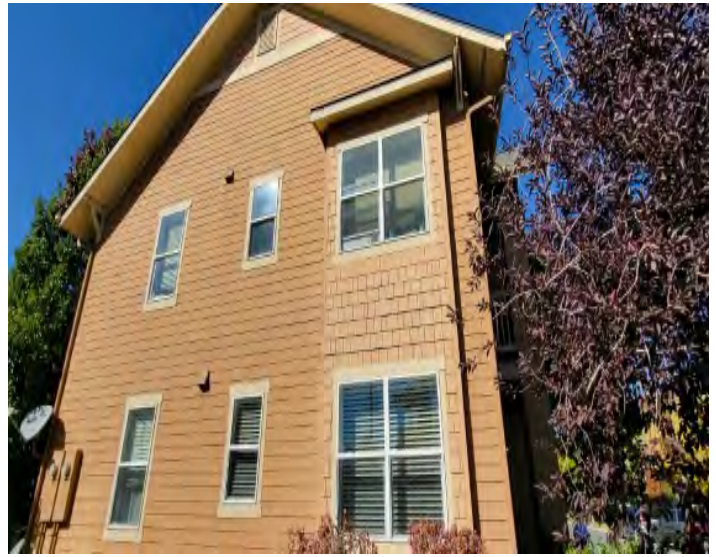
Comp #: 204 Exterior Surfaces - Repaint (Ph 3)

- Reported ALL buildings were last painted at the same time in 2015. No reported painting since then.
- Despite this information, client requested in the last Reserve Study that the community is separated into a 3-year cycle.
- Based on observed conditions, it does not appear any of the buildings have been painted
- If the association still prefers to paint in phases, we recommend starting with the first phase immediately.

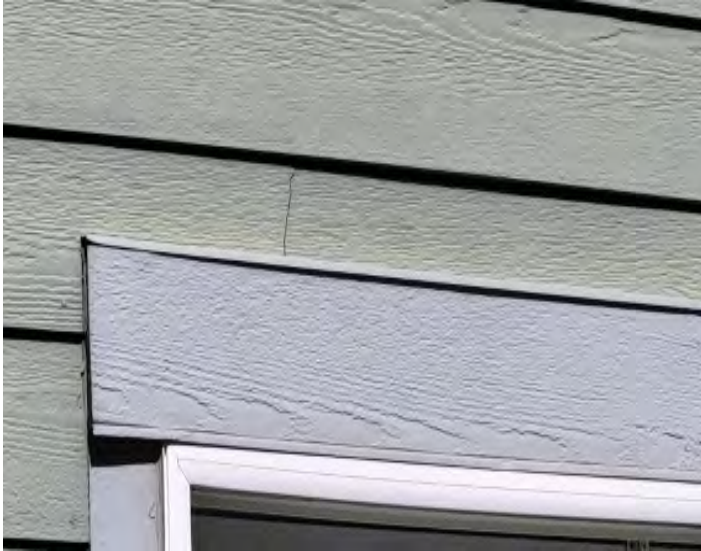
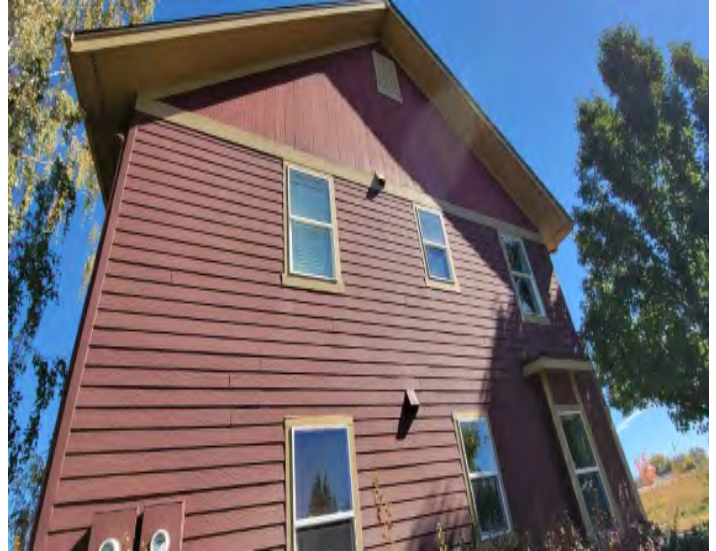
Comp #: 303 Siding/Trim - Major Repairs (Ph 2)

- As the property ages, this type of material has been known to start delaminating if not painted and caulked on a proper cycle.
- We suggest establishing Reserve funds for major repairs every other painting cycle.
- The remaining life is based on the observed conditions at the time of our site evaluation and the timing of the next paint job.

*Best Cost:*                    **\$20,400**  
 \$600/unit; Allowance for major repairs

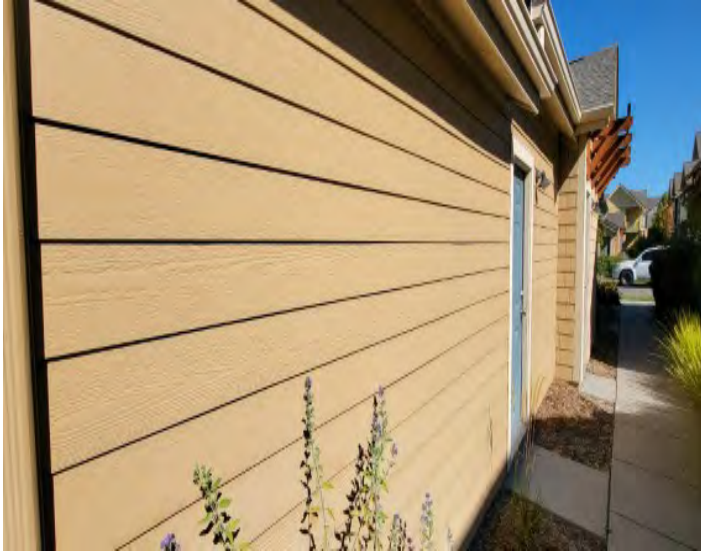
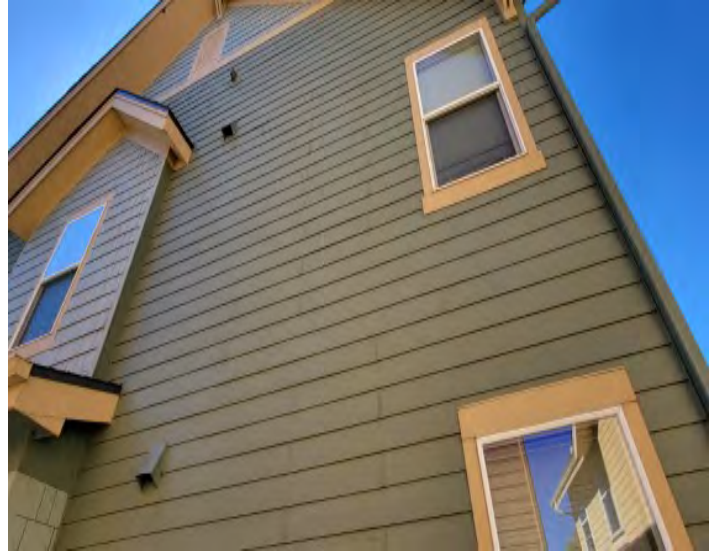
Comp #: 303 Siding/Trim - Major Repairs (Ph 3)

- As the property ages, this type of material has been known to start delaminating if not painted and caulked on a proper cycle.
- We suggest establishing Reserve funds for major repairs every other painting cycle.
- The remaining life is based on the observed conditions at the time of our site evaluation and the timing of the next paint job.

*Best Cost:*                    **\$18,000**  
 \$600/unit; Allowance for major repairs

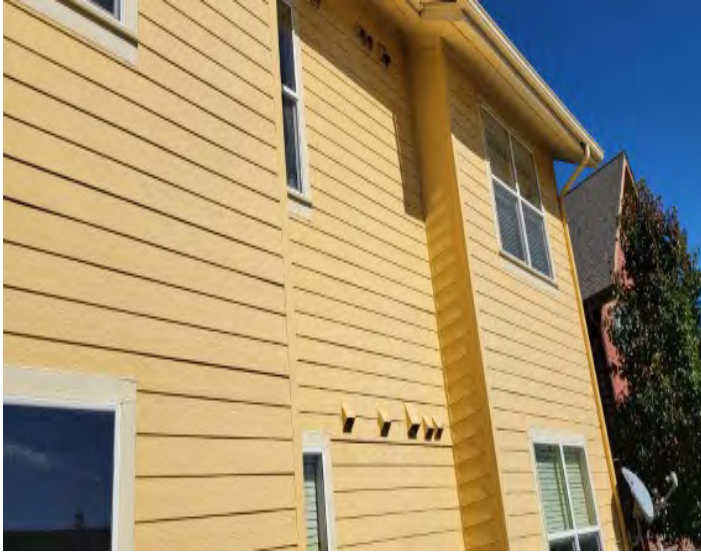
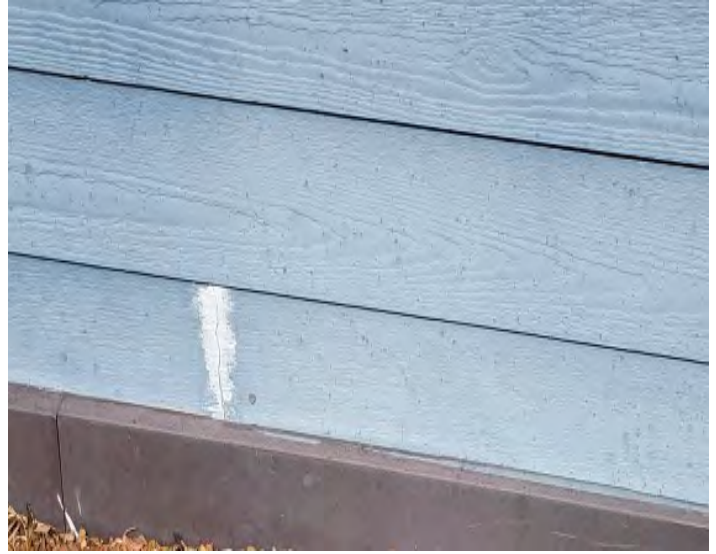
Comp #: 303     Siding/Trim - Major Repairs (Ph1)

- As the property ages, this type of material has been known to start delaminating if not painted and caulked on a proper cycle.
- We suggest establishing Reserve funds for major repairs every other painting cycle.
- The remaining life is based on the observed conditions at the time of our site evaluation and the timing of the next paint job.

*Best Cost:*                    **\$15,600**  
 \$600/unit; Allowance for major repairs

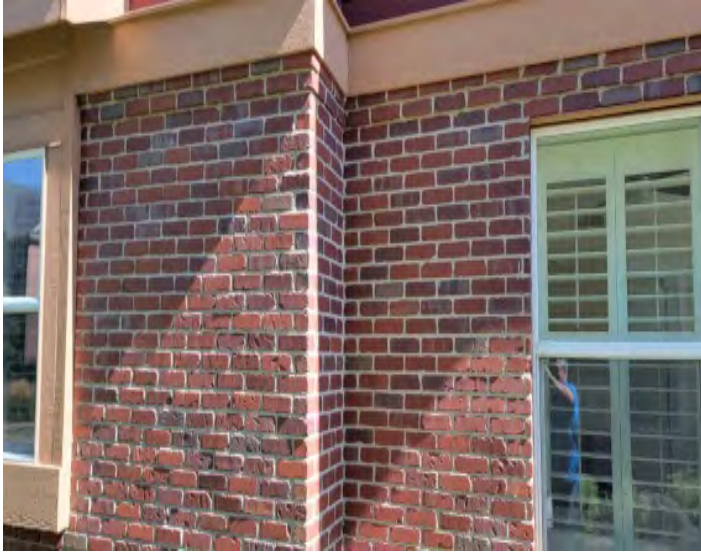
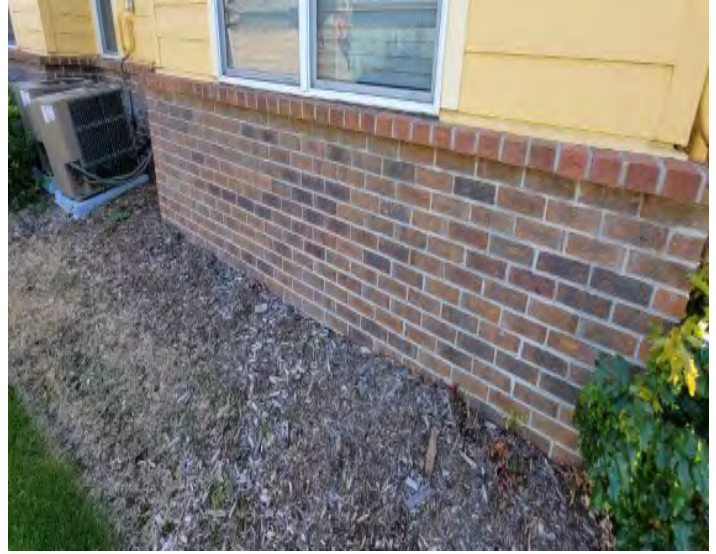
Comp #: 306 Brick - Inspect/Major Repairs

- Typically, this material has an extended life expectancy and complete replacement is unlikely.
- There are times where minor repairs may become necessary, but this is unpredictable when and how much would occur.
- However, based on the age of building, we recommend establishing an allowance for periodic inspections and repairs
- This line item is for periodic inspections and repairs and should not be misinterpreted as complete replacement.

Allowance for periodic inspections and repairs

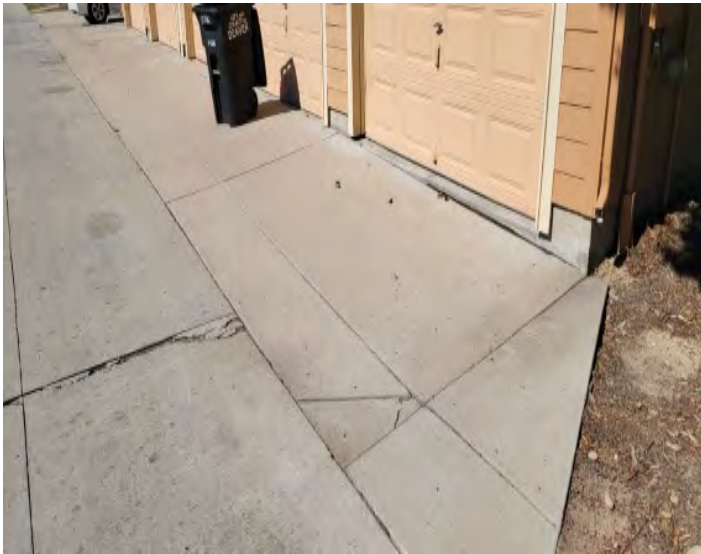
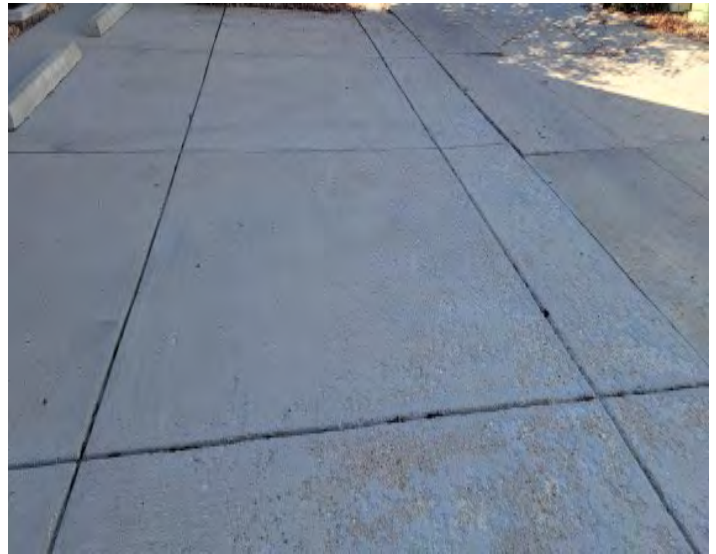
Comp #: 403 Concrete - Partial Replace

- At time of site observation, apron at 9971/2607 is in poor shape
- It is unlikely that all concrete will fail and need to be replaced at the same time. Therefore, we recommend reserving an allowance for periodic repairs to a percentage of the total area.
- Coordinate this project with other concrete projects for best cost estimates based on quantity of work.
- This line item is not intended to be interpreted as complete replacement.

*Best Cost:* **\$9,750**  
Allowance to replace 5% of area

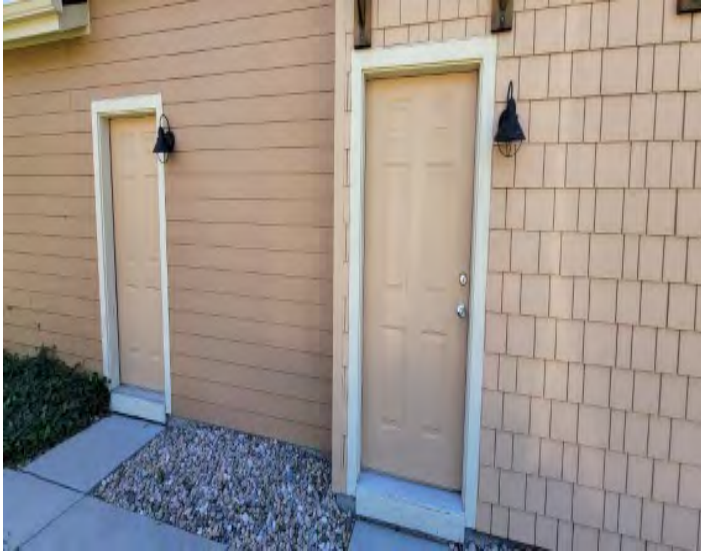
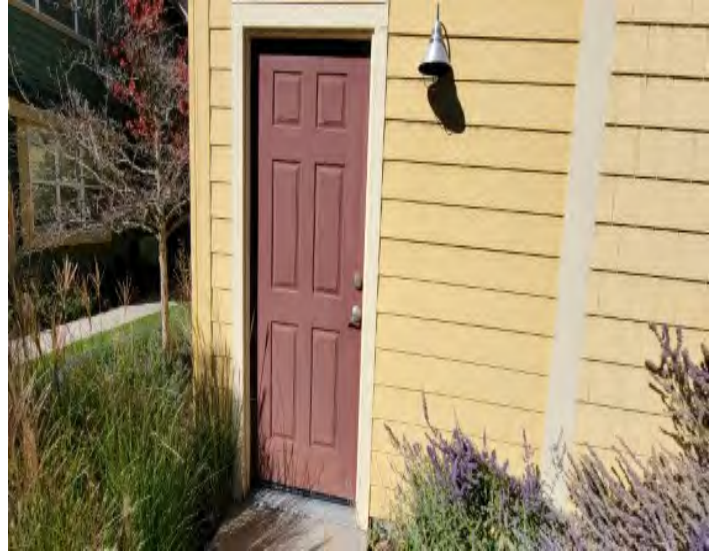
Comp #: 501 Front Doors - Replace

- According to the associations maintenance chart that was developed by an attorney after reviewing the legal documents, it was determined the doors are the responsibility of the unit owner.
- Therefore, separate Reserve funding is not required for this component.

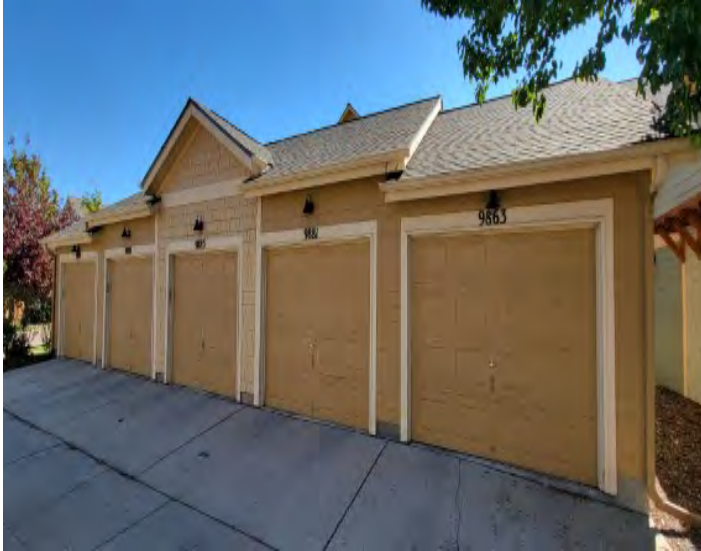
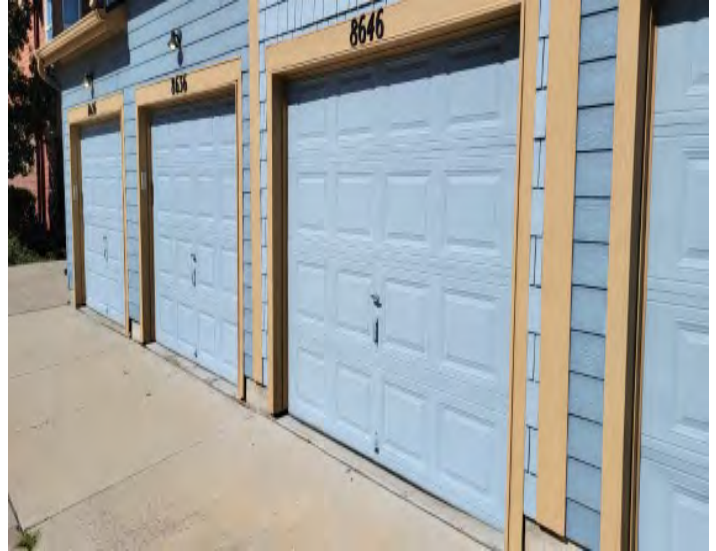
Comp #: 502 Garage Doors - Replace

- According to the maintenance responsibility chart in the declarations, the garage doors are not the responsibility of the association.
- Therefore, at this time, Reserve funding is not required for this component.
- Some associations decide to take on the responsibility as an HOA expense in order to maintain a consistent appearance and to obtain the best replacement cost possible.
- For now, Reserve funding will continue to be excluded from the report. If the philosophy of the association changes, we can add Reserve funding in future Reserve Study updates.

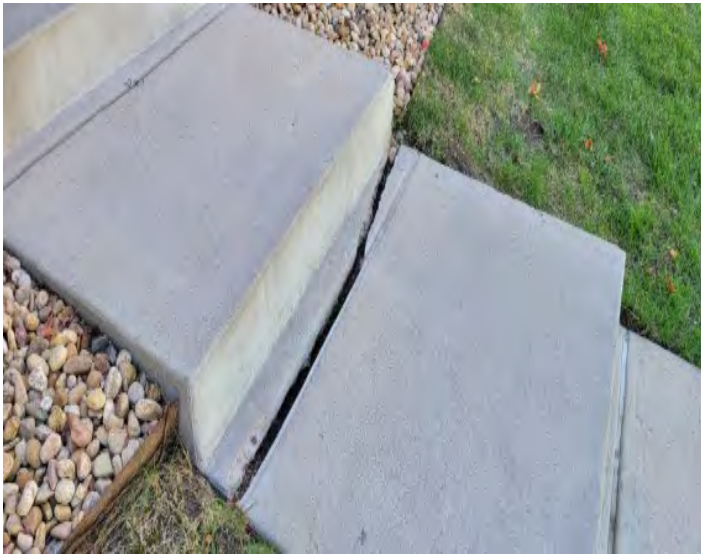
Comp #: 601 Concrete Surfaces - Repair

- At time of site observation, there are major cracking issues by 8686. Throughout the community there are several trip hazards and cracked areas.
- While it is unlikely that all concrete surfaces will fail at the same time and completely need replacement, it is likely that major repairs will be needed periodically.
- We suggest establishing Reserve funding for periodic major repairs, as opposed to minor repairs annually.
- Each time a contractor comes out to the property to fix an area, a "trip charge" is usually built into the repair bill.
- Therefore, by doing larger areas at the same time, the cost is cheaper on a per square footage basis.
- This line item is for periodic major repairs and should not be misinterpreted as complete replacement.

Estimate to replace 5% of area every 4-years

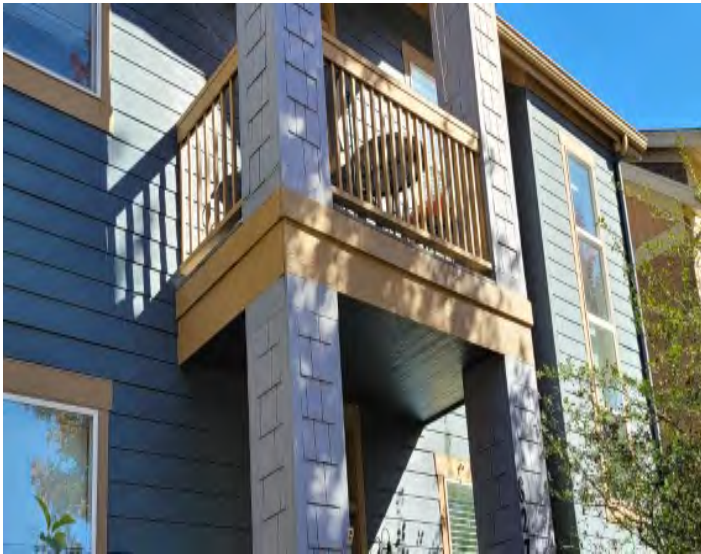
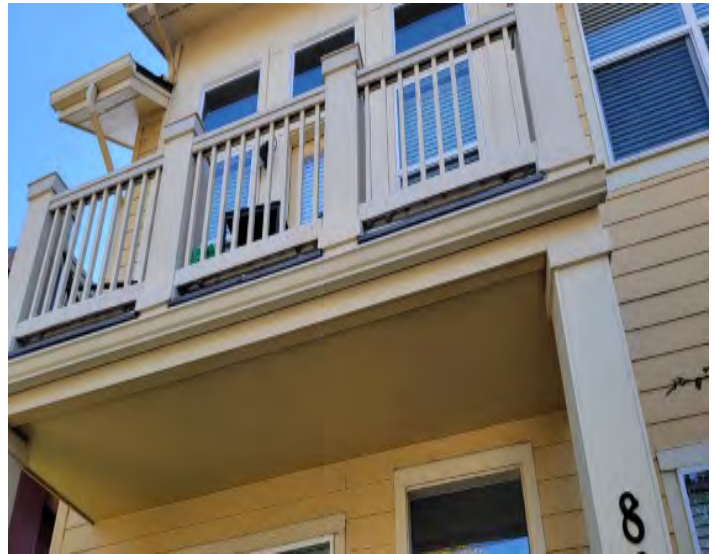
Comp #: 607 Unit Trex Decks - Replace

- Unable to access each deck due to privacy and exclusive use areas.
- There were no reported problems with the decks.
- It was reported these are the responsibility of the association to maintain and replace when necessary.
- While the life expectancy established by the manufacturer is considered "lifetime", this material is also subject to scratching and deterioration that could warrant replacement within 20 - 25 years.
- For aesthetic purposes, we suggest establishing a life cycle of 25 years at this time.
- If it later turns out that the deterioration rate is not as we expected, then the life and remaining life can be adjusted in future Reserve Study updates.

*Best Cost:* **\$135,000**  
\$3000/deck; Average cost to replace each deck

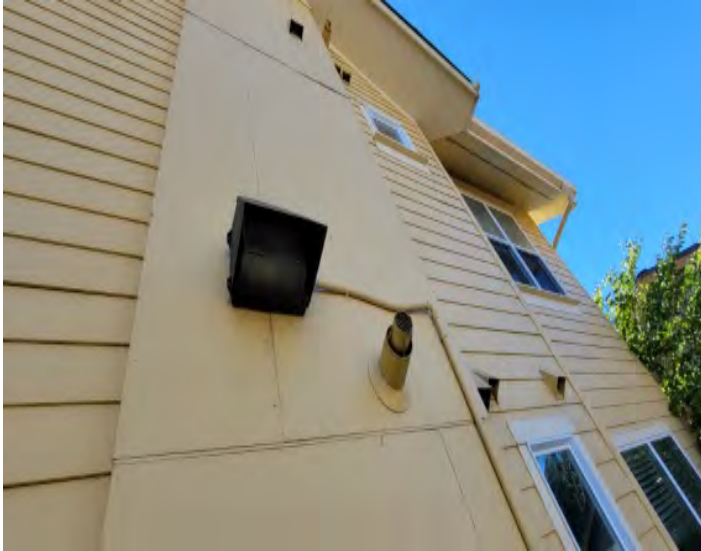
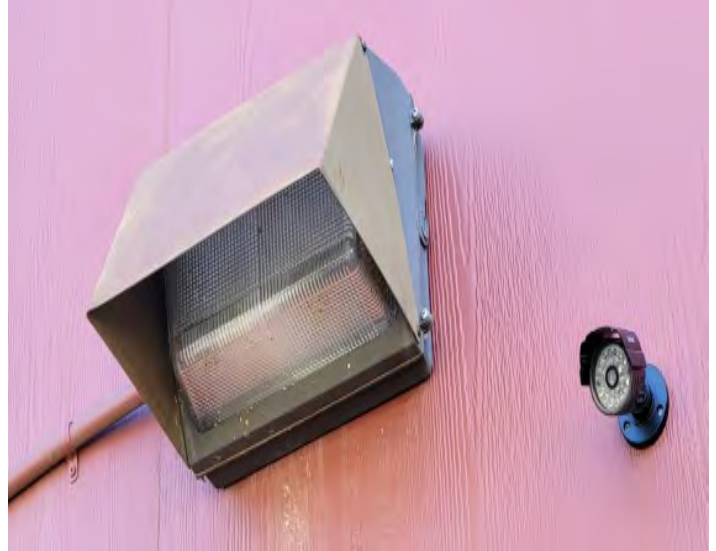
Comp #: 1601 Flood Lights - Replace

- Due to small quantity of lights and since individual replacement can occur without affecting the consistent appearance, we suggest replacing these as needed with general operating funds.
- Therefore, at this time, Reserve funding is not required for this component.

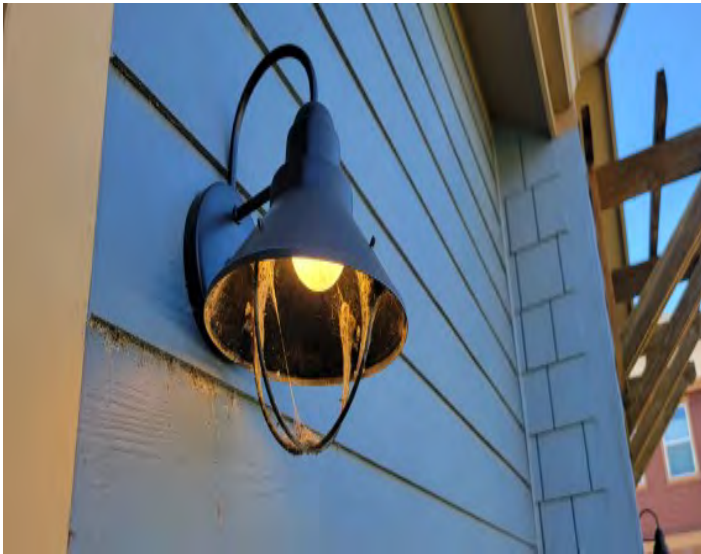
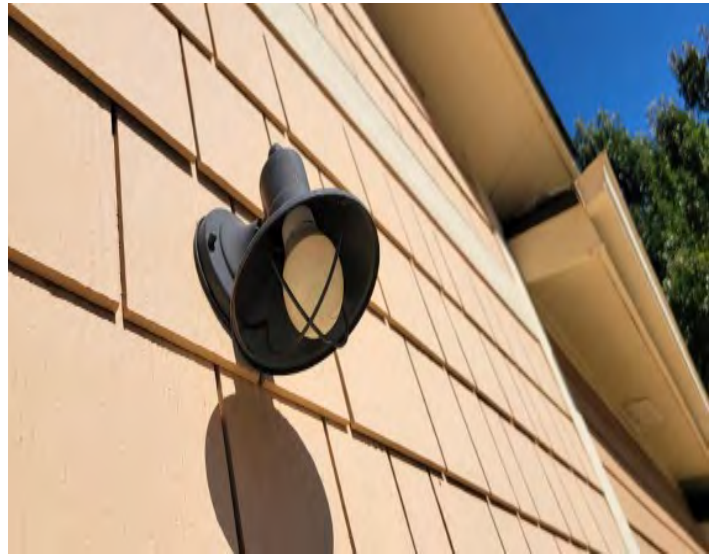
Comp #: 1602 Exterior Wall mount - Replace (Ph 1)

- While replacement can occur on an as needed basis, it is our opinion and recommendation to replace all lights at the same time every 15 - 20 years to maintain a consistent appearance throughout the property.
- By replacing multiple fixtures, the association will be able to obtain a quantity discount for replacement and installation of the fixtures.
- This will also ensure a consistent appearance for the community by replacing all at the same time.

*Best Cost:* **\$22,725**  
\$225/light; Estimate to replace 101 lights

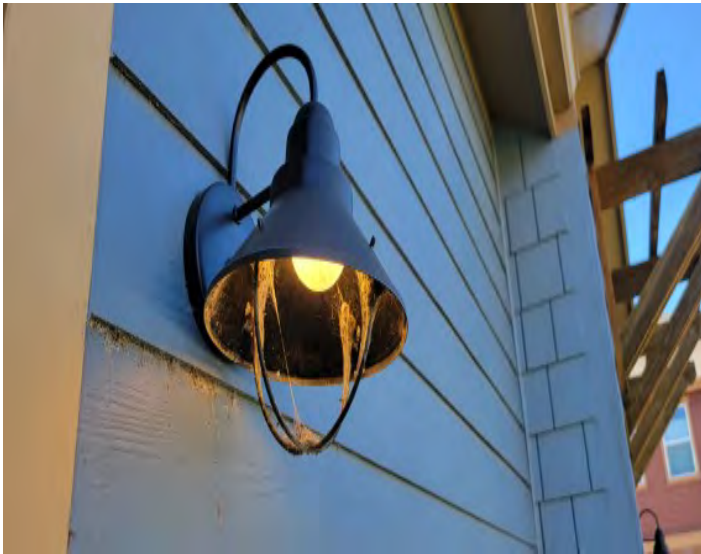
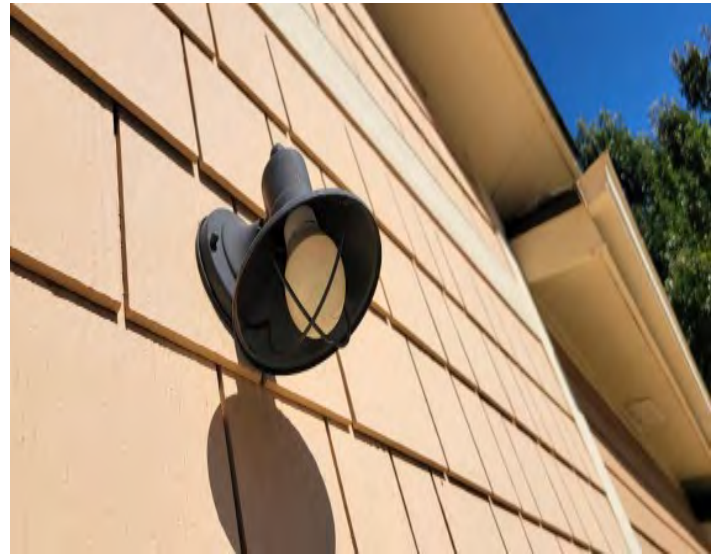
Comp #: 1602 Exterior Wall mount - Replace (Ph 2)

- While replacement can occur on an as needed basis, it is our opinion and recommendation to replace all lights at the same time every 15 - 20 years to maintain a consistent appearance throughout the property.
- By replacing multiple fixtures, the association will be able to obtain a quantity discount for replacement and installation of the fixtures.
- This will also ensure a consistent appearance for the community by replacing all at the same time.

*Best Cost:* **\$22,725**  
\$225/light; Estimate to replace 101 lights

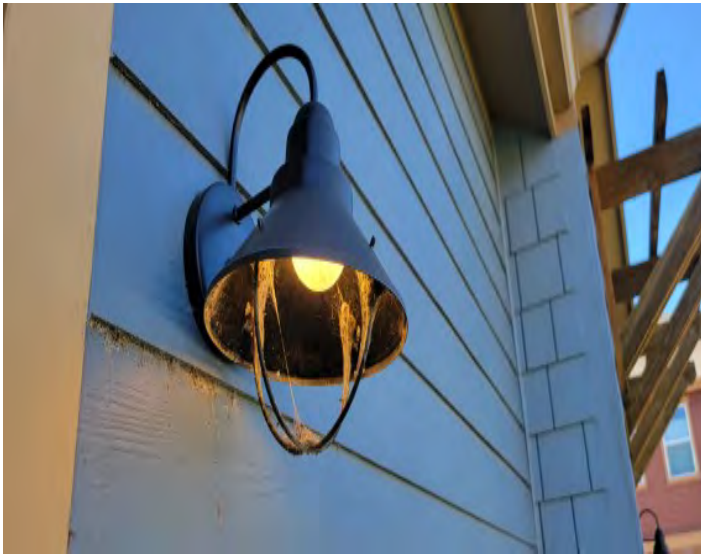
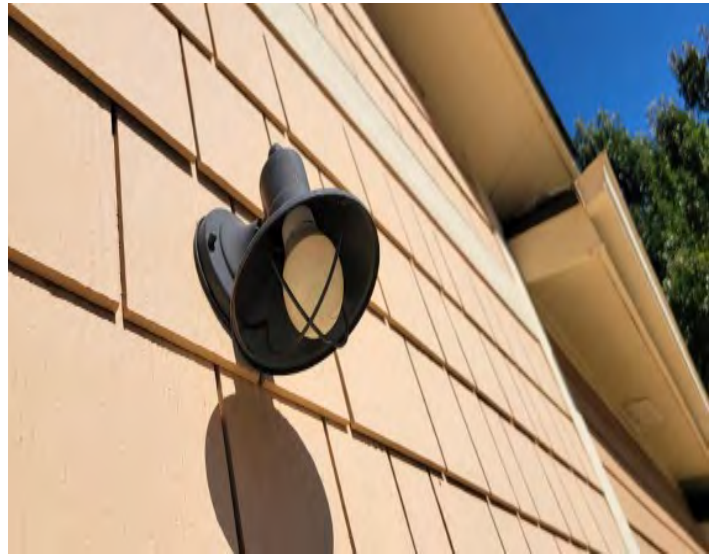
Comp #: 1602 Exterior Wall mount - Replace (Ph 3)

- While replacement can occur on an as needed basis, it is our opinion and recommendation to replace all lights at the same time every 15 - 20 years to maintain a consistent appearance throughout the property.
- By replacing multiple fixtures, the association will be able to obtain a quantity discount for replacement and installation of the fixtures.
- This will also ensure a consistent appearance for the community by replacing all at the same time.

*Best Cost:* **\$22,725**  
\$225/light; Estimate to replace 101 lights

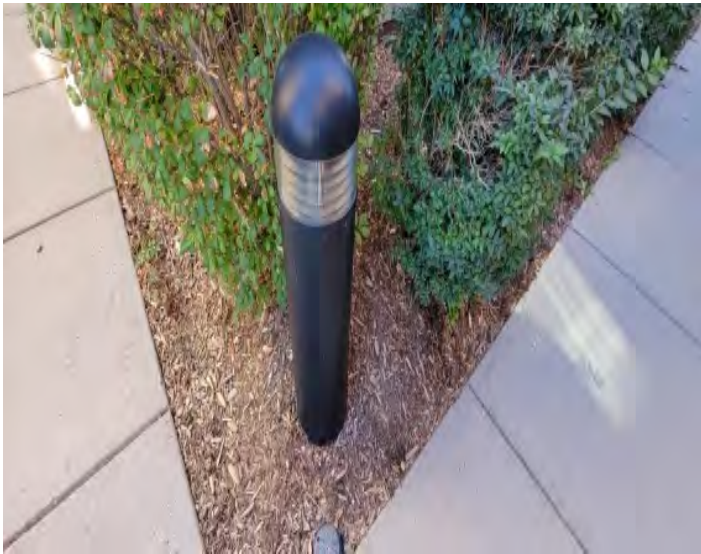
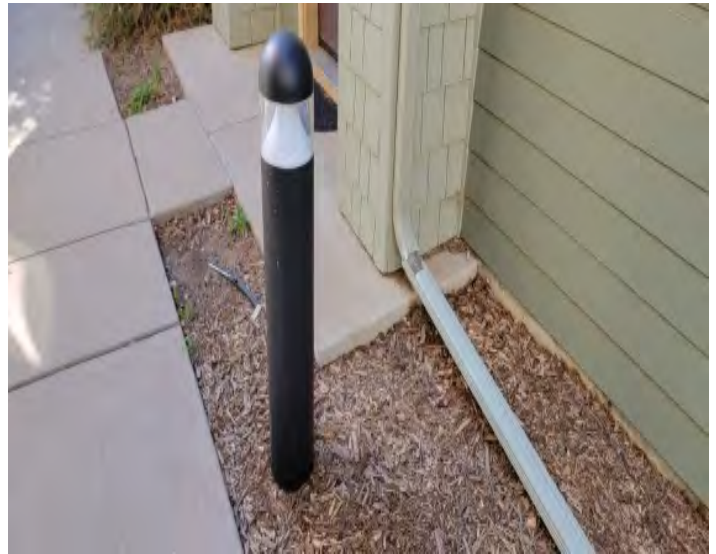
Comp #: 1605    Bollard Lights - Replace

- One light in the 10351/10381 section has been replaced due to unknown reasons.
- Majority of lights appeared in good to fair condition with the only consistent issue being faded and/or thinning paint near the base (at grade).
- The typical useful life for this type of fixture is 18 - 20 years with a high level of maintenance and care.

*Best Cost:*                    **\$28,000**  
 \$700/light; Estimate to replace

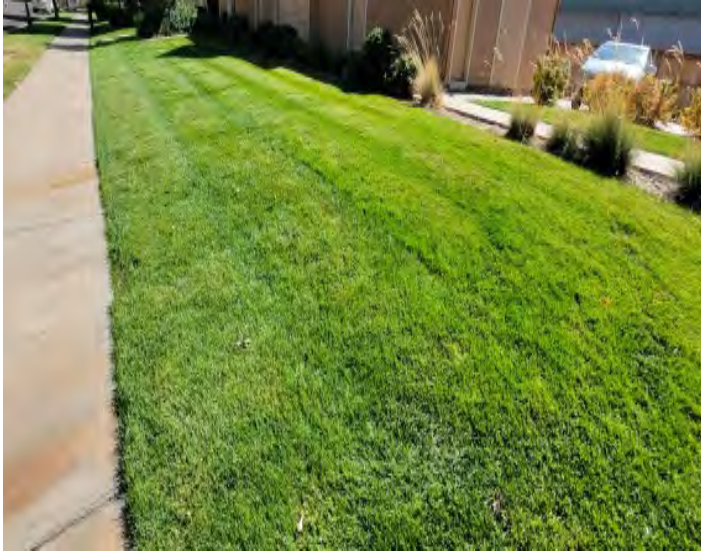
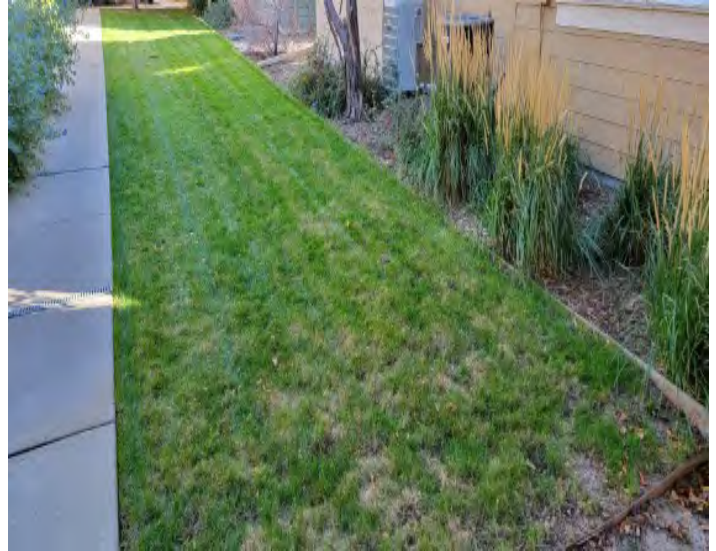
Comp #: 1701      Irrigation System - Rebuild

- This line item is for repairs and replacement that lies outside the scope of routine maintenance: bulk sprinkler head replacement, bulk valve replacement, backflow devices, rerouting lateral lines, rewiring, etc.
- In order to ensure the funds are available for major repairs, we recommend reserving funds for these projects every 4 - 5 years.
- The funding on this line item is for major repairs and is not to be interpreted as complete irrigation system replacement.

*Best Cost:*                    **\$16,500**  
 Estimate for major repairs and renovating system

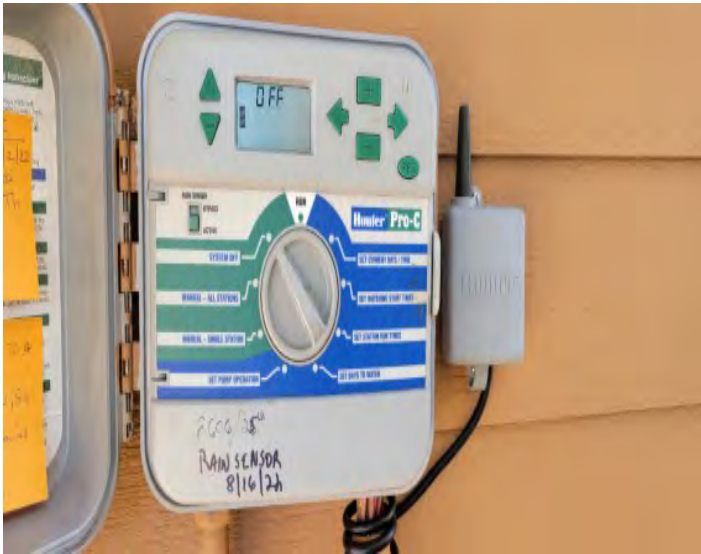
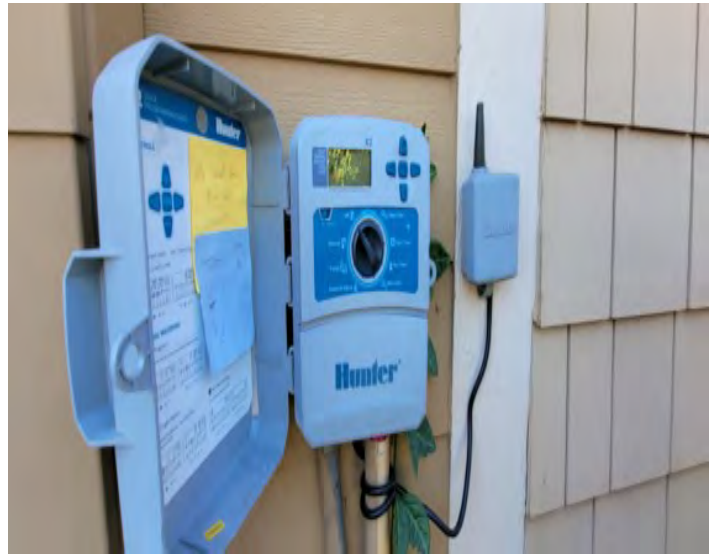
Comp #: 1703    Irrigation Timeclocks - Replace

- Approximately 6 controllers have been replaced over the past 4 years. The rest are original to when the property was constructed.
- The overall life expectancy of irrigation controllers typically ranges between 10 - 12 years if properly maintained and under normal conditions.
- Due to the varying types and ages of controllers, we have established a Reserve allowance for partial replacement of controllers every 3 years.
- This line item should not be intended to be interpreted as complete replacement.

*Best Cost:*                    **\$6,000**  
 \$1500/clock; Estimate to replace 4 controllers every 4 years

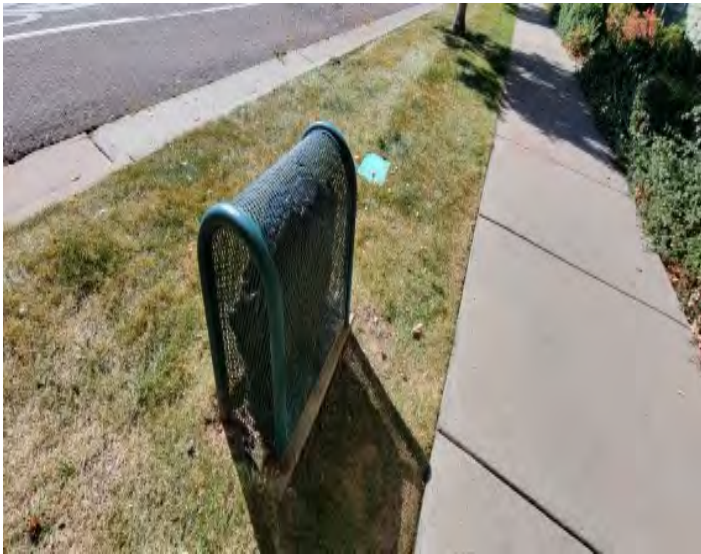
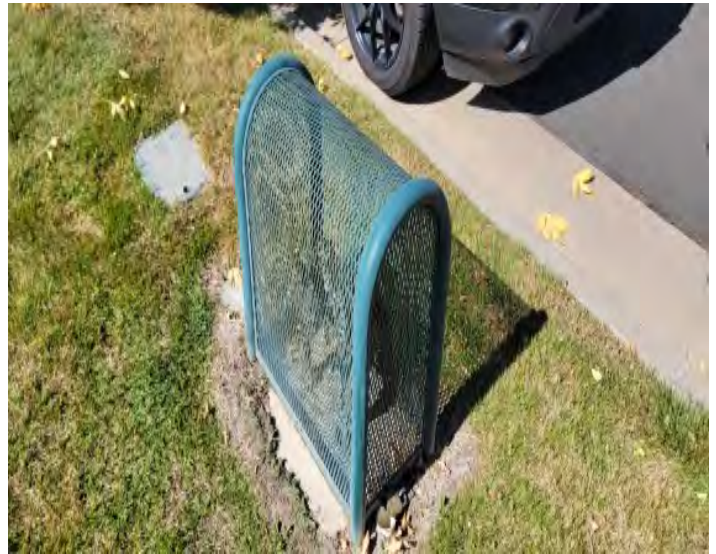
Comp #: 1706 Backflow Devices/Cages - Replace

- Devices are enclosed in a protective enclosure to prevent theft. No reported problems with any of the devices.
- Due to the ability to rebuild and replace these devices for a relatively low cost and the fact that failure of the device is unpredictable, we do not recommend reserving for replacement.
- Repair and/or replace these devices/enclosures on an as needed basis using operating funds, or include as part of major irrigation repairs (See component #1701)

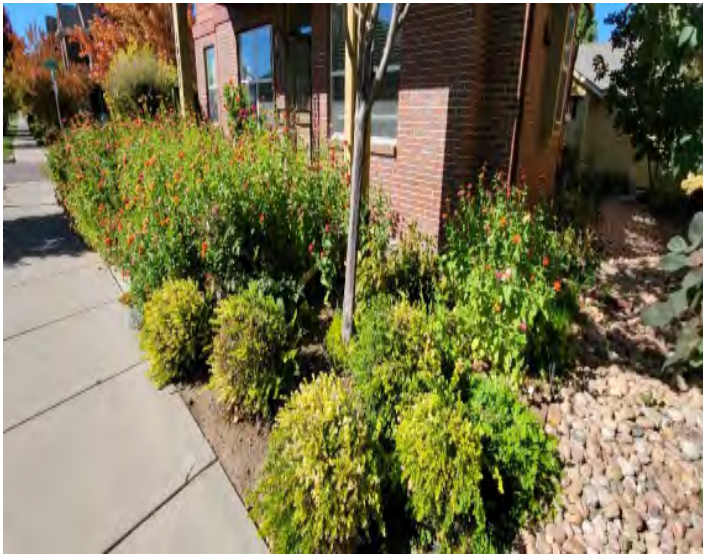
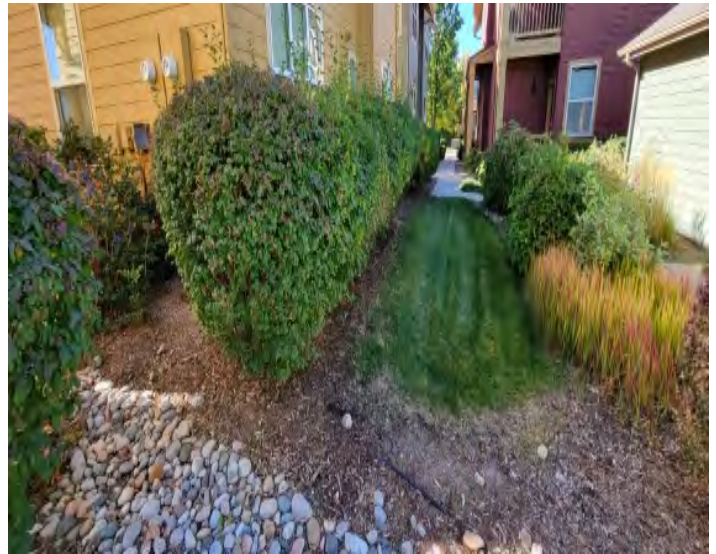
Comp #: 1801      Groundcover - Replenish

- This line item, similar to irrigation repairs, is for projects that lie outside the scope of routine maintenance.
- In order to preserve an attractive curb appeal and to maintain the health of the plants and shrubs, we recommend reserving for refurbishment projects every 2 - 4 years.
- This line item is for cyclical refurbishment and should not be considered as complete landscaping replacement.

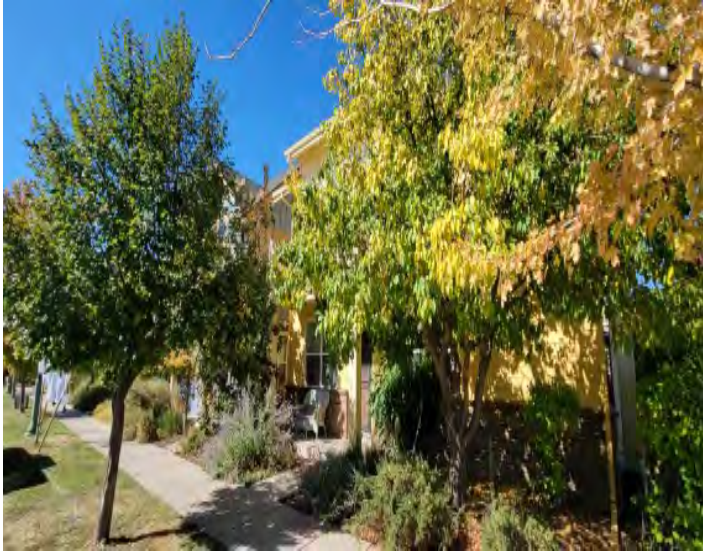
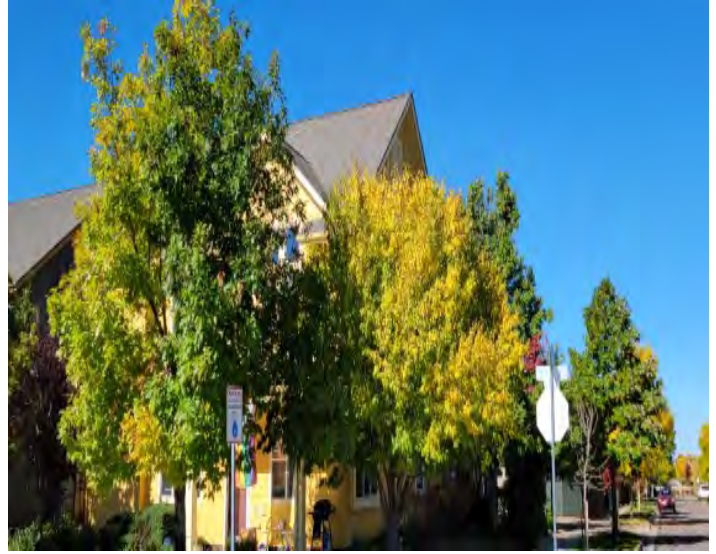
Comp #: 1804 Tree - Replacement/Major Maintenance

- It is very difficult to predict a replacement cycle for trees as there are several factors that will contribute to a tree dying. - Factors such as disease, infestation of insects, heavy snow storms, etc. can all attribute to eventual tree replacement. - Since it is difficult to predict when the replacement will be necessary, Reserve funding is typically not a factor. - However, based on our recent experience, an allowance for periodic replacement has been included.

*Best Cost:* **\$8,000**  
Allowance for major maintenance/replacement
