Level 2, Premium Reserve Analysis

# Carriage Homes at Stapleton

8606 E. 25<sup>th</sup> Pl.  
Denver, CO. 80236

## FINAL VERSION

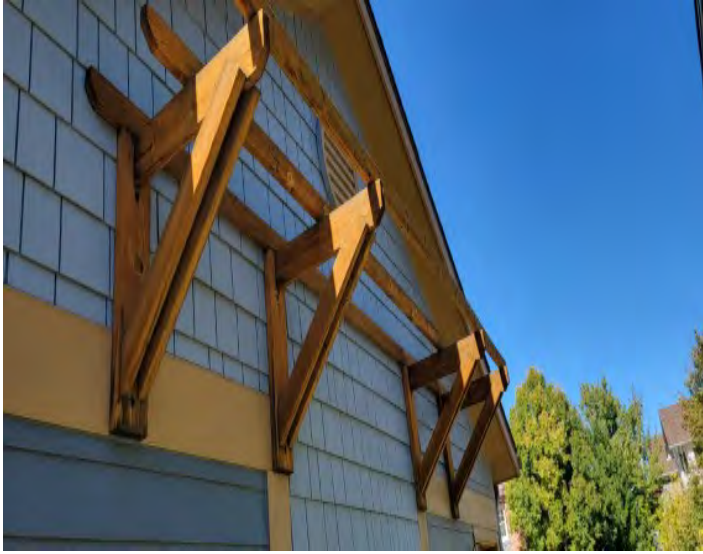
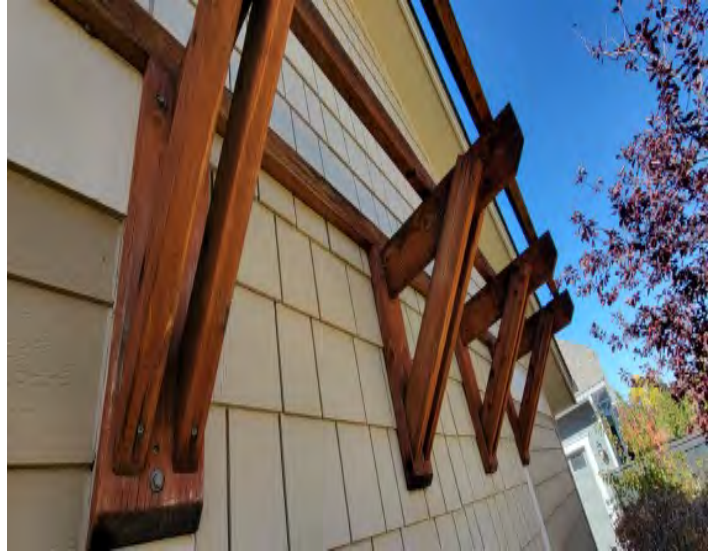
Comp #: 2001 Wood Trellis' - Replace

- All trellis' were weathered and in fair condition with typical signs of deterioration for raw wood in this climate.
- We suggest repairing these as part of prep work before painting.
- Therefore, separate Reserve funding is not required for this component at this time.
