# Greenbrook Townhouses Reserve Study

Reserve Study  
Project No. 15041

Prepared for  
Greenbrook Townhouses Association  
Aurora, Colorado

April 18, 2016

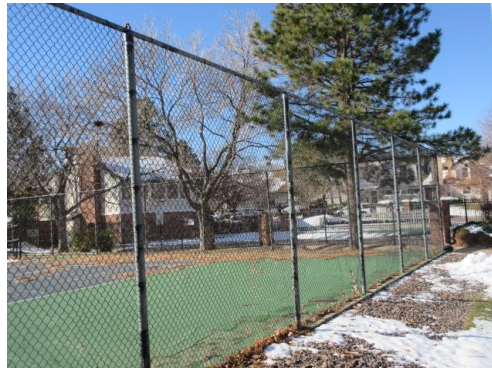
**Description:** Estimated 350 linear feet of 10-foot high vinyl coated chain link fence.

**Condition:** Fair condition.

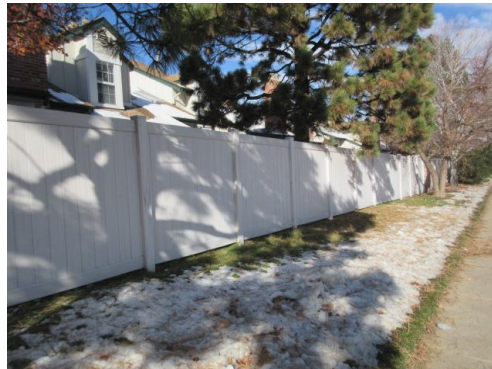
**Description:** Estimated 2,375 linear feet of white vinyl fencing intermittent between 1,056 square feet of brick veneered columns.

**Condition:** The vinyl fencing is in excellent condition. The brick veneered columns are in good condition.

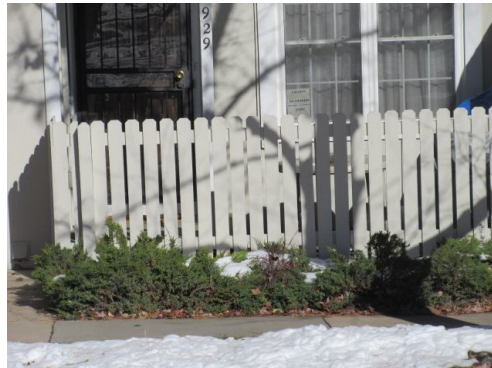
**Description:** Estimated 1,513 linear feet of 4-foot high, white painted wood patio fencing for the 1<sup>st</sup> phase townhomes.

**Condition:** Good condition. We noted that fencing has been painted in the last couple of years.

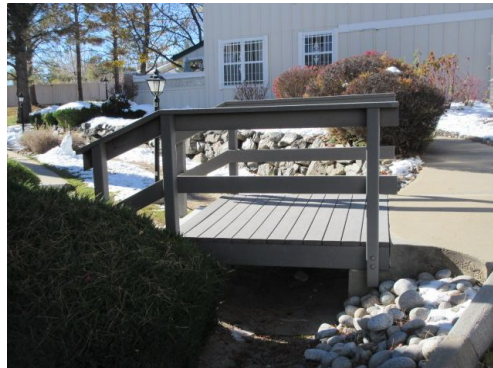
**Description:** The bridge is built with Trex® floor boards and railing. The decking has an under-structured wood frame with an estimated 390 square feet of Trex® deck boards and Trex® built-in benches.

**Condition:** The bridge and deck are in good condition.

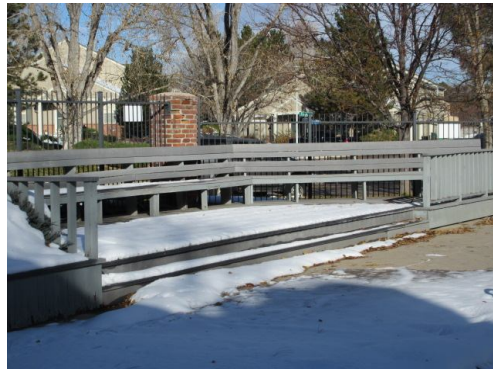
**Description:** The bridge is built with Trex® floor boards and railing. The decking has an under-structured wood frame with an estimated 390 square feet of Trex® deck boards and Trex® built-in benches.

**Condition:** The bridge and deck are in good condition.

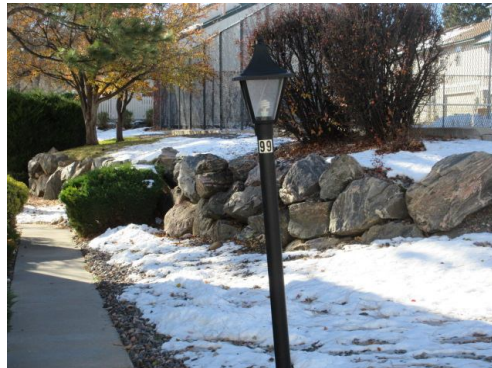
**Description:** Estimated 110 pathway pole lights. The lights have a 6-foot tall metal pole with lantern type light housing attached to the top of the pole. The majority of the pole lights are anchored in concrete with several anchored with soil.

**Condition:** The site observation was performed during the day, so we cannot verify if lights are in good working condition but aesthetically they are in good to fair condition. We noted that several pole lights are tilted.

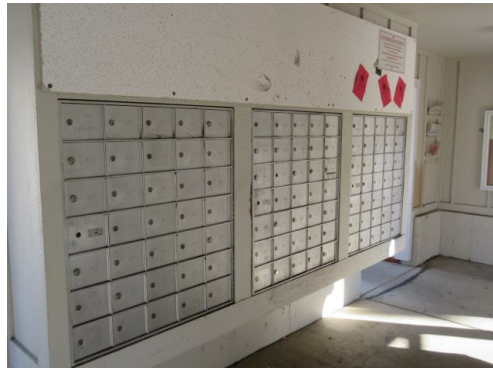
**Description:** There are six 35-door front loading mailboxes, two 21-door front loading mailboxes, and ten sets of 2-package boxes.

**Condition:** Fair condition, with some signs of corrosion.

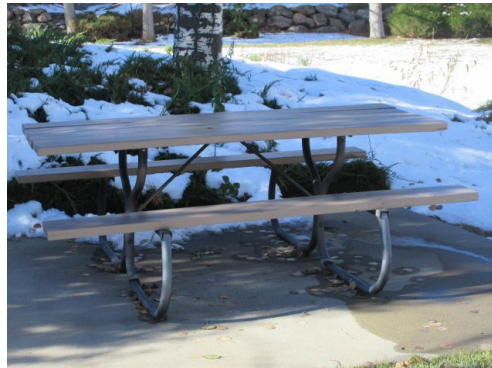
**Description:** Two composite picnic tables with powder-coated steel legs.

**Condition:** Good condition.

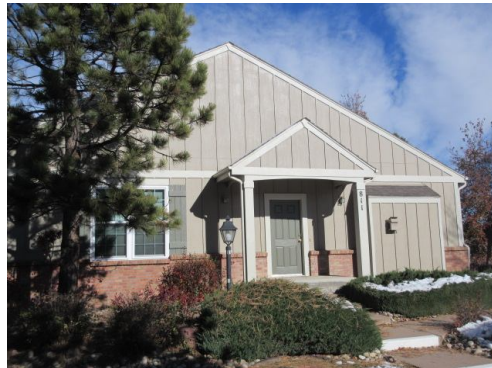
**Description:** Various species of trees, shrubs, and plants.

**Condition:** Good condition.

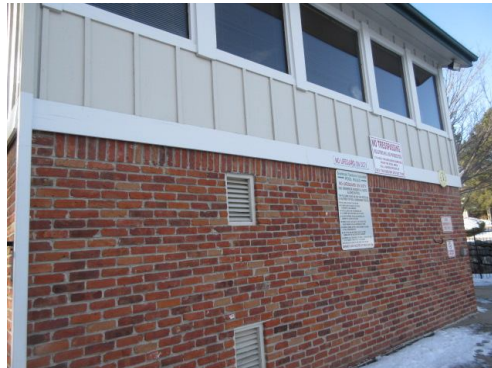
**Description:** Estimated 20,204 square feet of brick veneer with mortar joints.

**Condition:** Good condition.

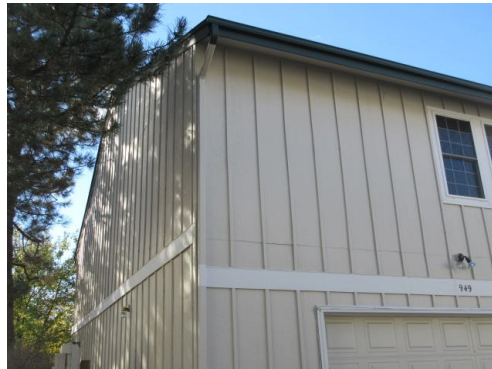
**Description:** Estimated total of 194,201 square feet of vertically-orient, channel board siding. The trim around the windows and at corners is installed on the top of the siding boards. Lap siding is installed in the horizontal direction for the Phase 2 patios.

**Condition:** Good condition.

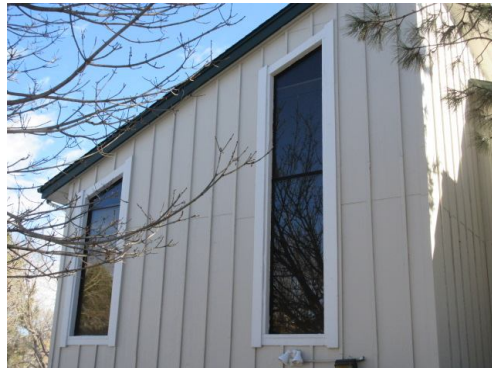
**Description:** Nine wood framed windows.

**Condition:** Good to fair condition based on age and efficiency.

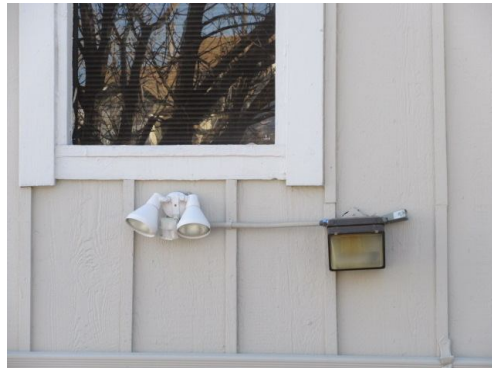
**Description:** Eleven exterior, wall- and ceiling-mounted fixtures composed of glass and metal.

**Condition:** Good condition.

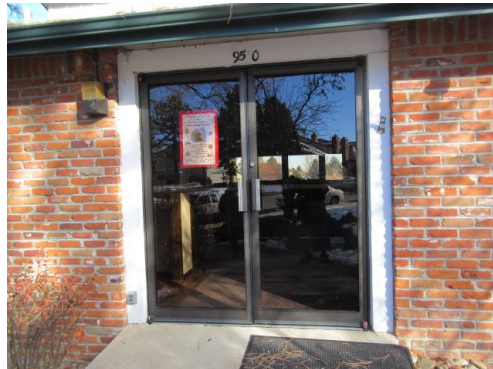
**Description:** Four glass and steel, 6-foot panel doors at the clubhouse entrances.

**Condition:** Good condition.

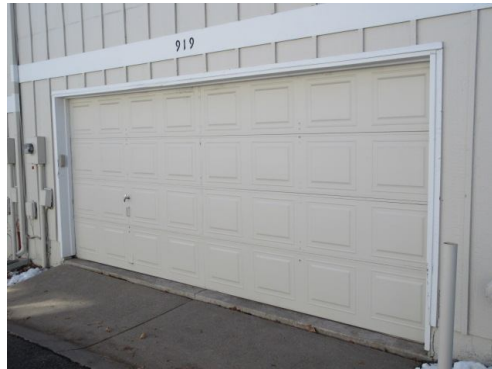
**Description:** 212 panelized metal garage doors.

**Condition:** The paint is in good condition. We were informed that the Association is only responsible for painting the garage doors.

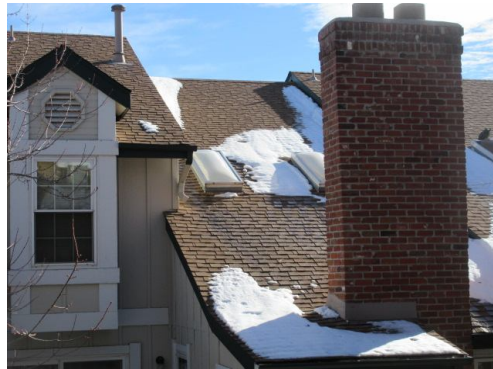
**Description:** Estimated total of 3,586 squares of asphalt shingles over a membrane.

**Condition:** Good to fair condition.

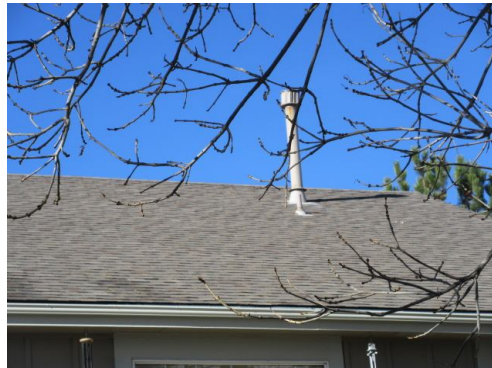
**Description:** Estimated total of 3,586 squares of asphalt shingles over a membrane.

**Condition:** Good to fair condition.

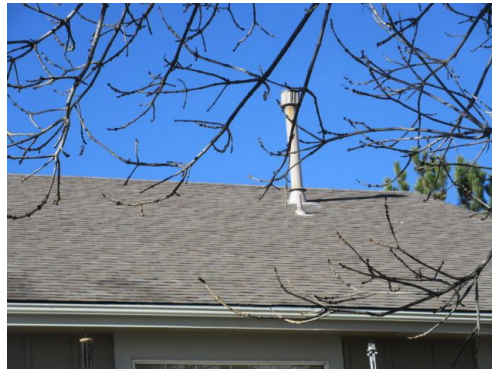
**Description:** Estimated 14,942 linear feet of aluminum gutters, downspouts, and extensions.

**Condition:** Good to fair condition. We noted some areas where the arrangement of the downspout extensions are displacing landscaping materials and other locations where the current geometry is unsatisfactory for effectively conveying the runoff from the roof.

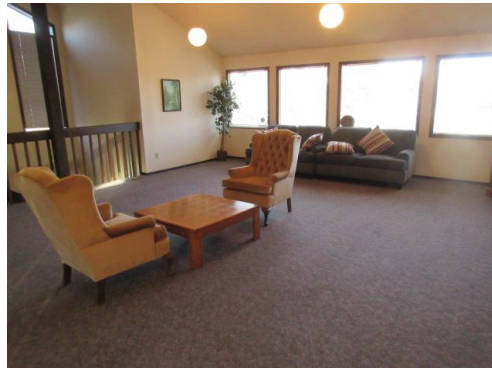
**Description:** There are four cushioned chairs, one corner couch, and one table with four matching chairs, two end tables, three lamps, and five pieces of wall art.

**Condition:** Fair condition based on aesthetic appearance.

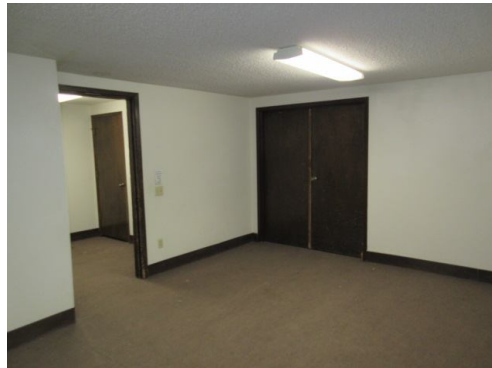
**Description:** Estimated 4,867 square feet of painted drywall walls and ceilings.

**Condition:** Good condition.

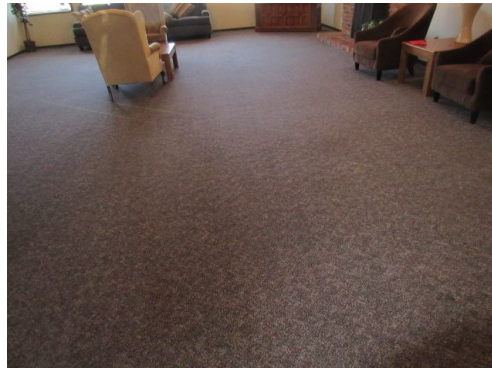
**Description:** The majority of the flooring for the interior common areas is finished with commercial grade carpet, estimated at 1,311 square feet. The upper level bathrooms and kitchen is finished with brick tile flooring, estimated at 264 square feet.

**Condition:** Fair condition based on aesthetic appearance. We noted significant wear associated with the lower level carpeting.

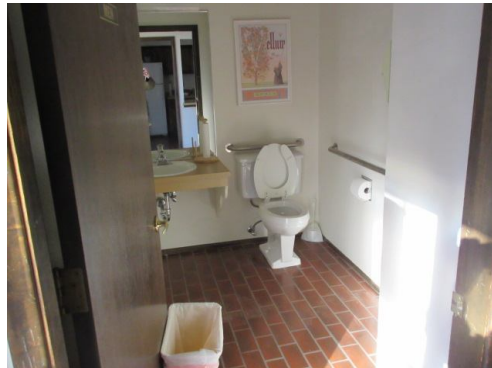
**Description:** The majority of the flooring for the interior common areas is finished with commercial grade carpet, estimated at 1,311 square feet. The upper level bathrooms and kitchen is finished with brick tile flooring, estimated at 264 square feet.

**Condition:** Fair condition based on aesthetic appearance. We noted significant wear associated with the lower level carpeting.

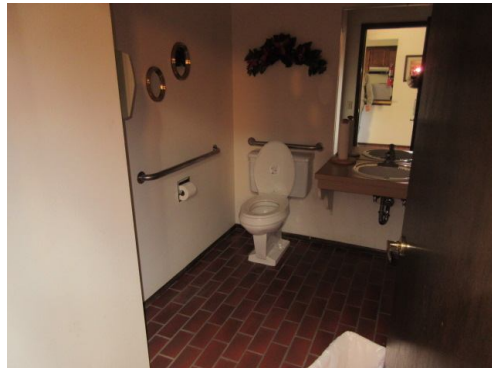
**Description:** The two upper level restrooms each have a toilet, sink, brick tile flooring, countertop, and mirror. The two lower level restrooms each have a toilet, sink, concrete flooring, ceramic tile walls, shower, countertop, and mirror.

**Condition:** Fair condition.

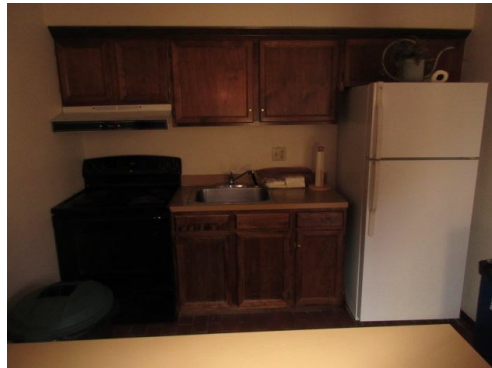
**Description:** There is a microwave, full size refrigerator, electric stove, cabinets, sink, and countertops.

**Condition:** Fair condition.

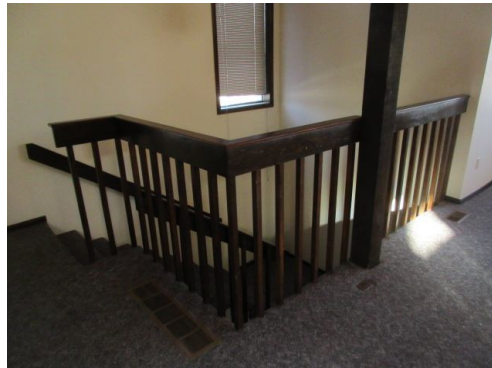
**Description:** Estimated 35 linear feet of wood guardrails and handrails associated with the stairs and ledge.

**Condition:** Good condition.

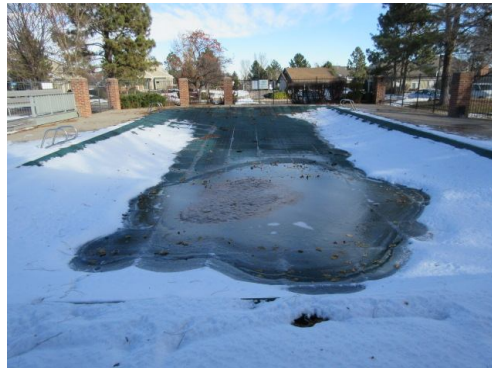
**Description:** Estimated 3,188 square feet of swimming pool surface. The swimming pool is finished with a cementitious plaster basin. The pool coping appears to be colored and stamped concrete product integral with the pool deck.

**Condition:** The pool surface is in good to fair condition.

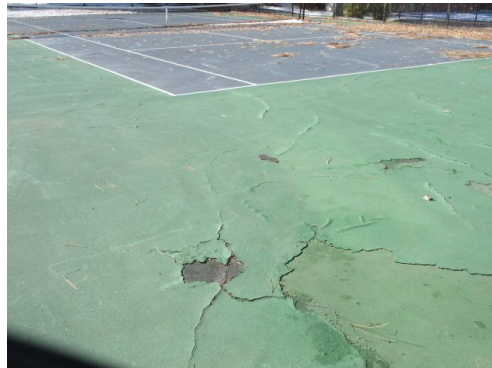
**Description:** Hard court surface tennis court.

**Condition:** Poor condition with cracking and spalling noted.

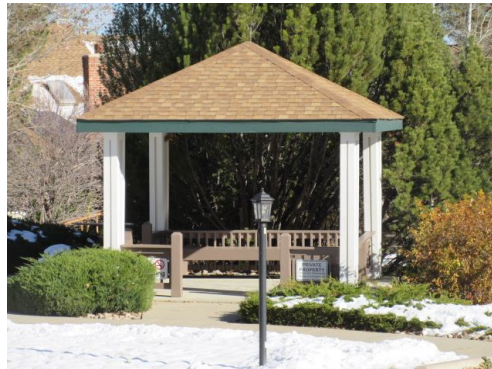
**Description:** Asphalt shingled roof structure with wood trim and fascia supported by four wood posts. The interior of the gazebo area contains built-in wooden benches.

**Condition:** Good condition.

- Remove and replace the asphalt shingled roof in 2025.
- Cyclically inspect and repair damaged or deteriorated wood components associated with the gazebo every year. This cost is not included in the Study because normally associations perform this as a maintenance item and the cost is considered an operating expense.

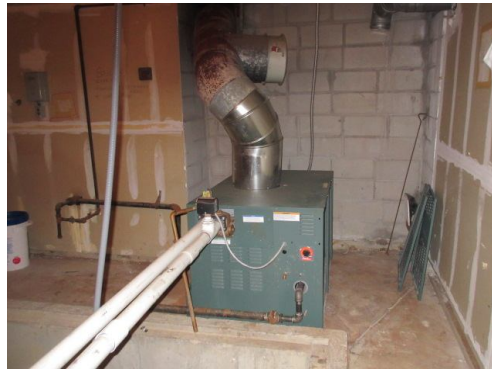
**Description:** Model WH-970, Parker Boiler Company gas fired boiler assembly.

**Condition:** Good condition

- Remove and replace the boiler in 2044.

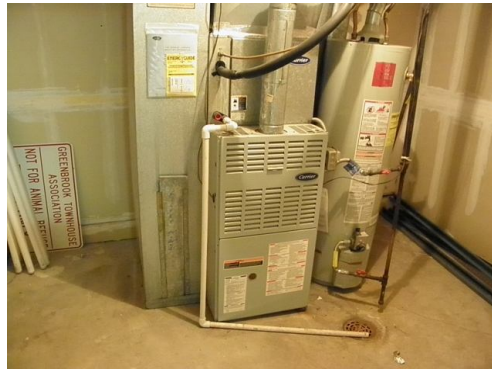
**Description:** Model 58PAV111-16, Carrier forced air natural gas furnace. The unit has an input rating of 110,000 BTU/hr. output rating of 89,000 BTU/hr., and maximum outlet temperature of 185°F.

**Condition:** We were informed that this unit is in good working condition.

- Remove and replace the furnace in 2030.

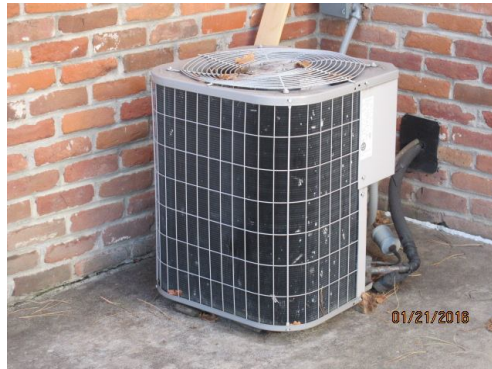
**Description:** Model 38CKC, Carrier Weather Mate Series air conditioner. The air conditioner has a seasonal energy efficiency ratio of 11.5.

**Condition:** We were informed that this unit is in good working condition.

- Cyclically remove and replace the air conditioner unit every 20 years, starting in 2020.

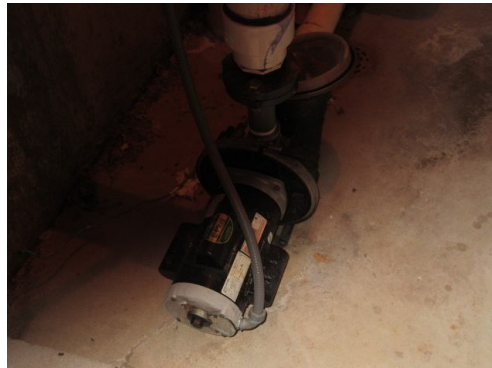
**Description:** Pentair Pool Products, 5 horsepower Challenger circulation pump.

**Condition:** We were informed that this unit is in good working condition.

- Cyclically replace the circulation pump every 10 years, starting in 2023.

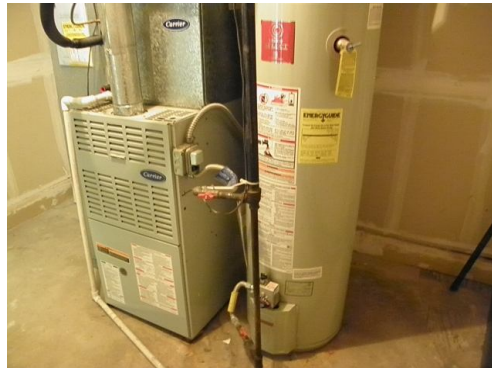
**Description:** Model PR640, State Select automatic storage water heater. The water heater has a 40 gallon capacity with an input rating of 40,000 BTU/hr.

**Condition:** We were informed this water heater is in good condition.

- Cyclically replace the water heater every 15 years, starting in 2018.

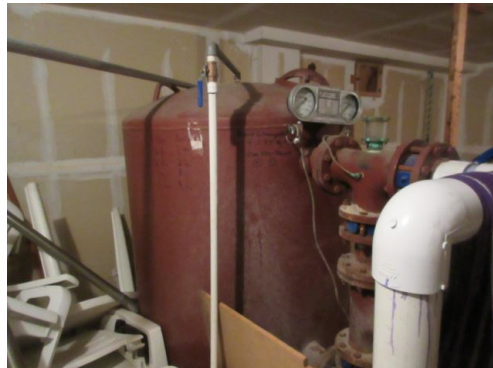
**Description:** Model HRL-48, Swimquip sand filter. The filter has filtration area of 12.6 square feet and a design flow capacity of 15 to 20 gallons per minute.

**Condition:** Fair to poor condition based on age.

- Remove the sand filter and replace with a cartridge filtration system in 2020.
