Regarding: Reserve Study Final Version

Level 1, Platinum Reserve Analysis

Innsbruck in Aurora COA, Inc. 2503 S. Peoria Aurora, CO. 80014

Date of Property Observation – August 30, 2022

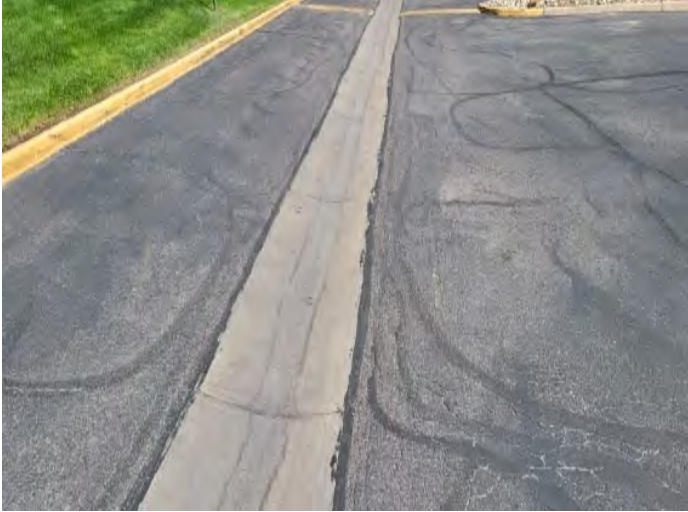
Comp #: 403 Concrete Drive Materials - Partial Replace

- Majority of the drain pans are in good condition, but many curbs and gutters are cracked and damaged.
- It is unlikely that all concrete will fail and need to be replaced at the same time. Therefore, we recommend reserving an allowance for periodic repairs to a percentage (10% or 1100 GSF) of the total area.
- Coordinate this project with other concrete and/or asphalt projects for best cost estimates based on quantity of work.
- This line item is not intended to be interpreted as complete replacement.

Allowance to replace 10% of area every 4 yrs.

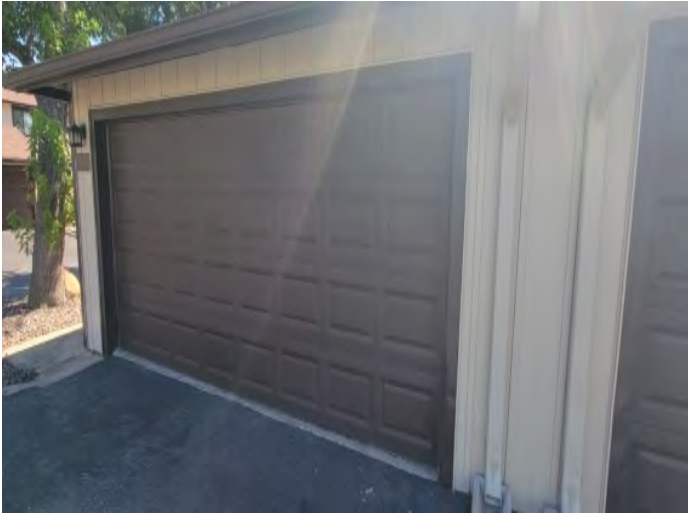
Comp #: 502 Garage Doors - Replace

- According to Article 8, subsection 1 (a), the association shall maintain the exterior of the buildings, provided however that such exterior maintenance shall not include doors (except painting).
- Some associations decide to include garage doors as an association expense to obtain the best cost available and to maintain a consistent appearance for the association.
- Unless otherwise noted, Reserve funding will not be included based on the rules stated in the declarations.
- We suggest the association establish a design guideline so that when an owner goes to replace a door, it will match and be consistent with the others.

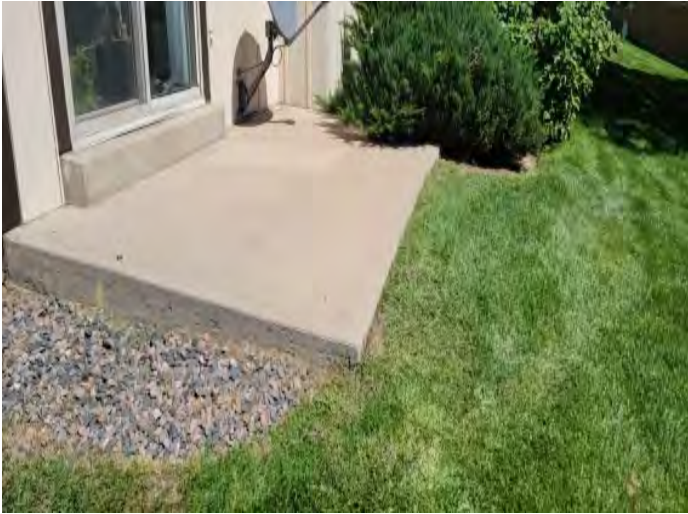
Comp #: 601 Concrete Flatwork - Partial Replace

- Similar to other concrete assets within the community, it is unlikely that all will fail at the same time, therefore, we recommend reserving to replace approximately 10% of the total area (1,475 GSF) every 4 years.
- Coordinate this project with other concrete projects for best cost estimates based on quantity of work.

Allowance to repair 10% of area every 4 years

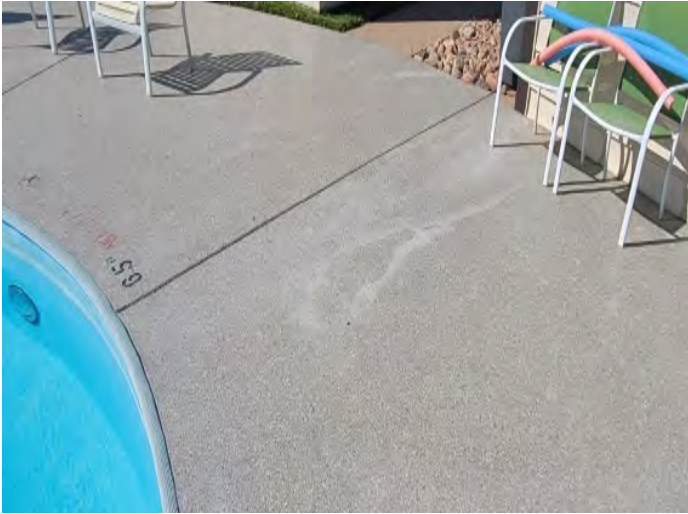
Comp #: 608 Pool Deck - Replace

- At some point, an epoxy coating was applied to the pool deck. This surface is very slippery when it gets wet, and there are sections of the deck that are deteriorating.
- To improve the safety of the deck, it is recommended the pool deck is replaced
- Since the liner needs to be replaced, and the skimmers are at the end of their life as well, we recommend doing a full renovation of the pool area at the same time for best cost estimate and best results.

\$17/GSF; Estimate to replace

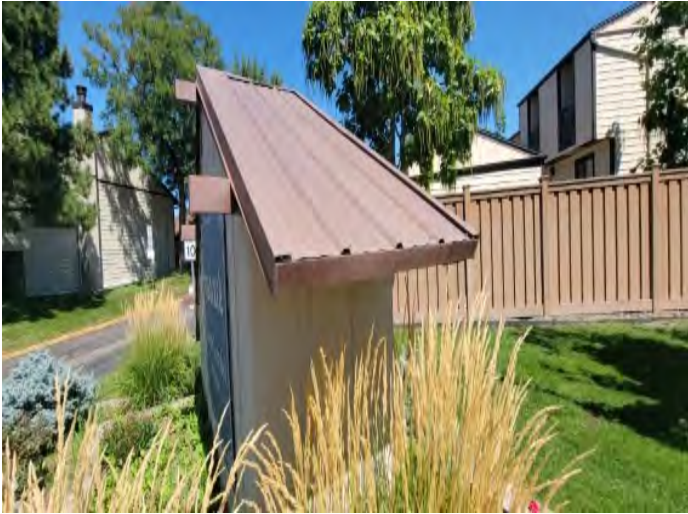
Comp #: 801 Monuments - Rebuild

- The monument structure appeared in good condition at time of observation with no noticeable damage to the materials.
- It is unlikely that the monument will require replacement or rebuilding due to the materials failing. However, due to changes in decorative trends, we recommend reserving to update the monument every 20 - 25 years to ensure an appropriate and attractive appearance to the community entrance.

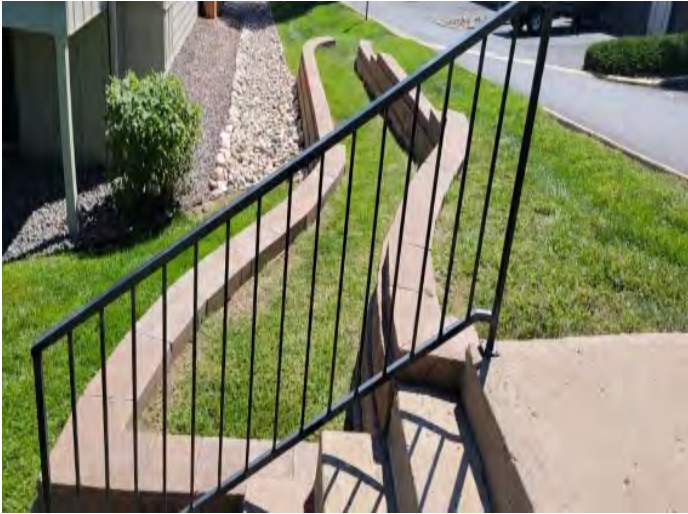
Comp #: 1002 Hand Rails - Replace

- Due to small quantity, we recommend replacing these on an as needed basis with general operating funds.

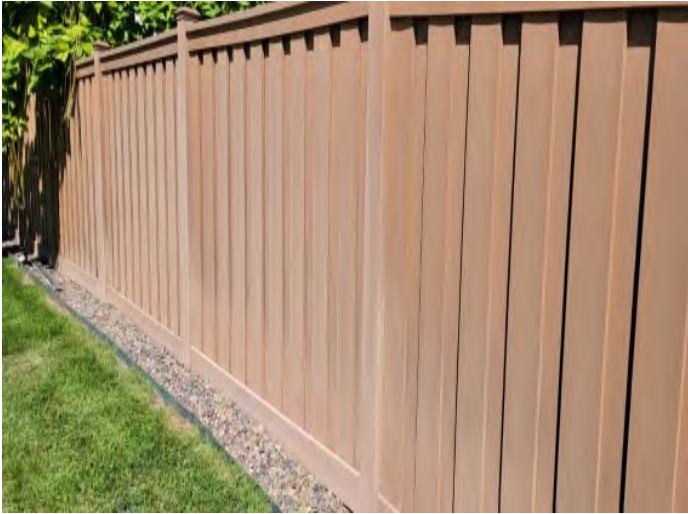
Comp #: 1008 Composite Fencing - Replace

- According to the manufacturer, Trex products shall be free of material defects in workmanship and materials, and shall not check, split, splinter, rot, or suffer structural damage from termites or fungal decay.
- The commercial warranty for Trex fencing is 10 years that is offered from the manufacturer.
- Since this product was introduced to the industry, we have seen some minor warping, discoloring from irrigation spray, and minor cracking that gradually starts developing after approximately 10 - 15 years from installation date
- At the current time, we suggest establishing a replacement cycle of 25 years.

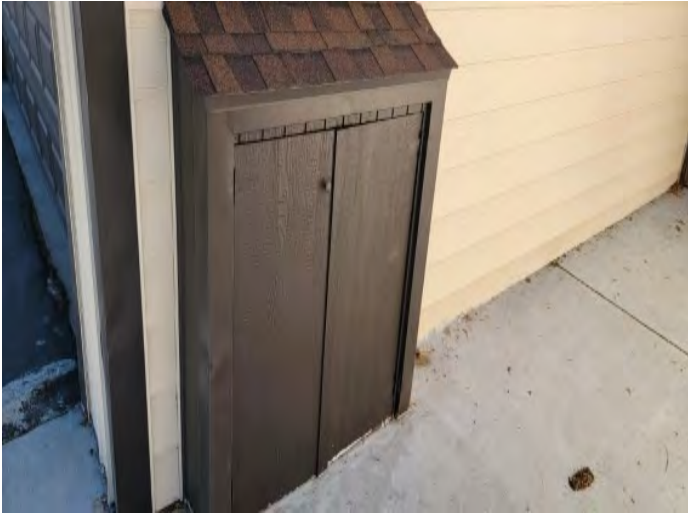
Comp #: 1010 Trash Cabinets - Rebuild

- Conditions vary throughout community
- We recommend treating repairs on an as needed basis with general operating funds, or include as part of prep work prior to painting.
- Therefore, at this time, separate Reserve funding is not required for this component

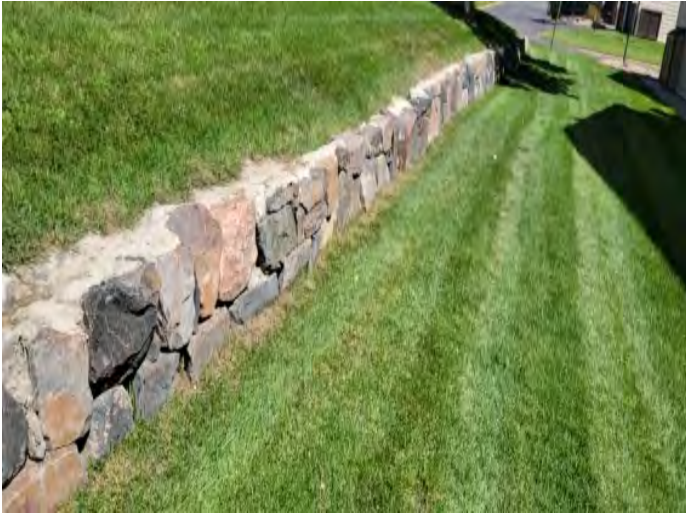
Comp #: 1011 Rock Wall - Replace

- Wall appears to be structurally stable and in good condition.
- This wall should have an indefinite life expectancy and replacement is unlikely.
- At this time, separate Reserve funding is not required for this component.

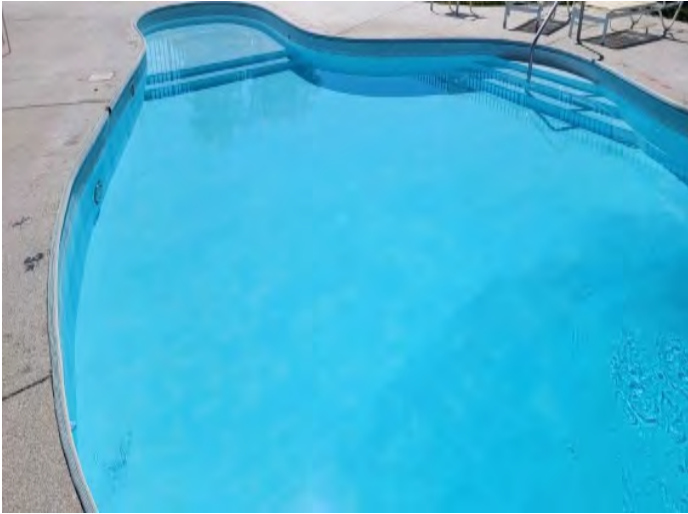
Comp #: 1101 Fiberglass Pool - Reline

- It was reported there is a small hole in the liner that needs to be repaired.
- Depending on the quality of the liner, in our experience, we have seen these liners last on average 20 - 25 years
- Based on the age of the liner and the report of a hole, we recommend the association plan on replacing the liner soon.
- Since the pool deck needs to be replaced and one of the skimmers is not working, we recommend planning on a total retrofit of the pool area this year.

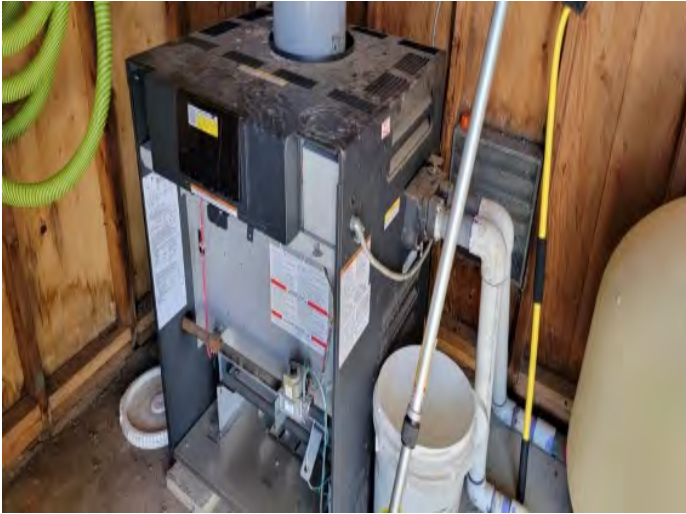
Comp #: 1105 Pool Heater - Replace

- Heater is about 5 years old and there are no signs of scaling or deterioration under the burners.
- The overall life expectancy depends on the level of maintenance and the quality of the water running through the system.
- For this type of heater, the average replacement cycle will range between 12 - 18 years with proper maintenance and under normal conditions.

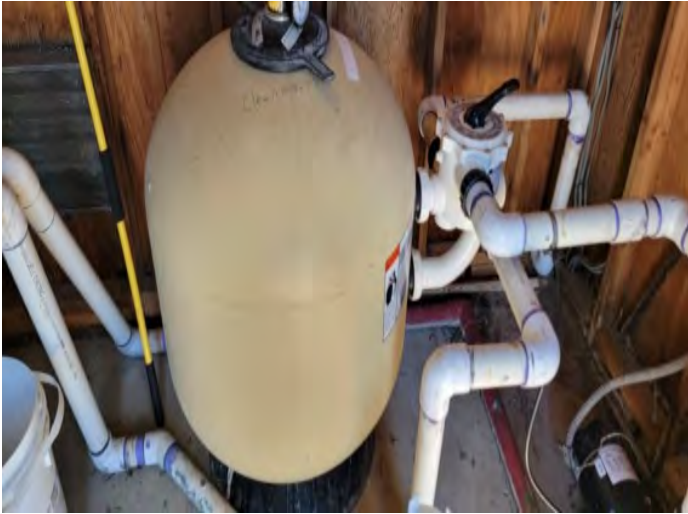
Comp #: 1108 Pool Filter - Replace

- Filtration system is almost 10 years and there are no reported problems with the system.
- The shell will have an extended useful life of 18 - 20 years and most leaks can be attributed to gaskets and seals that can be replaced on an as needed basis.
- Remove and replace filter sand on an as needed basis using operating funds.

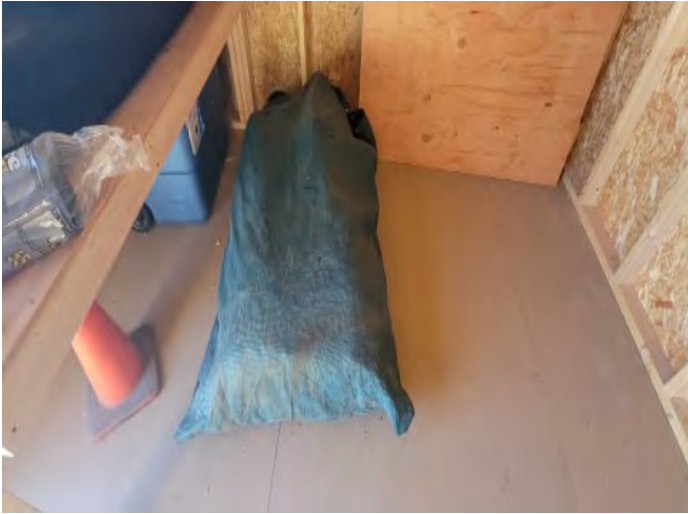
Comp #: 1113 Pool Cover - Replace

- Pool cover was rolled up and in storage at time of site evaluation. Of the sections of the cover we were able to evaluate, there were a few small holes noted.
- While most cover manufacturers carry a 10 - 15 year warranty against defects, there are strict storage requirements to adhere to the warranty.
- In this environment, the cover fabric typically has a life expectancy of 8 - 12 years in most situations
- The replacement cost is a little higher than normal for the pool cover due to the need for a custom design.

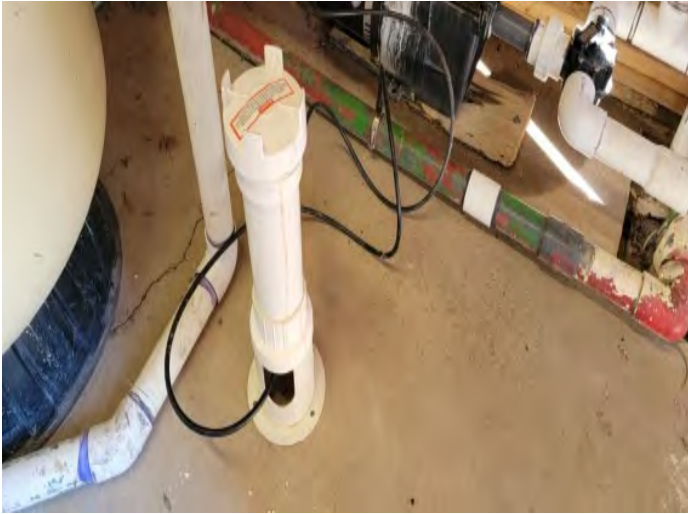
Comp #: 1117 Miscellaneous Pool Equipment - Replace

- The individual replacement cost of these items is too small for separate Reserve designation.
- Replace on an as needed basis with general operating funds.

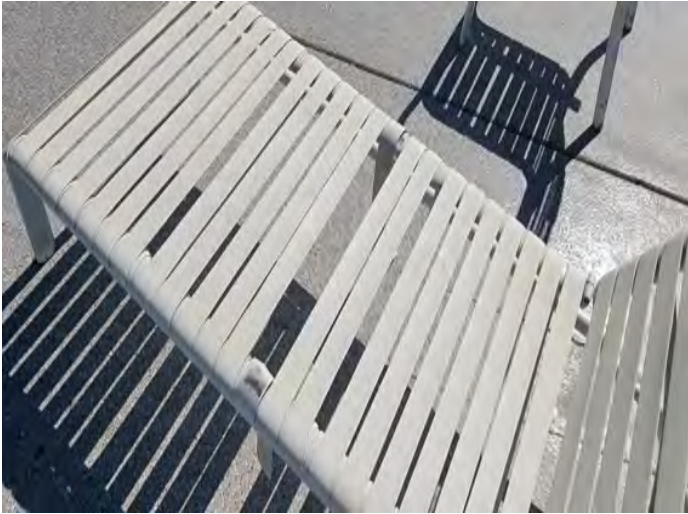
Comp #: 1121 Pool Furniture - Replace

- Straps are in poor condition, they are cracking and rotting. Types of furniture varies, and it appears the association purchases pieces as needed.
- Due to varying types of furniture and different levels of use each piece received, we recommend establishing funds for partial replacement every 5 years.
- Remaining life is based on the observed conditions of the strapped furniture.

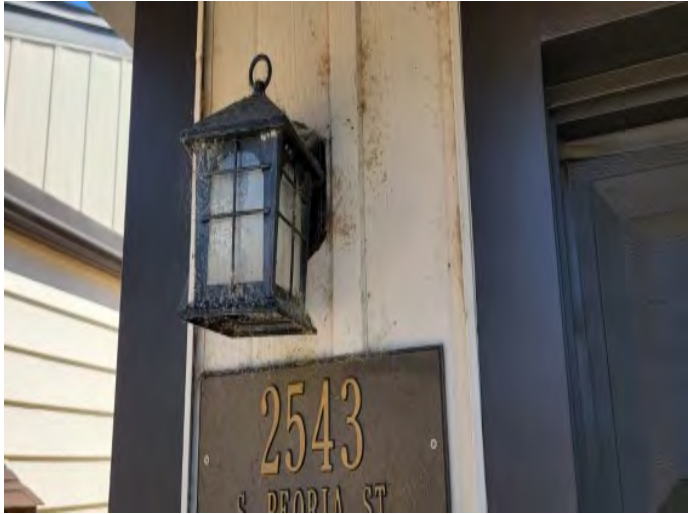
Comp #: 1602 Exterior Wall Mount - Replace

- Lights differ from unit to unit, but according to the declarations, the association is responsible for repair, replacement, and maintenance of light fixtures (Article 8, section 8.1 (b))
- While replacement can occur on an as needed basis, it is our opinion and recommendation to replace all lights at the same time every 15 - 20 years to maintain a consistent appearance throughout the property.
- In addition, by replacing multiple fixtures, the association will be able to obtain a quantity discount for the fixtures.

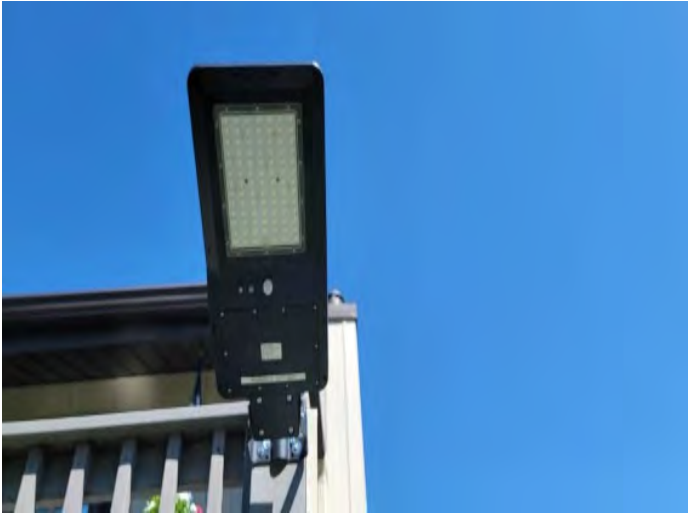
Comp #: 1612 LED Wall Paks - Replace

- Styles of lights differ on various decks. It appears these have been installed at various times as the need arises.
- LED technology is still relatively young, but is expected to have at least a 10 - 15 year life expectancy under normal conditions
- If projections differ from expectations, then the useful life can be adjusted in future Reserve Study updates.

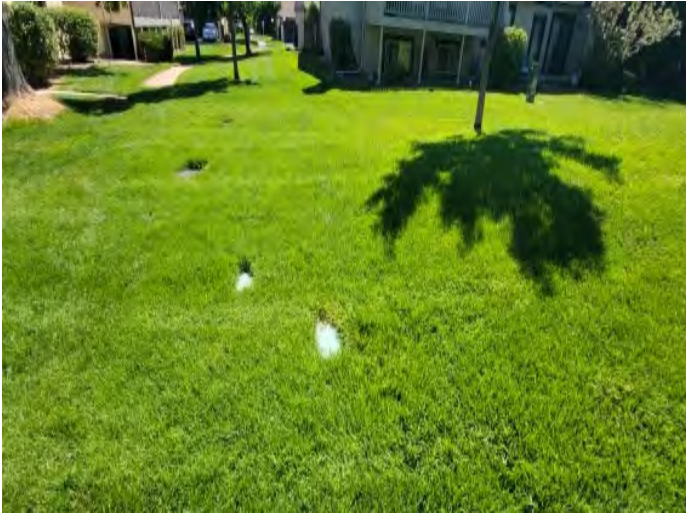
Comp #: 1701 Irrigation System - Major Repairs

- This line item is for repairs and replacement that lies outside the scope of routine maintenance: bulk sprinkler head replacement, bulk valve replacement, controller, backflow device, rerouting lateral lines, rewiring, etc.
- In order to ensure the funds are available for major repairs, we recommend reserving funds for these projects every 4 - 5 years.
- The funding on this line item is for major repairs and is not to be interpreted as complete irrigation system replacement.

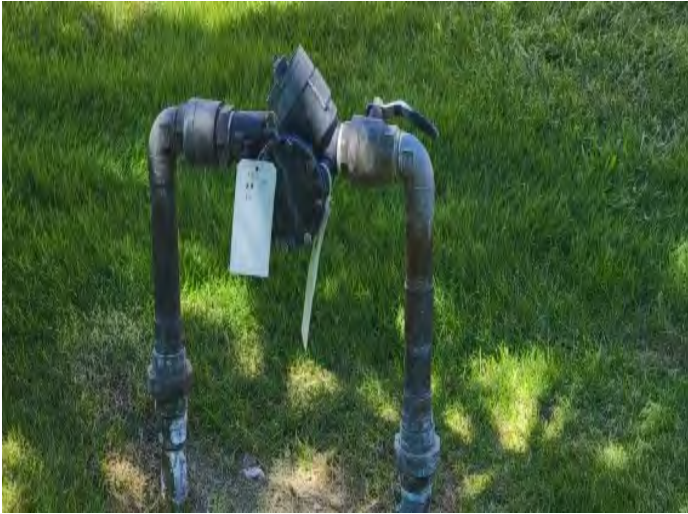
Comp #: 1706 Backflow Devices - Replace

- No reported problems with any of the devices.
- Due to the ability to rebuild and replace these devices for a relatively low cost and the fact that failure of the device is unpredictable, we do not recommend reserving for replacement.
- Repair and/or replace these devices on an as needed basis using operating funds.

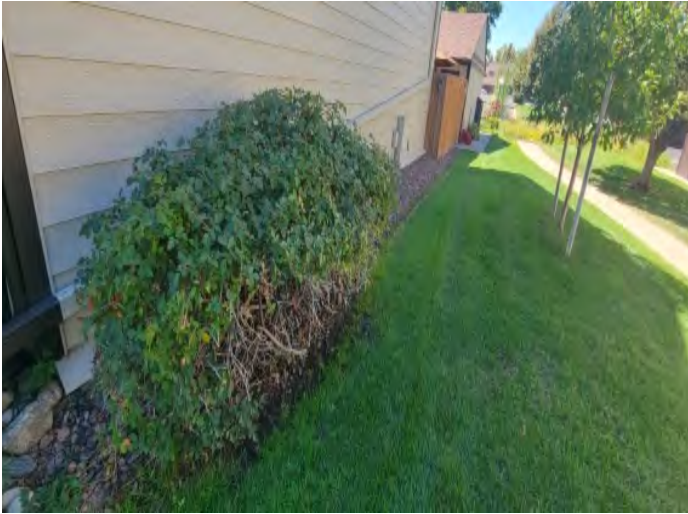
Comp #: 1801 Groundcover - Replenish

- The majority of the edging has corroded to a point that it either is not effective, or is dangerous for bare feet.
- Also, there is a lot of juniper bushes that can be a fire hazard for careless people discarding cigarettes.
- This line item, similar to irrigation repairs, is for projects that lie outside the scope of routine maintenance.
- In order to preserve an attractive curb appeal and to maintain the health of the plants and shrubs, we recommend reserving for refurbishment projects every 2 - 3 years.
- This line item is for cyclical refurbishment and should not be considered as complete landscaping replacement.

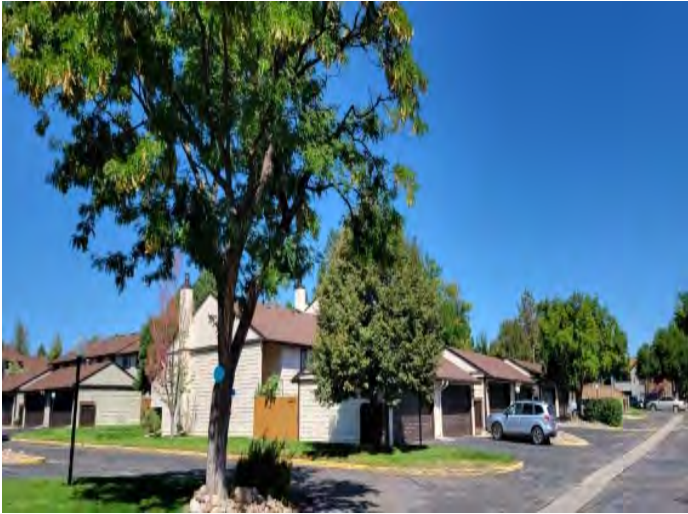
Comp #: 1804 Tree - Replacement/Major Maintenance

- It is very difficult to predict a replacement cycle for trees as there are several factors that will contribute to a tree dying.
- Factors such as disease, infestation of insects, heavy snow storms, etc. can all attribute to eventual tree replacement.
- Since it is difficult to predict when the replacement will be necessary, Reserve funding is typically not a factor.
- However, based on our recent experience, an allowance for periodic replacement has been included.

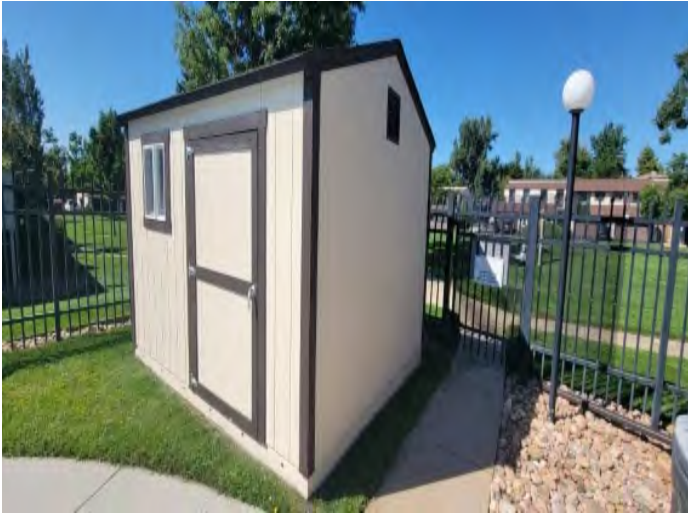
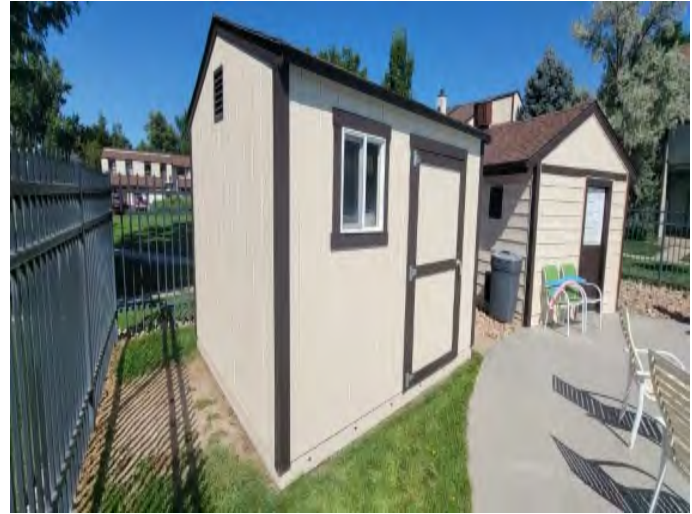
Comp #: 1904 Storage Shed - Replace

- Shed appears to be relatively new and in good condition.
- We recommending painting every 5 - 6 years as an operating expense to protect the materials from exposure to elements that can cause deterioration.
- As long as proper maintenance occurs and there is limited exposure to elements (irrigation spray, snow and ice buildup), then the replacement cycle of these sheds ranges from 20 - 25 years
